SB Number:	SB 2H9-021	Creation Date: 10/01/2012	
Subject:	Paper empty mis-detection when the paper cassette is full		
Model:	FS-1028MFP/1128MFP/1030MFP/1130MFP/1035MFP/1135MFP

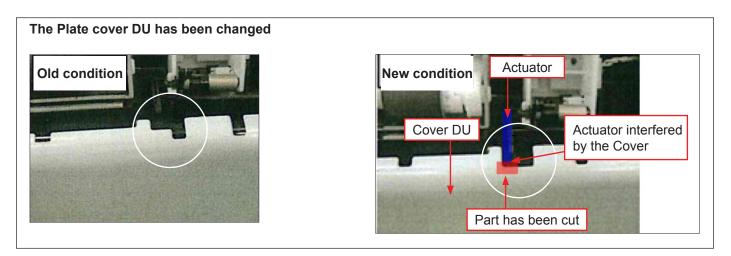
Phenomenon	Paper empty may be mis-detected, if the Paper cassette is fully loaded with paper.	
Cause	The leading edge of the Actuator may be caught by the paper.	
Solution	 The angle of the Actuator stoppage has been changed. Due to the above mentioned change, the shape of the Plate cover DU has been changed (To prevent interference by the Cover DU)

The Actuator has been changed Image: state of the state o

Classification	Entire stock rework	In-field modification at next visit	XIn-field modification by case	No modification necessary
Field measure	The old type of the Cover DU interferes with the latest type of the Actuator . Therefore use the latest type of the Cover DU (Parts plate cover DU assy SP) when replacing the Actuator with the latest type.
