Model: Cor-C1 / Cor-C1_SOP	Date: 05-Sep-14	No.: RD197001e
-----------------------------------	-----------------	----------------

Subject: Firmware Release Note: Engine		Prepared by: T. Tachibana	
From: 2nd Tech Service Sect., MFP/Printer Tech Service Dept.			
Classification:	<input type="checkbox"/> Troubleshooting	<input type="checkbox"/> Part information	<input type="checkbox"/> Action required
	<input type="checkbox"/> Mechanical	<input type="checkbox"/> Electrical	<input type="checkbox"/> Service manual revision
	<input type="checkbox"/> Paper path	<input type="checkbox"/> Transmit/receive	<input type="checkbox"/> Retrofit information
	<input type="checkbox"/> Product Safety	<input checked="" type="checkbox"/> Other (Firmware)	<input checked="" type="checkbox"/> Tier 2

This RTB has been issued to announce the firmware release information for the **Engine**.

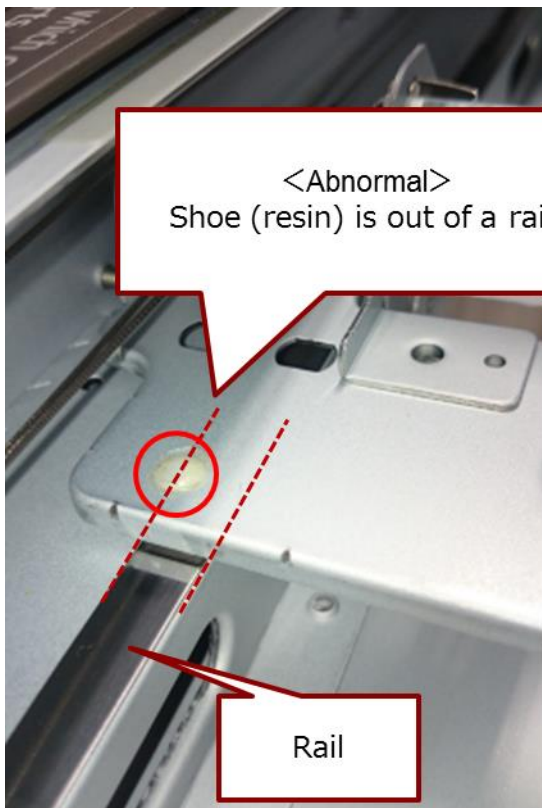
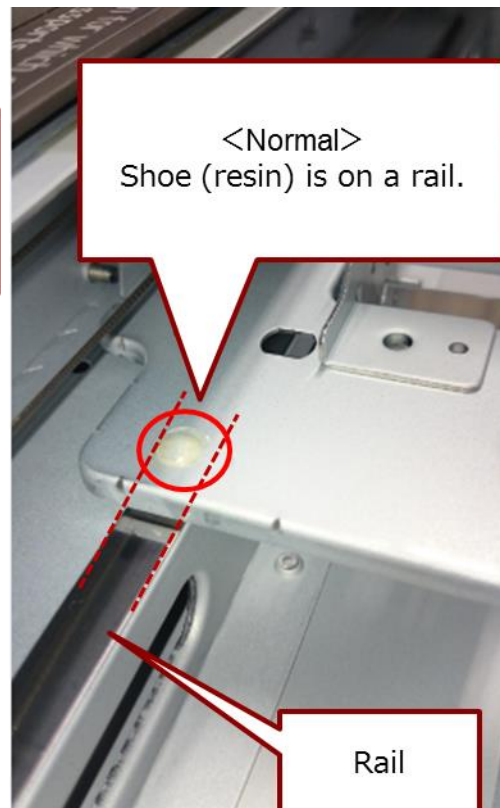
The shoe (resin part circled in red) on the second scanner carriage disengages from the rail, due to shock and/or shaking during machine transport.

- This ensures that the second carriage stays firmly fixed in place. When the first carriage is in this position, the second carriage is supported by the screw (circled in red).
- See Cut-in Serial Numbers below.

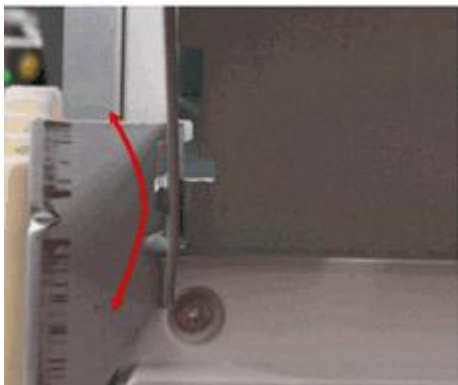
There is a difference in level on the frame of the side plate tray. If the screw is tightened too tightly, the side plate may deform.

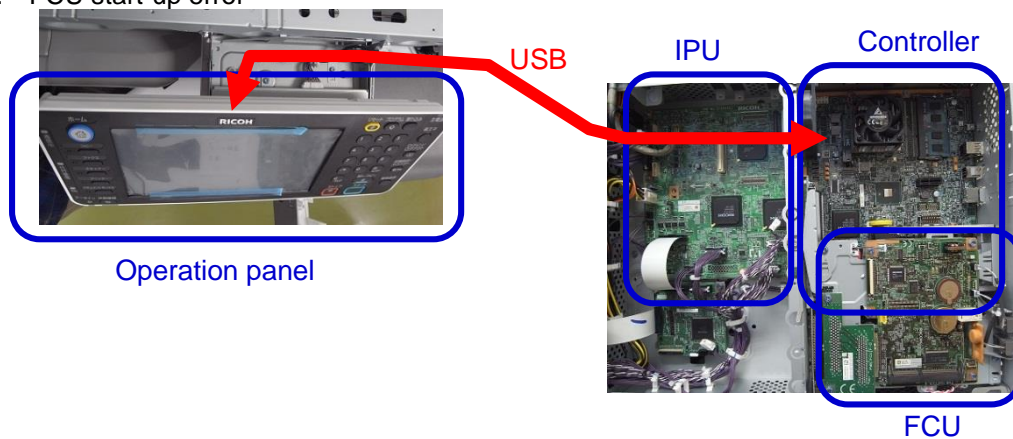
Figure 1: Operation panel, IPU and Controller / FCU

1. Failure of USB communication path (USB cable, IPU)
2. Data corruption of CTL onboard Flash memory
3. Poor supply voltage for CTL onboard ASIC
4. Firmware bug related to the energy saving system
5. Defective CTL onboard converter
6. Defective CTL onboard resistors
7. FCU start-up error

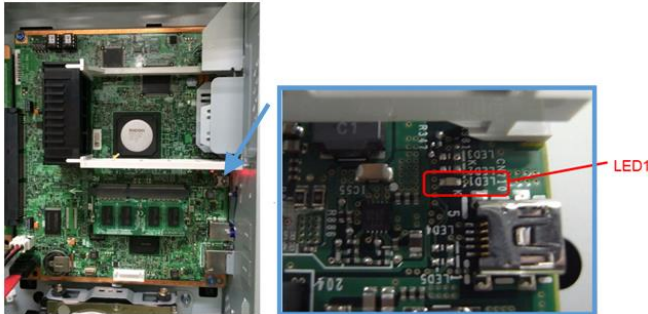
Figure 4: LED 1 on the CTL

No.	Note
LED 1	For CPU - LED blinks when the CPU is operating normally. - LED is lit or off when there is a problem with the CPU.
