Issued by Canon Europa N.V.

iR2270
iR2870
iR3570
iR4570

iR4570-004
(F1-T01-0M4-10007-01)

Service work when rear registration roller compression spring is replaced.

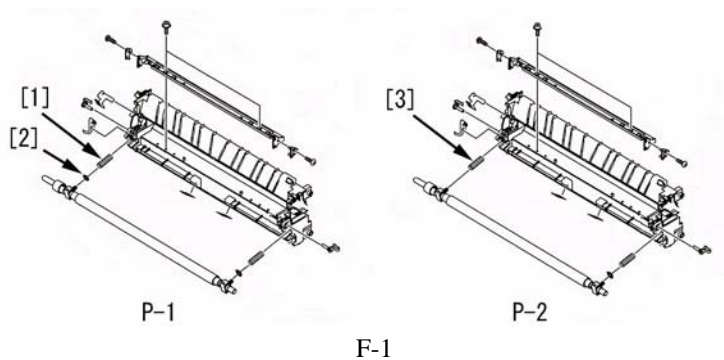
To prevent image distortion occurred around the trailing edge 45mm, a washer has been inserted to the clearance between the rear registration roller compression spring and the registration roller as a tentative measure since the production was started. However, as a permanent measure, the washer is discontinued and the compression spring is changed to increase its spring strength. This is to inform the points to know about service work for this permanent measure.

P-1 Old paper feeder frame assembly

P-2 New paper feeder frame assembly

[1] Old spring (FU6-2014-000 silver color)

[3] New spring (FU6-2020-000 gold color)

[2] Tentatively used washer

1. When the old spring (FU6-2014-000 silver color) is replaced with new one (FU6-2020-000 gold color), be sure to remove the washer before mounting the spring because if it is not removed, it might cause faulty image.
2. There is no change to the front registration roller compression spring (FU5-2611-000) and washer (XD1-1106-219).
