Model: Cor-C1 / Cor-C1_SOP	Date: 05-Sep-14	No.: RD197001e
-----------------------------------	-----------------	----------------

Subject: Firmware Release Note: Engine		Prepared by: T. Tachibana	
From: 2nd Tech Service Sect., MFP/Printer Tech Service Dept.			
Classification:	<input type="checkbox"/> Troubleshooting	<input type="checkbox"/> Part information	<input type="checkbox"/> Action required
	<input type="checkbox"/> Mechanical	<input type="checkbox"/> Electrical	<input type="checkbox"/> Service manual revision
	<input type="checkbox"/> Paper path	<input type="checkbox"/> Transmit/receive	<input type="checkbox"/> Retrofit information
	<input type="checkbox"/> Product Safety	<input checked="" type="checkbox"/> Other (Firmware)	<input checked="" type="checkbox"/> Tier 2

This RTB has been issued to announce the firmware release information for the **Engine**.

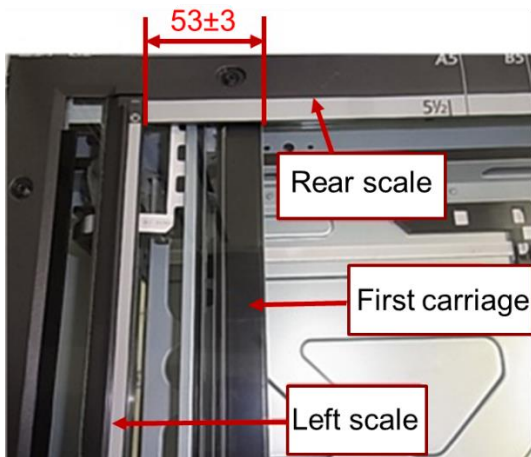
Pic. 1-1

Before:

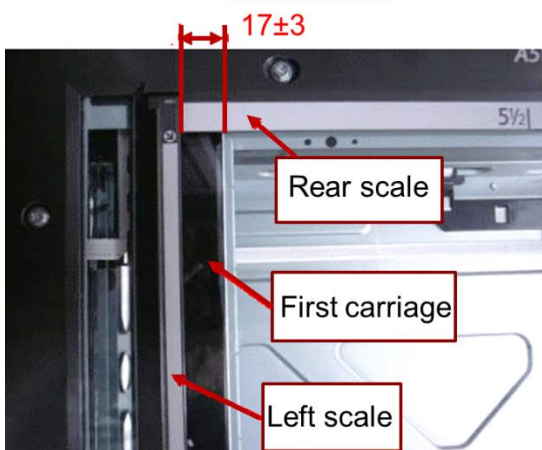
Pic. 1-3

- This ensures that the second carriage stays firmly fixed in place. When the first carriage is in this position, the second carriage is supported by the screw (circled in red).
- See Cut-in Serial Numbers below.

After:

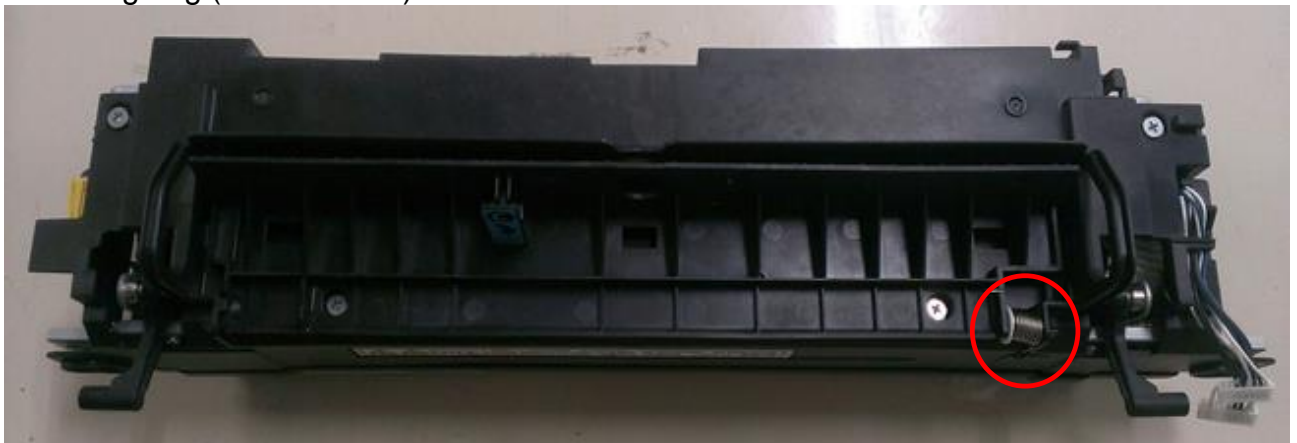
Old part number	New part number	Description	Q'ty	Int	Page	Index	Note
	08050106	RETAINING RINGS-E:SILENCER:DIA6	0-1				Set as X/O
AA061215	AA066435	SPRING:RELEASE:FUSING EXIT	1-1	X/X			
D2024214	D2024215	GUIDE PLATE:FUSING EXIT	1-1	X/X

Retaining ring (circled in red):

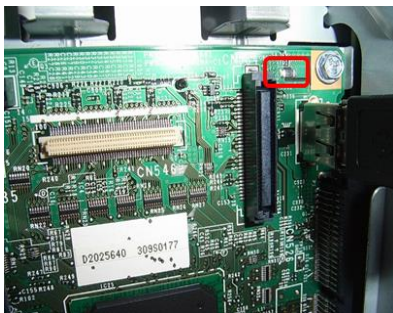
Figure 5: Fuse on the IPU

[B]: Fuse on the IPU

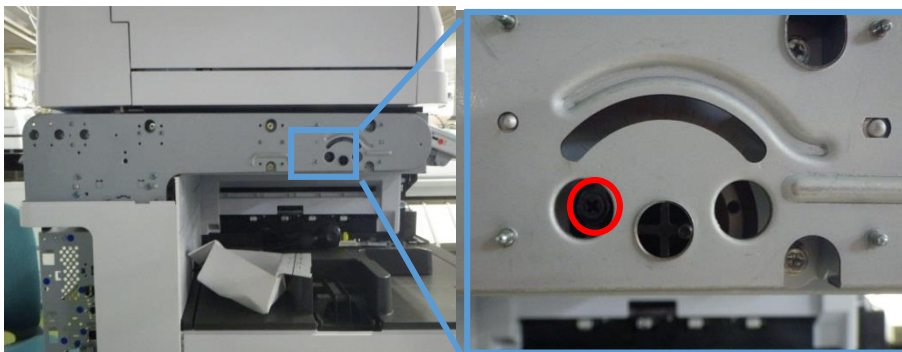
Important:

Never loosen or remove the following screw when you remove or re-attach the unit. This is because this screw fixes the scanner cam in place. If the position of the scanner cam changes, the scanner will be misaligned. This will result in image skew and other image alignment issues.

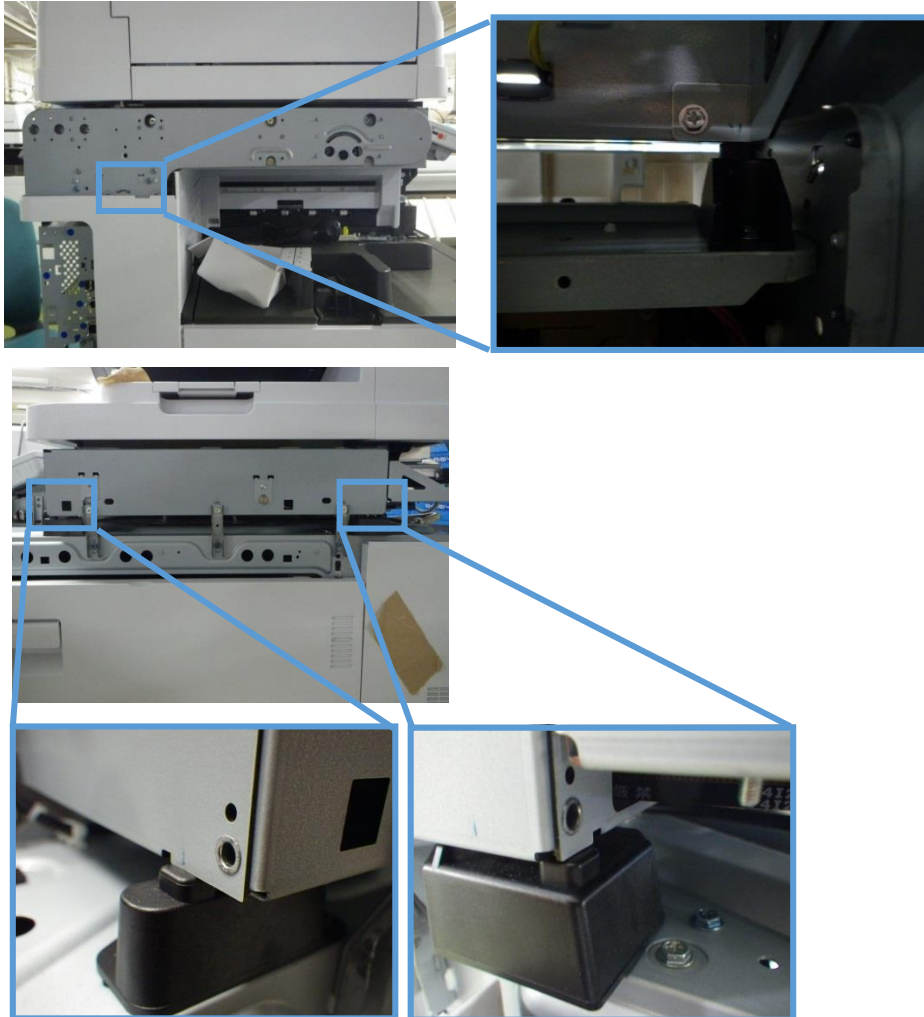
Important

Make sure that there is no space between the machine frame and the following three areas of the scanner unit when you re-attach the scanner unit.
