Xerox® VersaLink® C7000 Color Printer & C7030 Family Color Multifunction Printer Service Manual

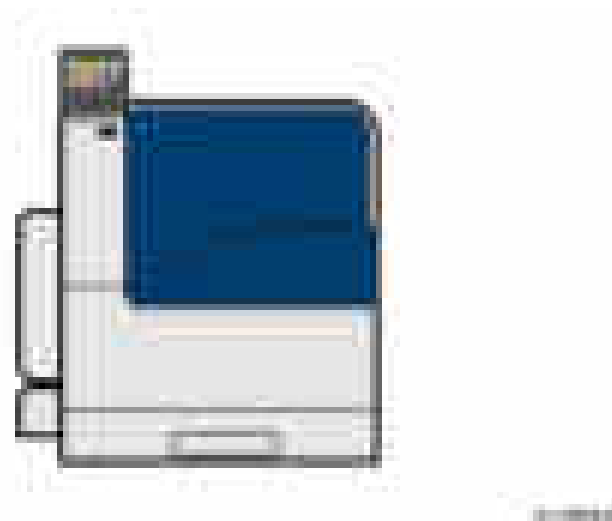
Figure 1 Desktop machine

- Xerox® VersaLink® C7000 desktop, [Figure 1](#).
- Xerox® VersaLink® C7020/C7025/C7030 with integrated finisher and 1TM, [Figure 2](#).
- Xerox® VersaLink® C7020/C7025/C7030 with office finisher LX and 3TM, [Figure 3](#).
- Xerox® VersaLink® C7020/C7025/C7030 with office finisher LX, booklet maker, HCF and TTM, [Figure 4](#).

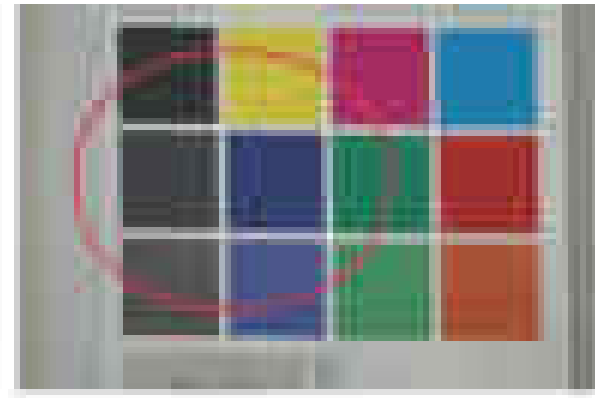
Since the resistance in the secondary transfer section also increases by lower humidity or over time, the required electrical field may not be attained, especially in the early mornings (low humidity environment).

Figure 1 Example

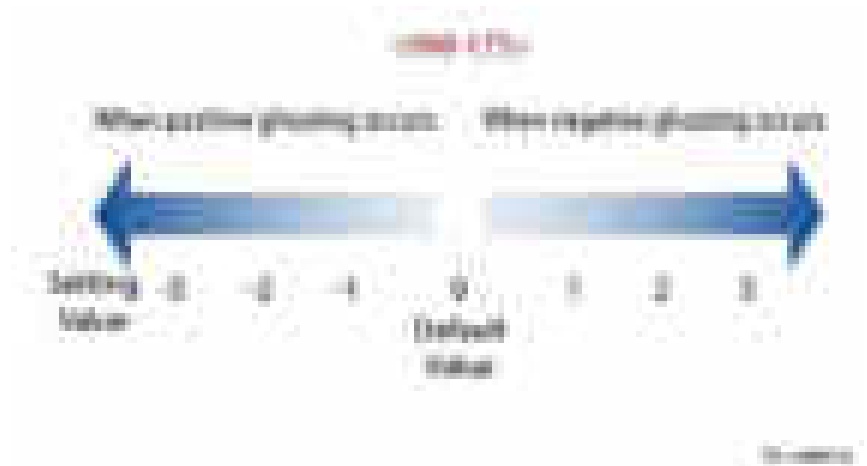
1. Enter [dC612](#) Print Test Pattern. Print a suitable test pattern. Identify if the ghosting is positive or negative.
2. Refer to [Figure 2](#). Enter [dC131](#). Perform the steps that follow:
 - For positive ghosting, reduce the value of NVM 998-175.
 - For negative ghosting, increase the value NVM 998-175.

Figure 2 NVM 998-175 setting

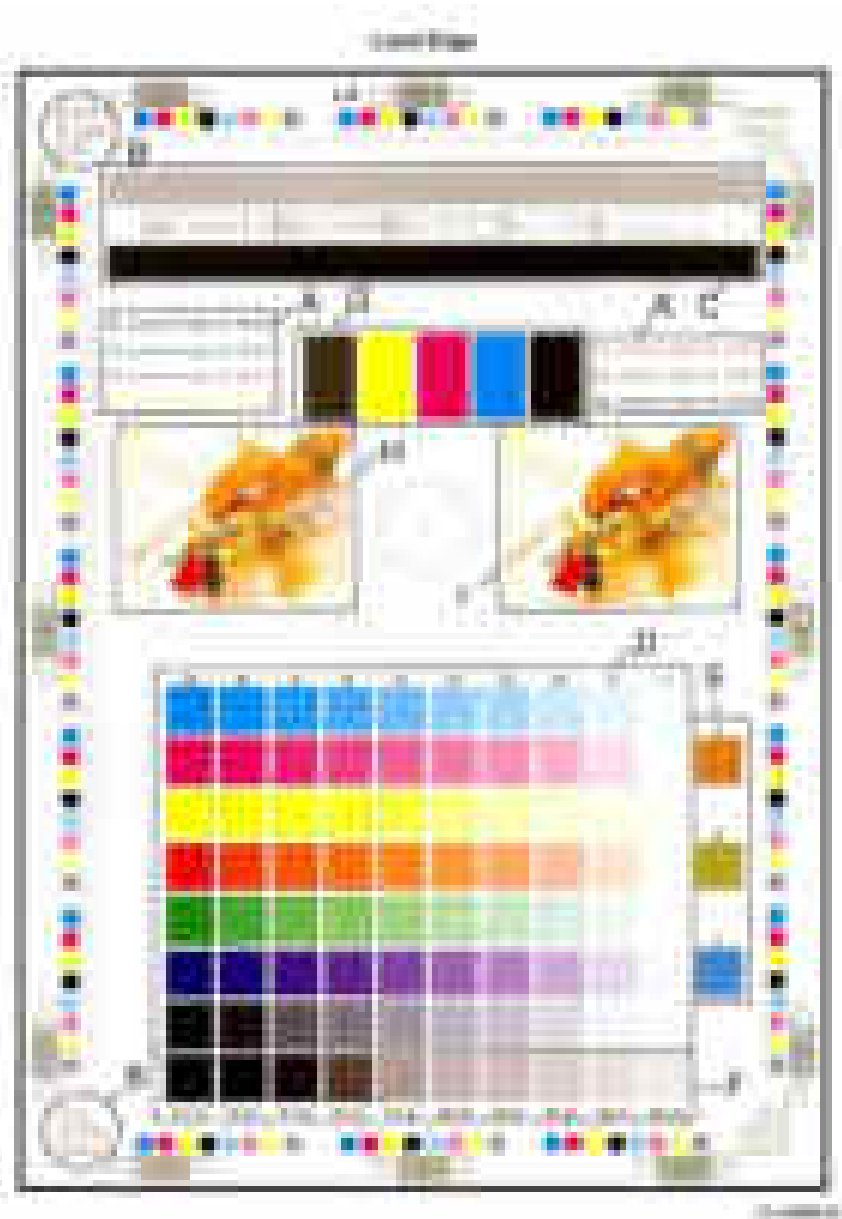
D	Color Gradation. This area should exhibit a decreasing density of each of the colors from 100% density to 5% density. In a properly adjusted machine, the 10% patches should be visible and the 5% patches should be barely visible or not visible on the test pattern copy (except for the bottom row). If the copy does not meet this definition, perform the dC991 Toner Density Adjustment.
E	Routine Color. Location E represents three general tests for the machine to reproduce colors common to customer originals. Location A is a general skin tone test. Location B represents the color of grass or other common foliage. Location C represents the color of the sky. If the copy does not meet this definition, perform the dC991 Toner Density Adjustment.
F	Photo Gradation. Not used.
G	IIT Calibration Patches. Not used
H	100 Lines/Inch Image. A Moire defect will show on this image. Moire on a 100 Line/Inch image is within specification.

I	175 Lines/Inch Image. This image is used to test for Moire. Depending on the degree of the defect, moire seen on this image should be considered out of specification, go to IQ2 IOT IQ Defects RAP.

Figure 1 Color test pattern 82E13120

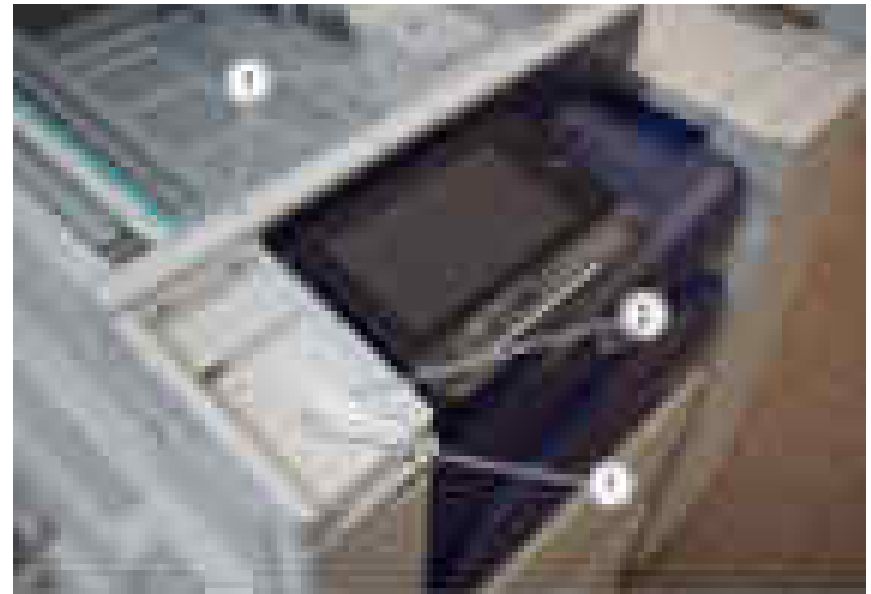
Figure 1 Upper cover

NOTE: The ICCR cover is secured by 2 clips at the front.

4. Remove the upper cover, [Figure 1](#):
 - a. Remove 3 screws (1).
 - b. Remove the upper cover (2).

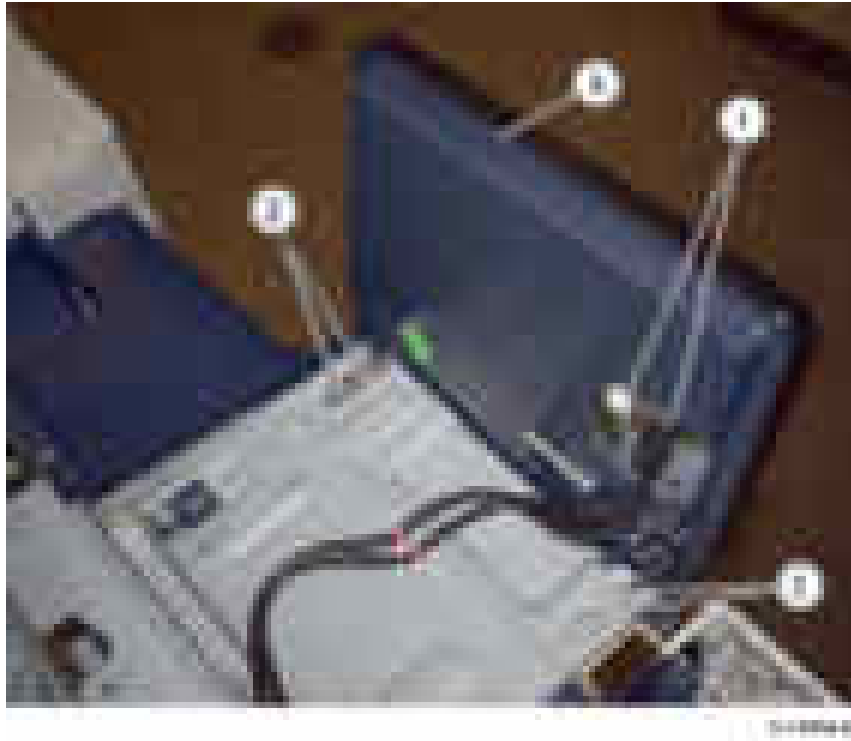
Figure 2 UI assembly removal

7. Remove the UI assembly, [Figure 2](#):
 - a. Disconnect both connectors (1).
 - b. Remove 4 screws (2), then the UI assembly (3).

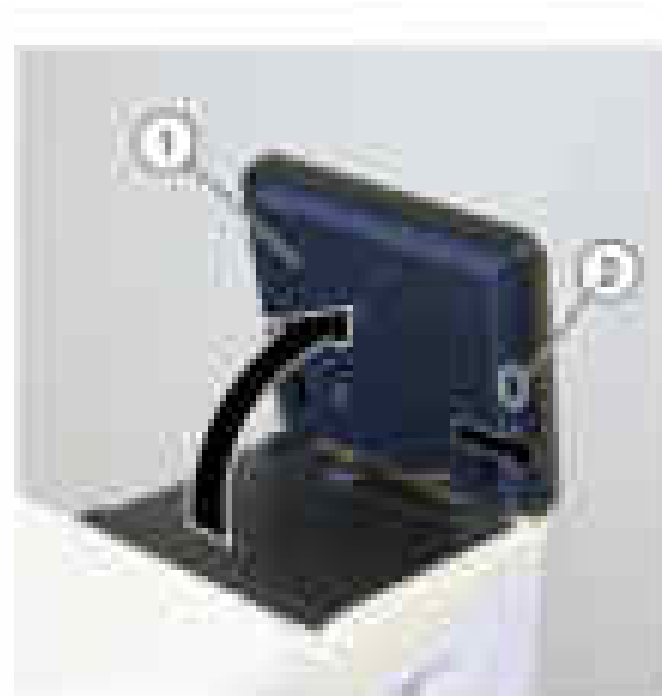
Figure 1 User interface rear cover

1. If possible, record the current software level by either:
 - Printing the configuration report, [GP 14](#).
 - From the user interface Home screen, touch Device, then About. Scroll down to view the Software Version.
2. Remove the UI rear cover, [Figure 1](#).
 - a. Lift the UI assembly (1) in the direction of arrow.
 - b. Insert a flat screwdriver in the gap between the UI rear cover and the UI assembly (2).

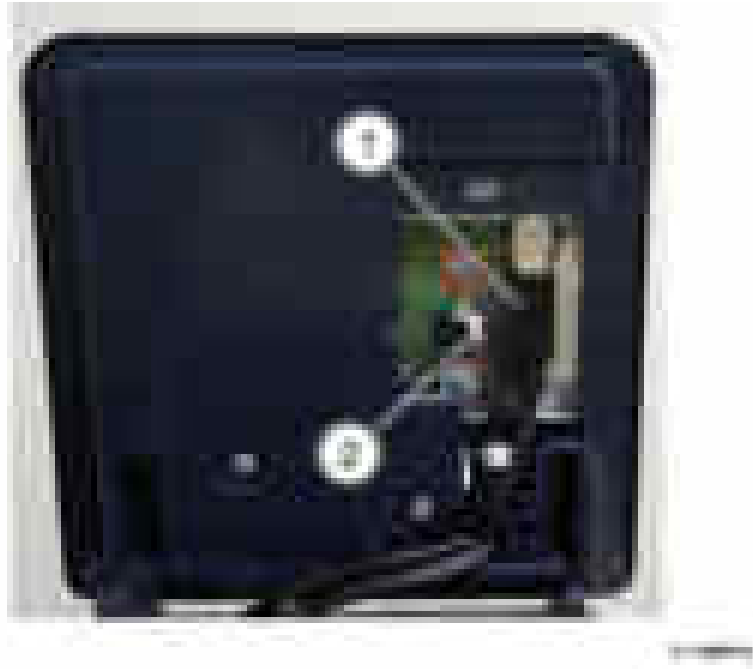
Figure 2 User interface connectors

3. Disconnect two connectors, [Figure 2](#).

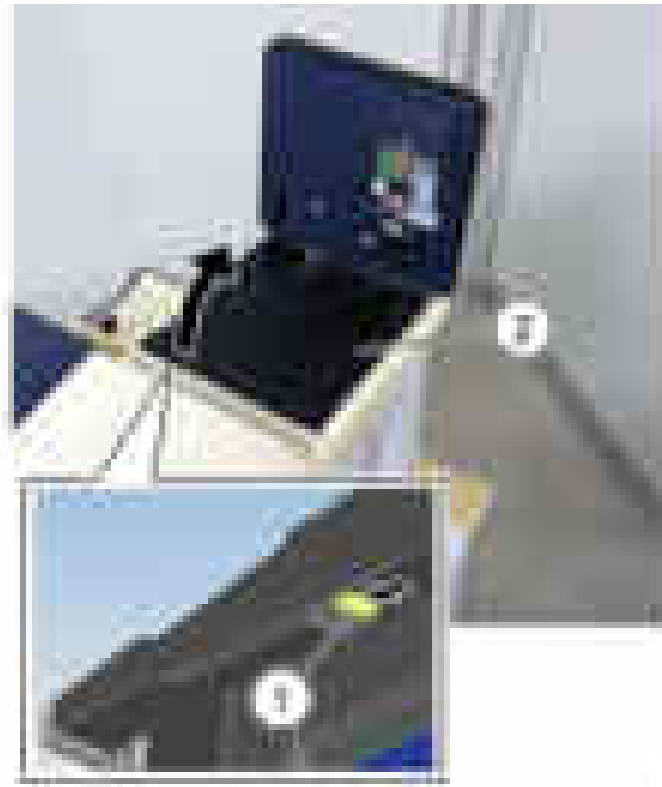
Figure 3 User interface inner cover

4. Remove the UI inner cover, [Figure 3](#).
 - a. Release the hook (1) inside the inner cover by pressing it in the direction of the arrow.
 - b. Lift the inner cover (2) in the direction of the arrow.

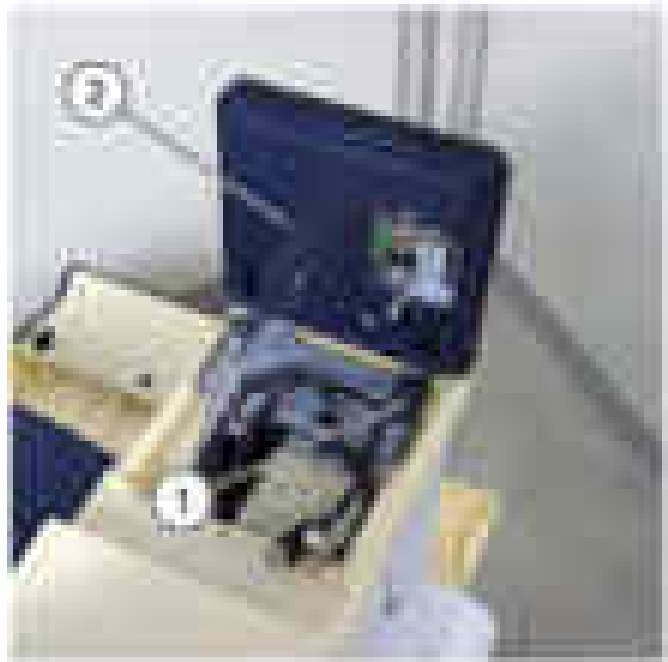
Figure 4 User interface connectors

5. Remove the UI assembly, [Figure 4](#).
 - a. Remove two screws (1).
 - b. Remove the UI assembly (2).

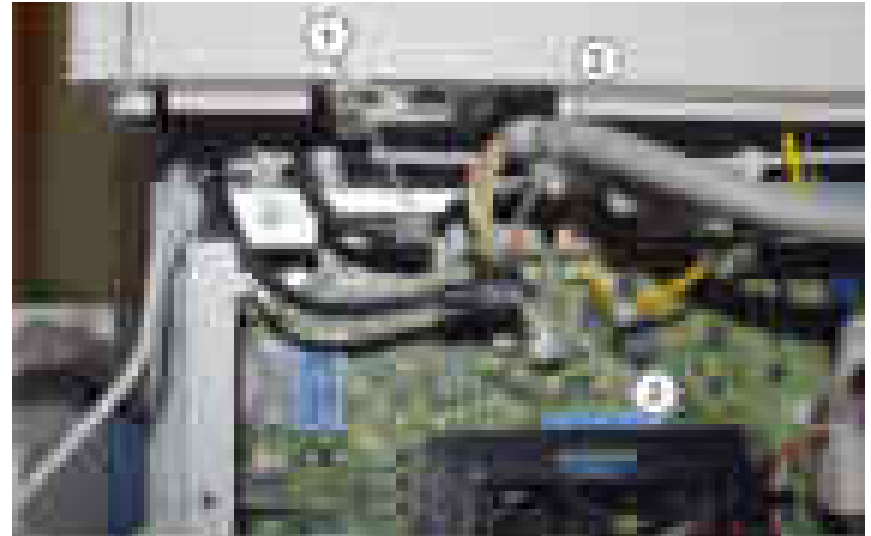
Figure 6 Cables

7. Disconnect the USB, DADF I/F and UI cables, [Figure 6](#):
 - a. Disconnect the USB cable (1).
 - b. Disconnect the DADF I/F cable (2). **(C7030F only)**.
 - c. Disconnect the UI cable (3).

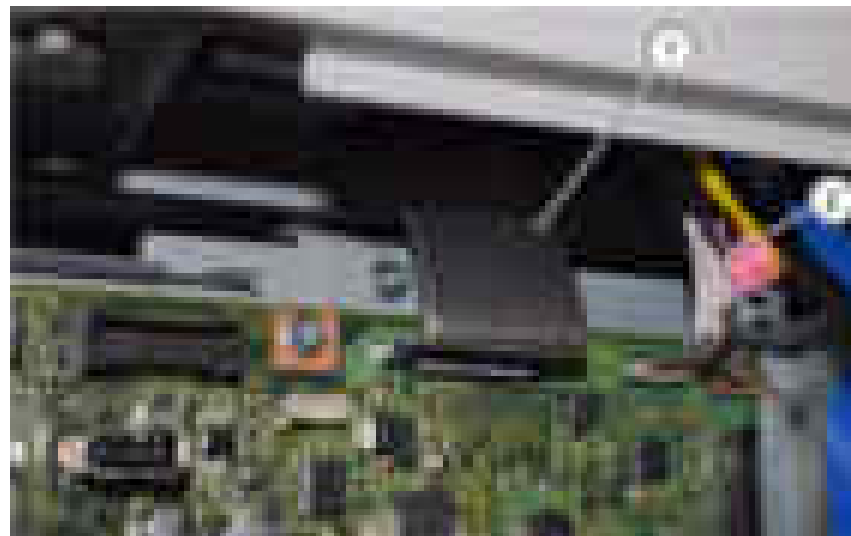
Figure 10 Cables

The FFC LED cable is secured by a clamp. Carefully lift both ends of the cable clamp simultaneously to release the cable.

13. **(C7030F only)**. Carefully disconnect the CCD ribbon cable (1) and the FFC LED cable (2), **Figure 10**.

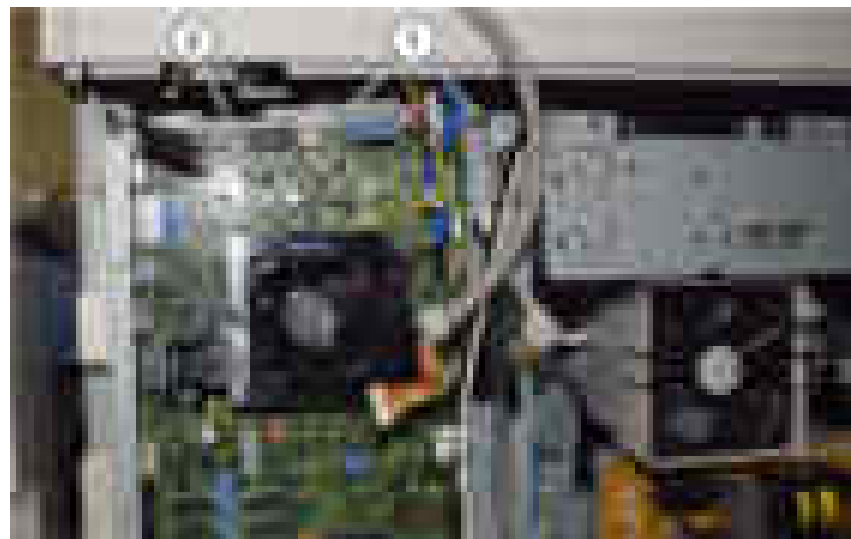
17. Remove two screws (1), then the ESS PWB chassis assembly (2), [Figure 14](#):

Figure 14 ESS PWB chassis assembly removal

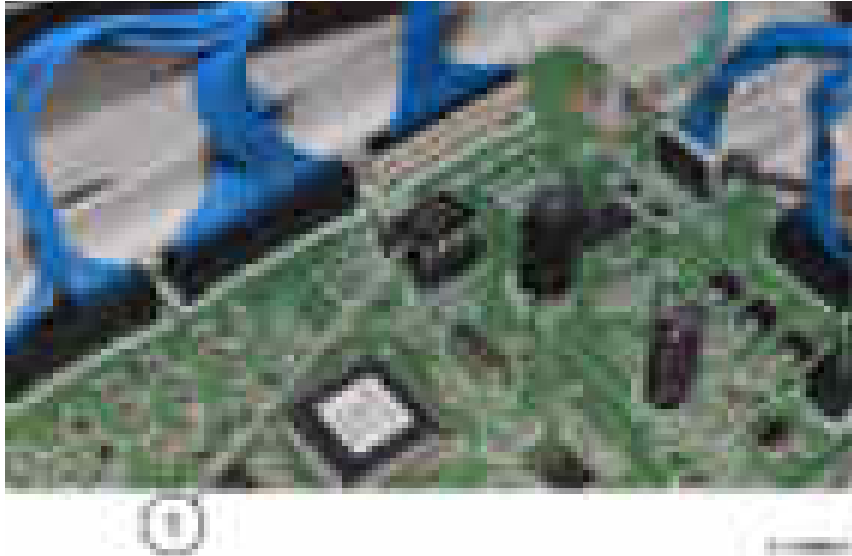
- b. Remove the SEEPROM (1) from the old DADF PWB, then install it onto the new DADF PWB, [Figure 4](#).

Figure 4 SEEPROM

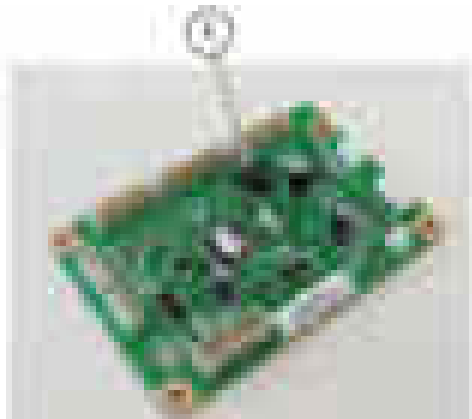
2. Remove the SEEPROM (1) from the old DADF PWB, then install it onto the new DADF PWB, [Figure 4](#).

Figure 4 SEEPROM

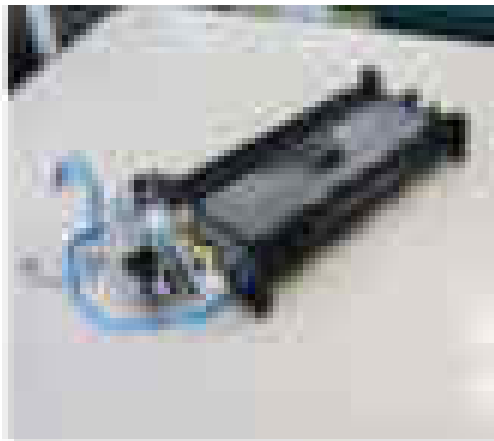
NOTE: The removed DADF feeder assembly is shown in [Figure 3](#).

Figure 3 Removed feeder assembly

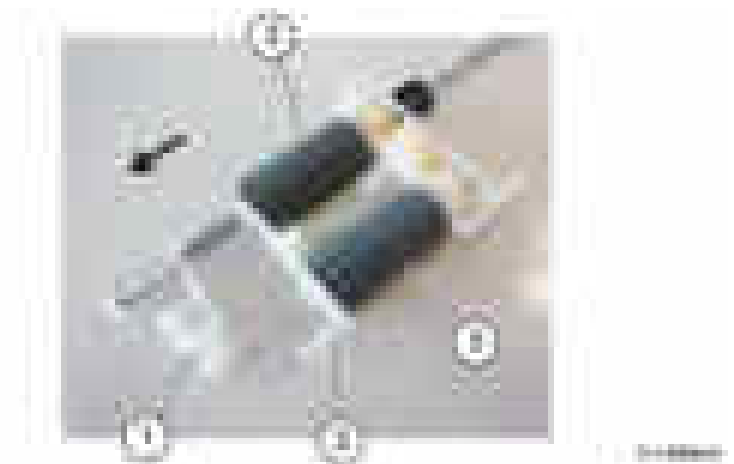
3. Remove the roll assemblies, [Figure 3](#):
 - a. Release the hook to remove the feed front handle (1).
 - b. Release the hook to remove the nudger CRU housing (2).
 - c. Remove the roll assemblies (3).

Figure 3 Roll assembly removal

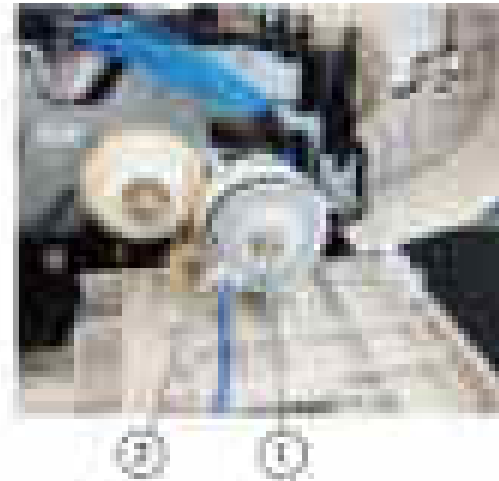
8. Remove the DADF T/A clutch, [Figure 3](#):
 - a. Remove the E-clip (1).
 - b. Remove the DADF T/A clutch (2).

Figure 3 T/A clutch removal

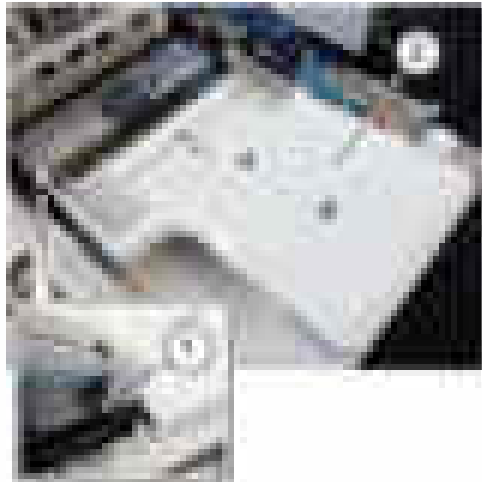
4. Remove the document tray, [Figure 3](#):
 - a. At the front, squeeze the boss (1) in the direction of the arrow, then remove it from the hole.
 - b. Remove the document tray (2).

Figure 3 Document tray removal

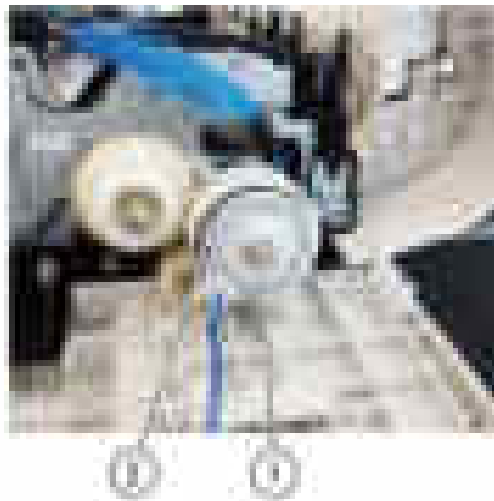
10. Remove the DADF T/A clutch, [Figure 3](#):
 - a. Remove the E-clip (1).
 - b. Remove the DADF T/A clutch (2).

Figure 3 T/A clutch removal

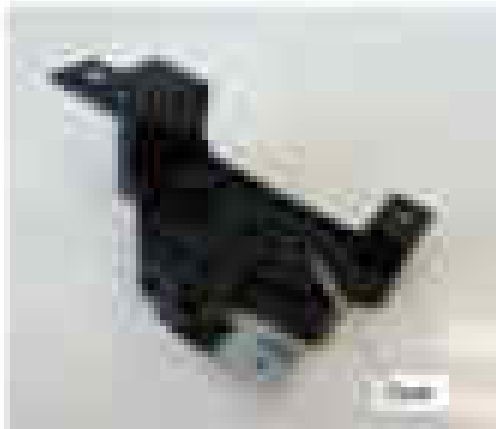
Do not lose the gear on the rear of the front bracket. Refer to [Figure 6](#).

Figure 6 Gear

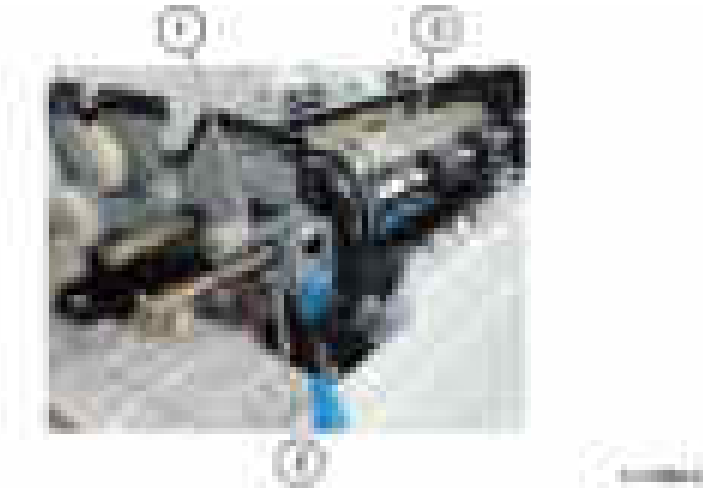
15. Remove the rear bearing, then the DADF takeaway roll, [Figure 9](#):
 - a. Remove the E-clip (1).
 - b. Remove the bearing (2).
 - c. Remove the DADF takeaway roll (3).

Figure 9 Takeaway roll removal

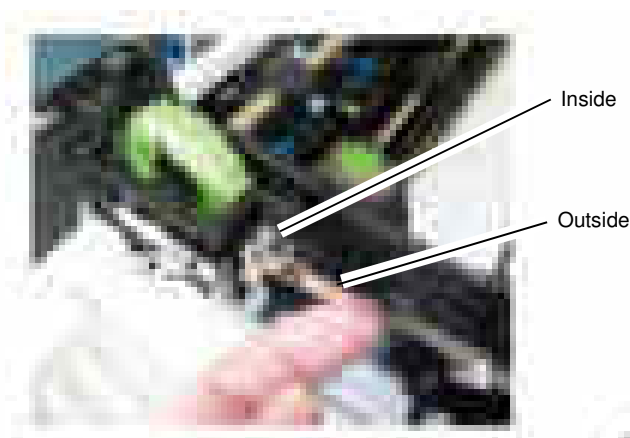
1. The replacement is the reverse of the removal procedure.
2. Install the front bracket and ground roll plate as shown in [Figure 10](#).

Figure 10 Ground plate installation

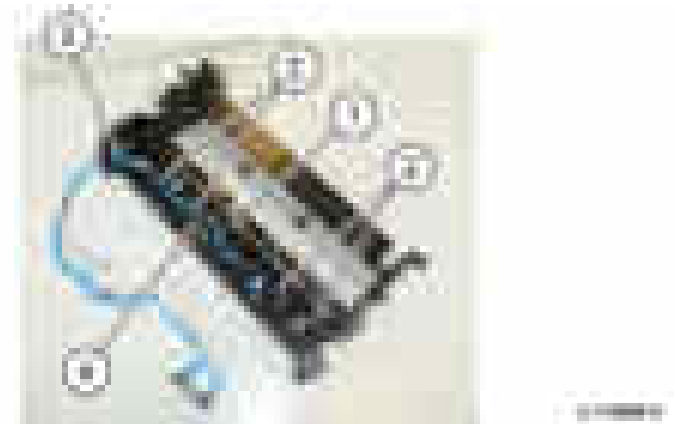
1. Remove the DADF front cover, [REP 5.3](#)
2. Remove the DADF rear cover, [REP 5.4](#).
3. Remove the document tray, [REP 5.14](#).
4. Remove the harness guide and wire harness, [REP 5.11](#).
5. Remove the upper feeder assembly, [REP 5.6](#).
6. Remove the DADF feeder assembly, [REP 5.7](#).
7. Remove the retard chute assembly, [REP 5.15](#).
8. Remove the invert chute assembly, [REP 5.16](#).
9. Remove the DADF feed motor assembly, [REP 5.12](#).
10. Remove the DADF takeaway roll, [REP 5.17](#).
11. Remove the sensor bracket assembly, [Figure 1](#):
 - a. Disconnect the connector (1).
 - b. Remove four screws (2).
 - c. Remove the wire harness (3) through the hole.
 - d. Remove the sensor bracket assembly (4).

Figure 1 Sensor bracket assembly removal

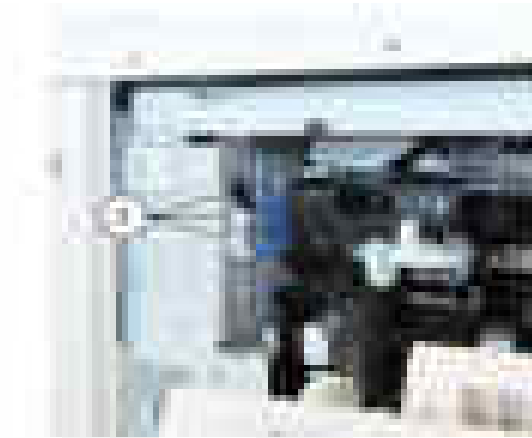
7. Disconnect three connectors (1), [Figure 2](#).

Figure 2 Connectors

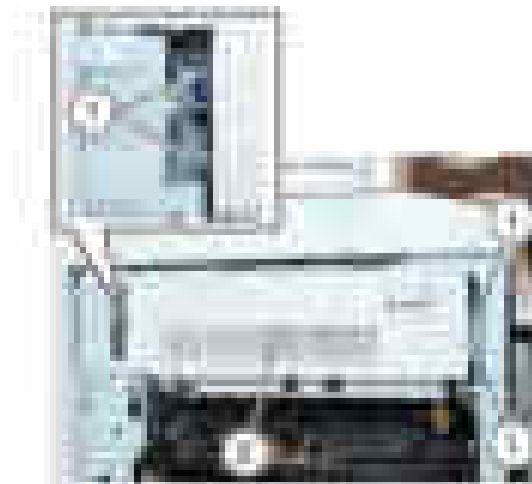
8. Close the exit 2 transport assembly.
9. Remove the exit 2 transport assembly, [Figure 3](#):
 - a. Remove four screws (1).
 - b. Remove the exit 2 transport assembly (2).

Figure 3 Transport assembly removal

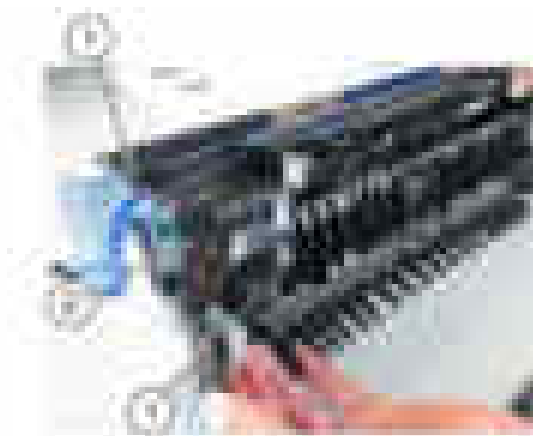
10. Disengage two hooks (1), then remove the rear cover (2), [Figure 4](#).

Figure 4 Rear cover removal

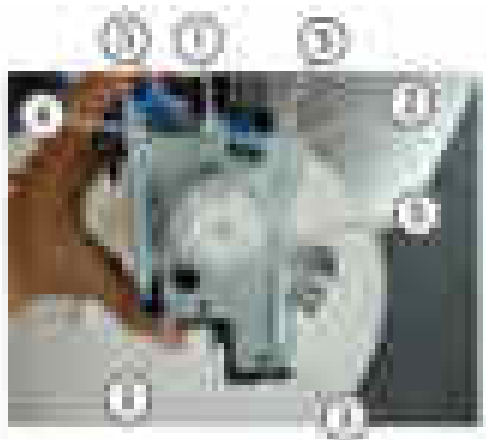
11. Remove the rear bracket and exit 2 motor, [Figure 5](#):
- Release the clamp, then remove the harness (1).
 - Disconnect the connector (2).
 - Remove four screws (3).
 - Disengage the hook (4),
 - Remove the rear bracket and exit 2 motor (5).

Figure 5 Motor removal

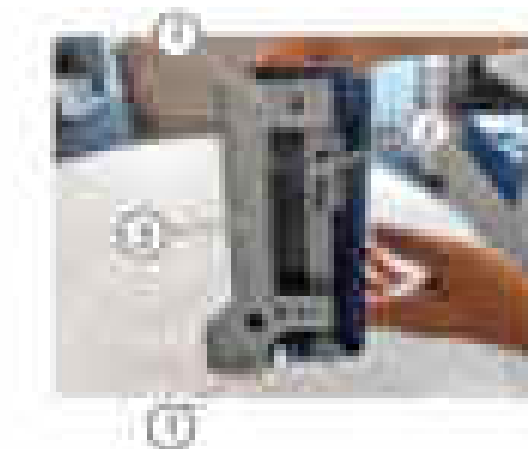
12. Remove the front bracket, [Figure 6](#):
- Remove two screws (1).
 - Remove the E-clip (2).
 - Remove the front bracket (3).

Figure 6 Front bracket removal

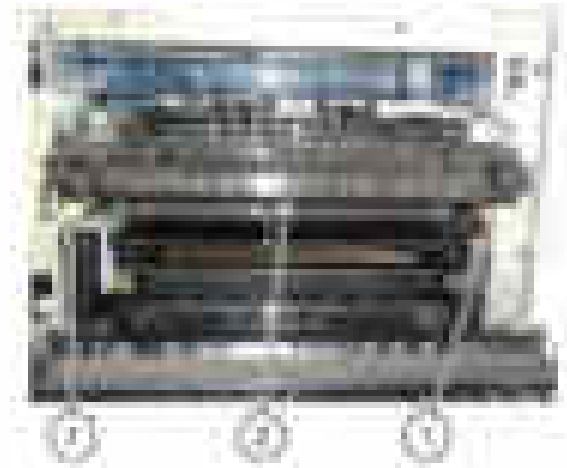
1. Open the LH transport assembly.
2. Remove the fuser, [Figure 1](#):
 - a. Loosen two screws (1).
 - b. Remove the fuser (2).

Figure 1 Fuser removal

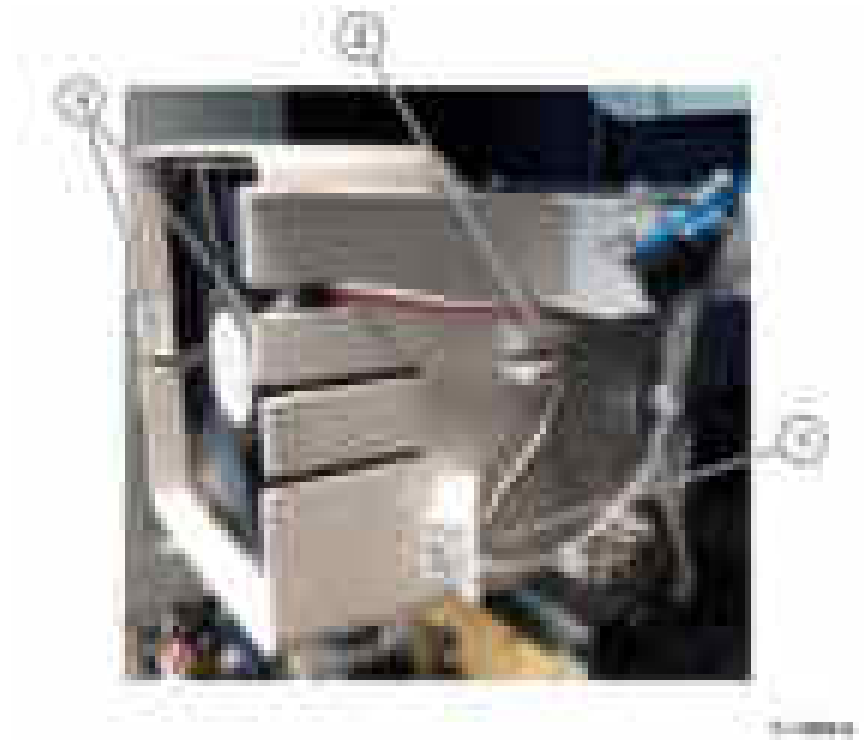
1. Remove the upper rear cover, [REP 28.5](#).
2. Remove the fuser fan from the rear duct fuser A, [Figure 1](#):
 - a. Disconnect the connector facing the chassis (1).
 - b. Remove the wire harness from the hook (2).
 - c. Disengage the right and left hooks at the front of the rear duct fuser A (3), then remove the fuser fan.

Figure 1 Fuser fan removal

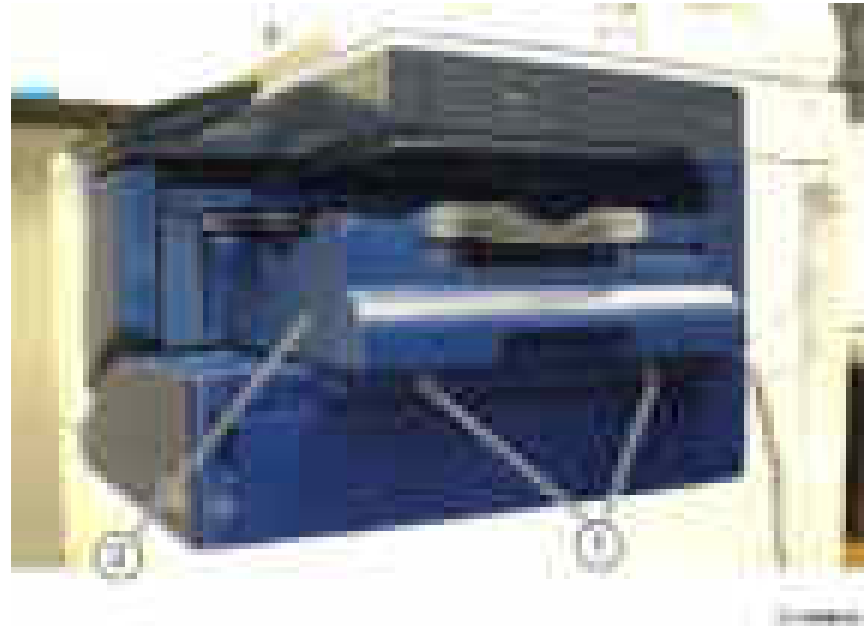
3. Remove the integrated office finisher, [Figure 2](#):
 - a. Remove two thumbscrews (1).
 - b. Remove the integrated office finisher (2) towards the front of the machine.

Figure 2 Finisher removal

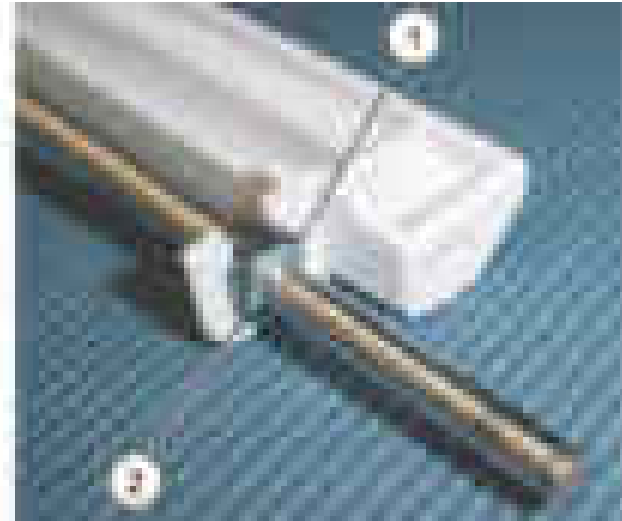
8. Remove the bearing, [Figure 6](#):
a. Remove the E-clip (1).
b. Remove the bearing (2).

Figure 6 Bearing removal

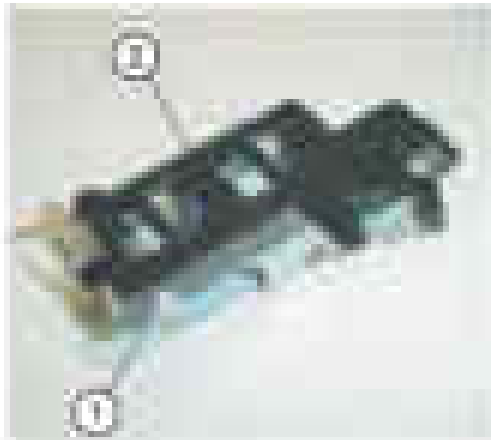
8. Remove the support, [Figure 3](#):
 - a. Remove the screw (1).
 - b. Remove the support (2).

Figure 3 Support removal

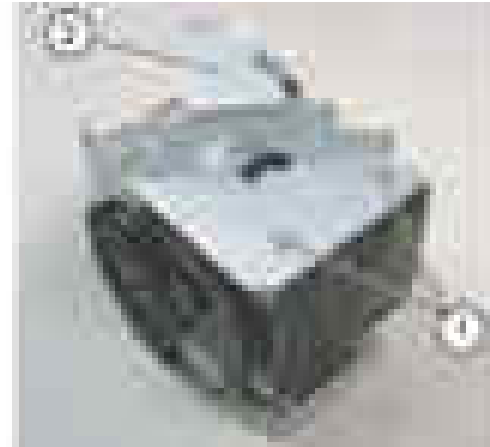
5. Remove the bracket from the stapler assembly, [Figure 2](#):
 - a. Remove two screws (1).
 - b. Remove the bracket (2).

Figure 2 Bracket removal

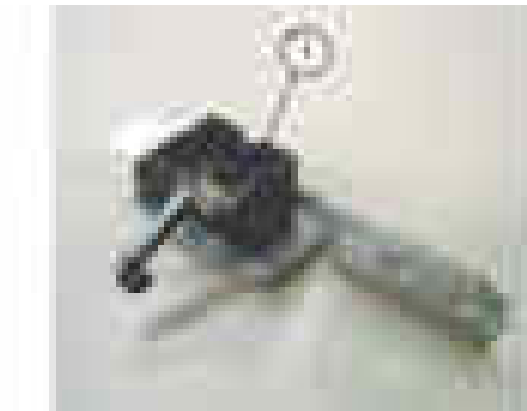
7. Remove the finisher entry sensor (1) from the bracket, [Figure 4](#).

Figure 4 Finisher entry sensor removal

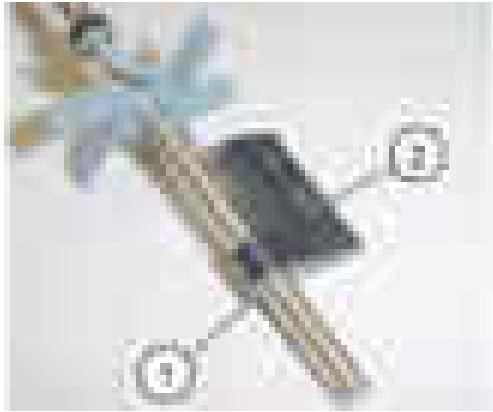
8. Remove the support bearing from the main paddle shaft assembly, [Figure 6](#):
 - a. Remove the E-clip (1).
 - b. Remove the support bearing (2).

Figure 6 Support bearing removal

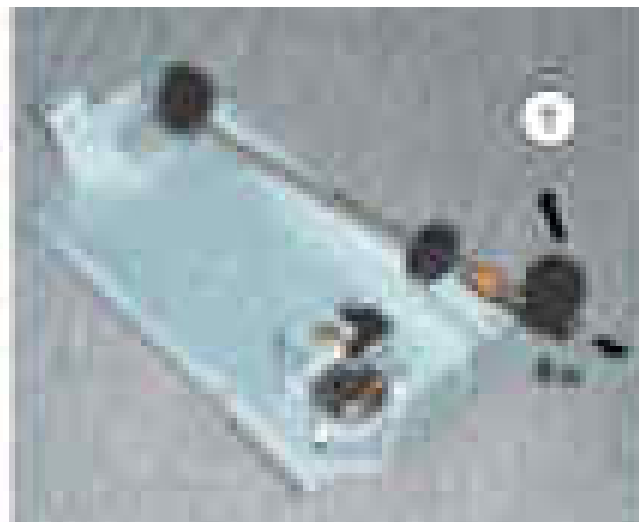
12. Remove the stacker shaft assembly in the direction of the arrow, [Figure 8](#).

Figure 8 Stacker shaft assembly removal

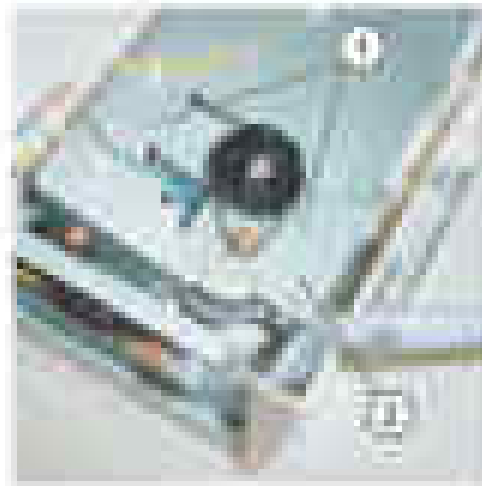
7. Remove the stacker motor assembly, [Figure 3](#):
 - a. Remove two screws (1).
 - b. Remove the stacker motor assembly (2).

Figure 3 Stacker motor assembly removal

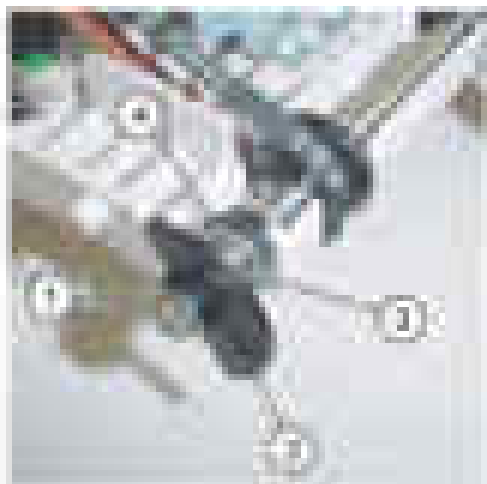
1. Remove the compiler assembly, REP 12.19.
2. Remove the eject shaft assembly, REP 12.24.
3. Remove the actuator and the bearing, Figure 1:
 - a. Remove the E-clip (1).
 - b. Remove the actuator (2).
 - c. Remove E-clip (3).
 - d. Remove the bearing (4).

Figure 1 Actuator and bearing removal

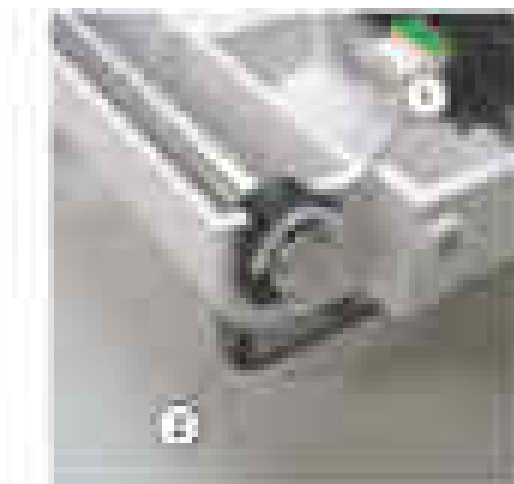
4. Remove the bearing, Figure 2:
 - a. Remove the E-clip (1).
 - b. Remove the bearing (2).

Figure 2 Bearing removal

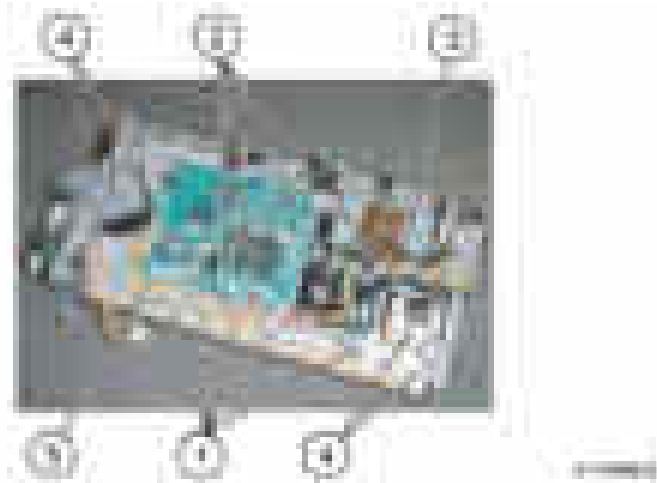
7. Remove the bottom plate, [Figure 2](#):
 - a. Release the harness from the 5 clamps (1).
 - b. Disconnect eight connectors (2).
 - c. Remove the harness from the retainers (3).
 - d. Remove four screws (4).
 - e. Remove the bottom plate (5).

Figure 2 Bottom plate removal

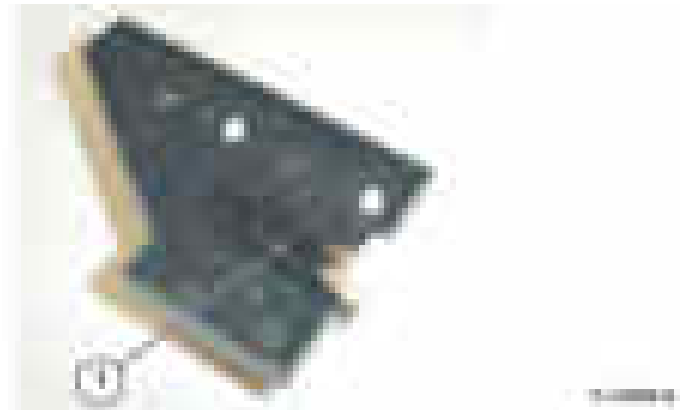
9. Remove the rear tamper home sensor (1) from the bracket, [Figure 4](#).

Figure 4 Rear tamper home sensor removal

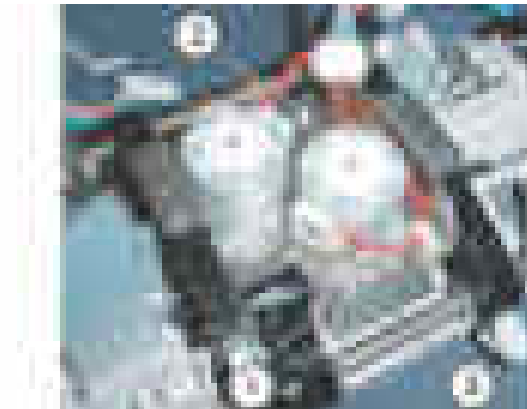
1. Remove the compiler assembly, [REP 12.19](#).
2. Remove the eject shaft assembly, [REP 12.24](#).
3. Remove the front/rear tamper motor assembly, [Figure 1](#):
 - a. Remove two self-tapping screws (1).
 - b. Remove the screw (2).
 - c. Remove the front/rear tamper motor assembly (3).

Figure 1 Tamper motor assembly removal

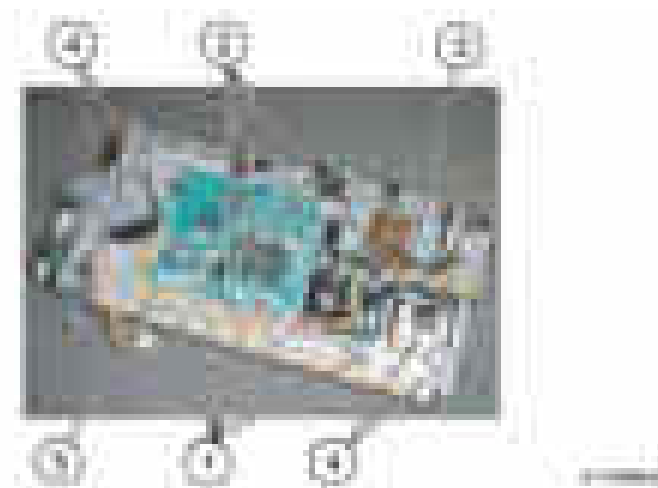
7. Remove the bottom plate, [Figure 2](#):
 - a. Release the harness from the 5 clamps (1).
 - b. Disconnect eight connectors (2).
 - c. Remove the harness from the retainers (3).
 - d. Remove four screws (4).

- e. Remove the bottom plate (5).

Figure 2 Bottom plate removal

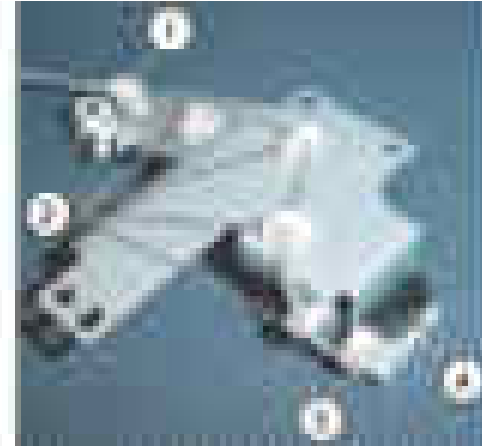
10. Remove the stack height sensor, **Figure 5** :
 - a. Remove the clamp (1).
 - b. Release the harness from the clamps (2).
 - c. Disconnect the connector (3).
 - d. Remove the stack height sensor (4) from the bracket.

Figure 5 Stack height sensor removal

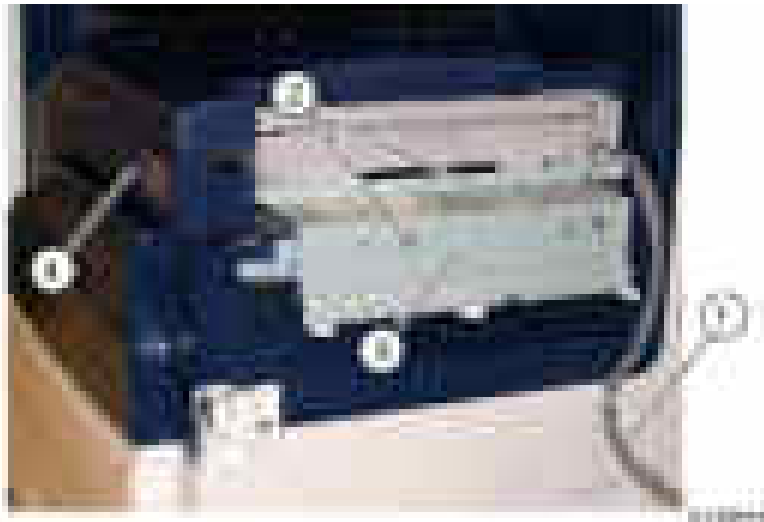
1. Undock the finisher, [REP 13.5](#).
2. Remove the H-transport assembly, [Figure 1](#):
 - a. Disconnect the harness (1).
 - b. Remove two screws (2).
 - c. Remove the docking plate (3).
 - d. Remove the H-transport (4).

Figure 1 H-transport removal

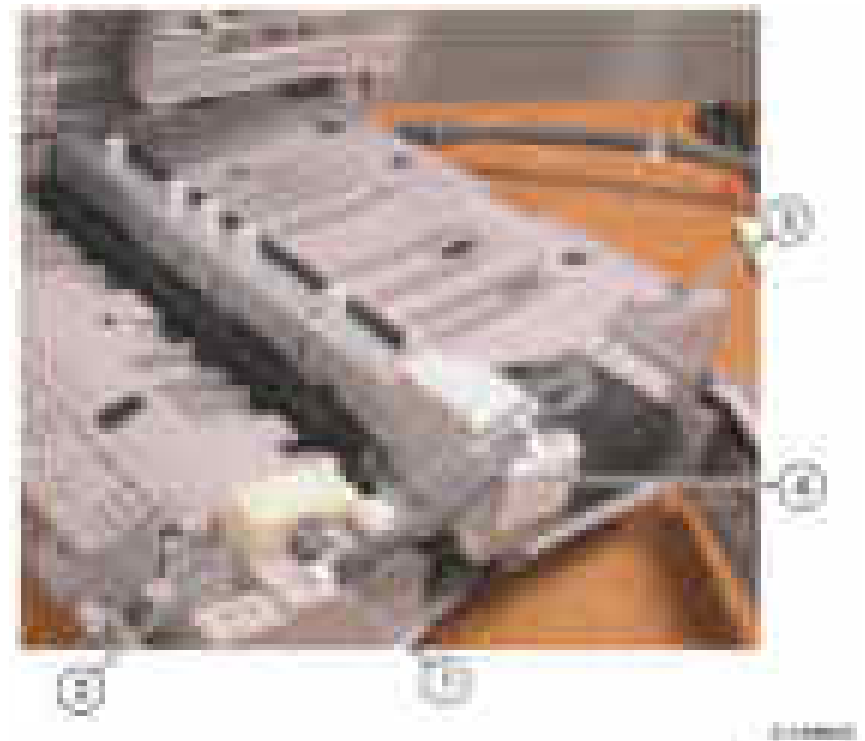
1. Hold open the H-transport top cover.
2. Open the H-transport front cover.
3. Remove the hole punch assembly, [Figure 1](#):
 - a. Release the cable clamp (1).
 - b. Remove the connector cover (2), then disconnect the connector.
 - c. Remove the thumbscrew (3).
 - d. Remove the hole punch assembly (4).

Figure 1 Hole punch assembly removal

NOTE: For clarity, the H-transport is shown removed from the machine in [Figure 1](#).

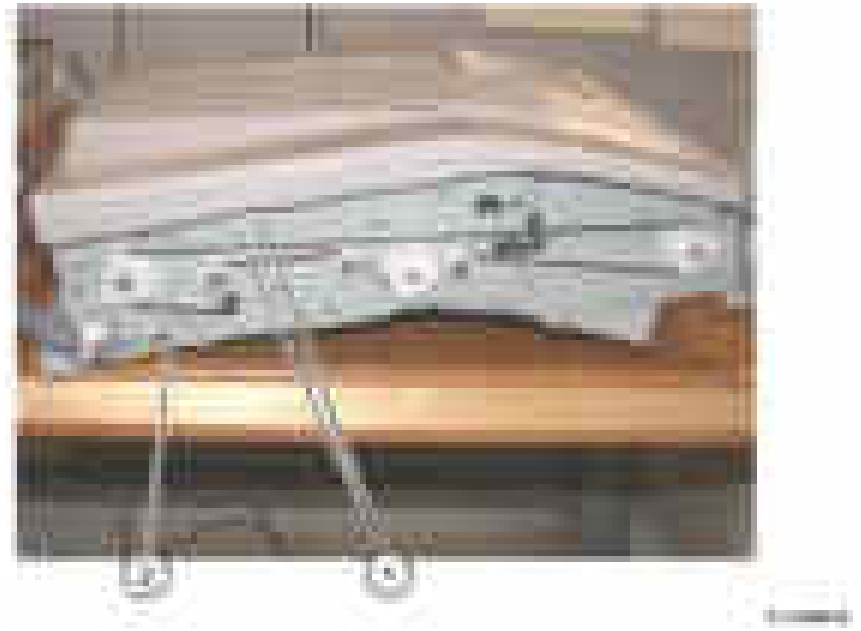
1. Remove the H-transport assembly, [REP 13.1](#).
2. Remove the H-transport rear cover, [PL 13.06](#) Item 9.
3. Remove the H-transport belt, [Figure 1](#):
 - a. Loosen two screws to release the belt tension (1).
 - b. Remove the belt (2).

Figure 1 H-transport belt removal

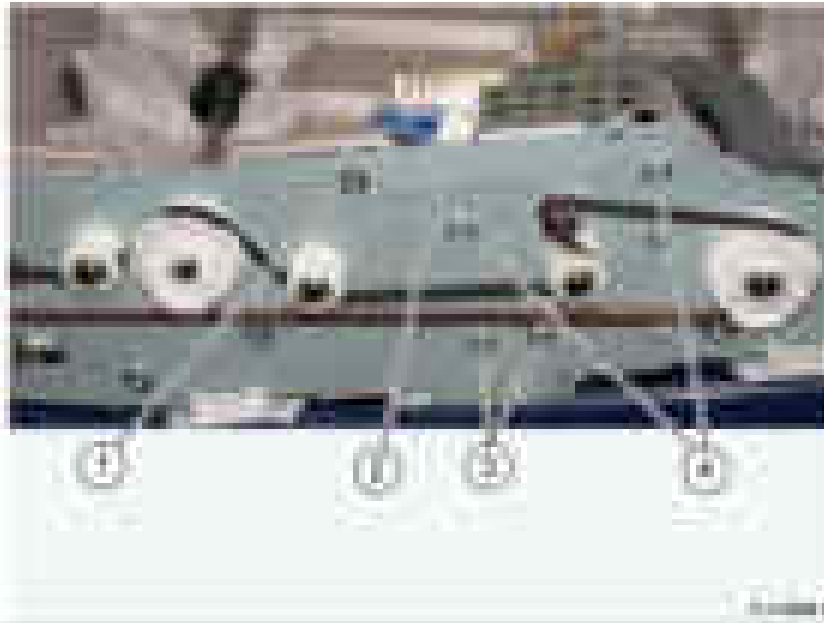
1. Remove the H-transport assembly, [REP 13.1](#).
2. Remove the H-transport rear cover, [PL 13.06 Item 9](#).
3. Place the H-transport top down on a work surface.
4. Remove the H-transport motor, [Figure 1](#):
 - a. Remove the screw, then the shield (1).
 - b. Disconnect the connector (2).
 - c. Loosen two screws to release the belt tension (3).
 - d. Remove two screws (3), then remove the H-transport motor.

Figure 1 H-transport motor removal

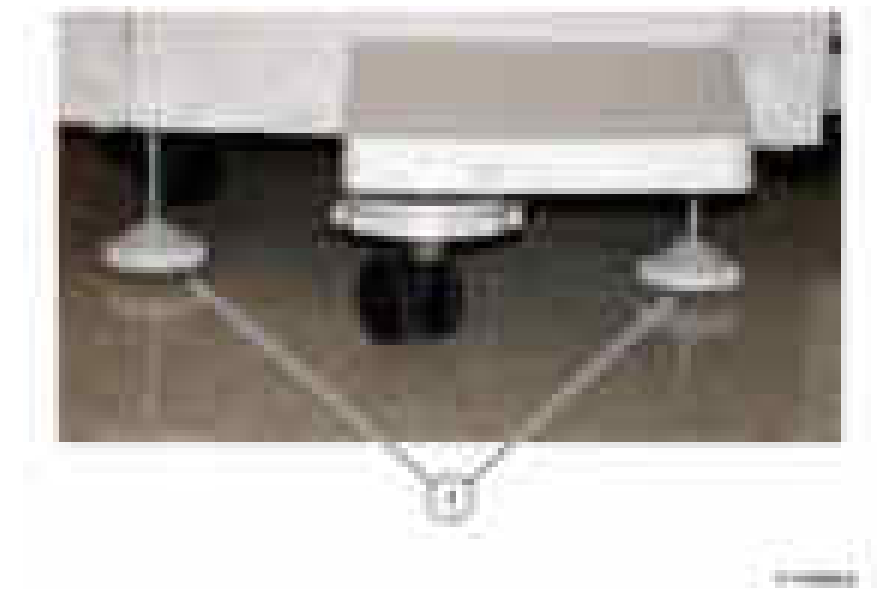
2. Raise the feet (1) to free the finisher, [Figure 1](#).

Figure 1 Finisher feet

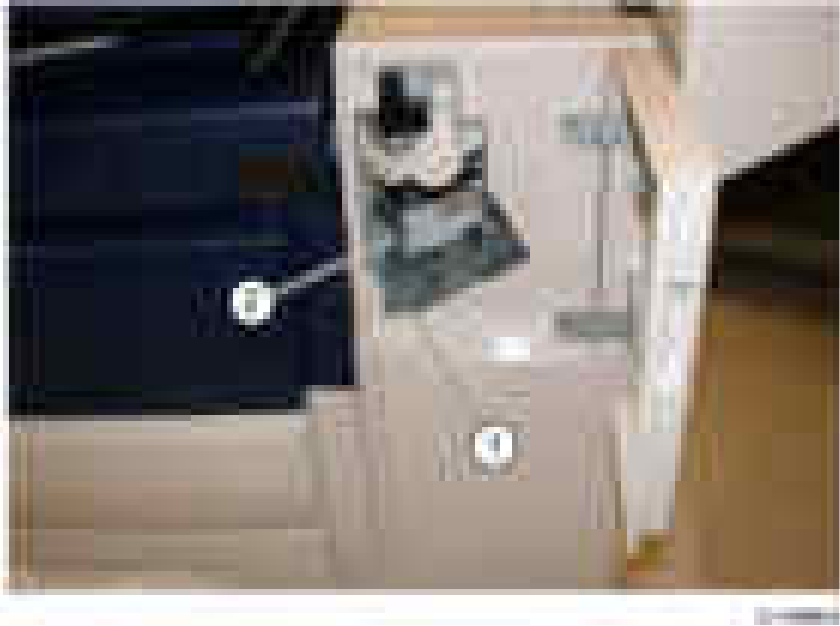
4. Undock the finisher, [Figure 2](#):
 - a. Remove the screw (1).
 - b. Pull the docking plate lever (2) forwards to detach the finisher.

Figure 2 Finisher undocking

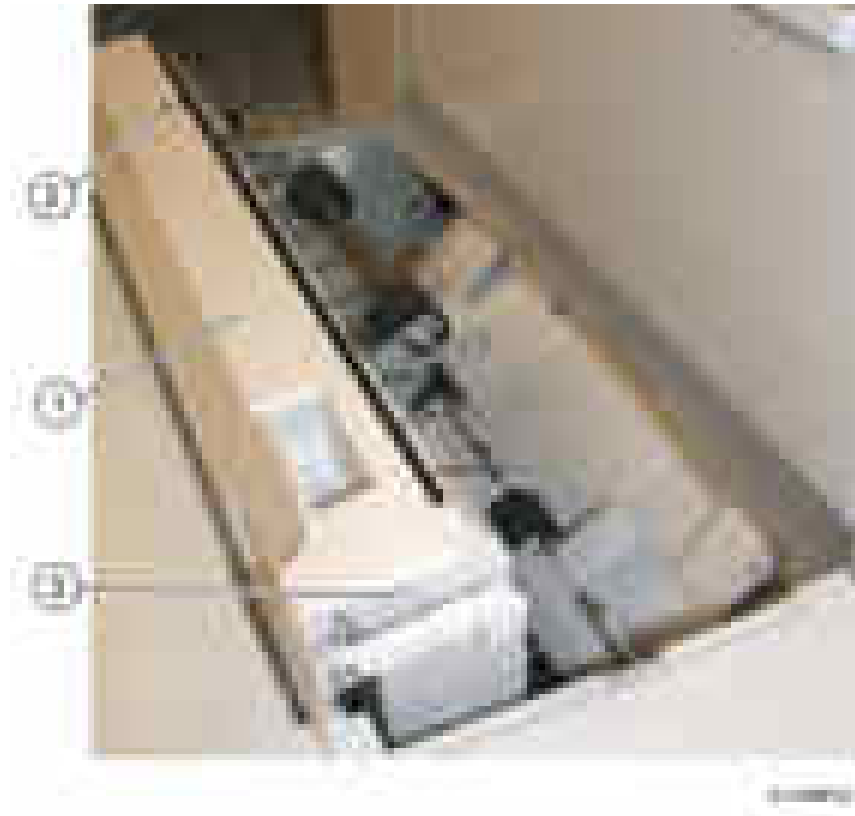
1. Remove the eject cover, [Figure 1](#):
 - a. Unlatch the eject cover (1), then move it to the left.
 - b. Remove the retaining screw (2).
 - c. Push the latch (3) through the hole in the cover.
 - d. Remove the cover by moving it to the left.

Figure 1 Eject cover removal
