Xerox® VersaLink® C7000 Color Printer & C7030 Family Color Multifunction Printer Service Manual

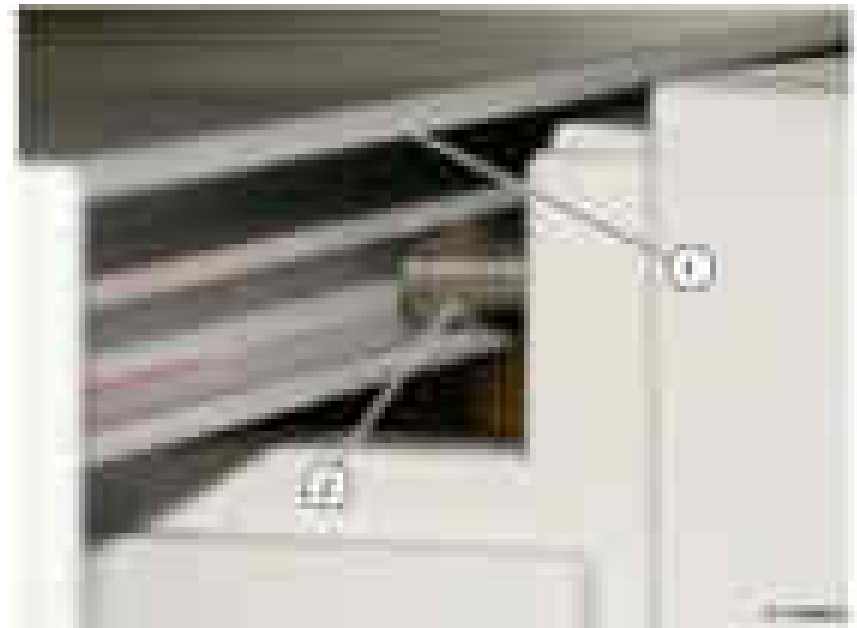
1. Align the eject cover (1) with the pins (2) on both sides, then slide it to the right, [Figure 2](#).

NOTE: The left side of the cover will be captured by the pins and cannot be lifted up.

Figure 2 Eject cover alignment

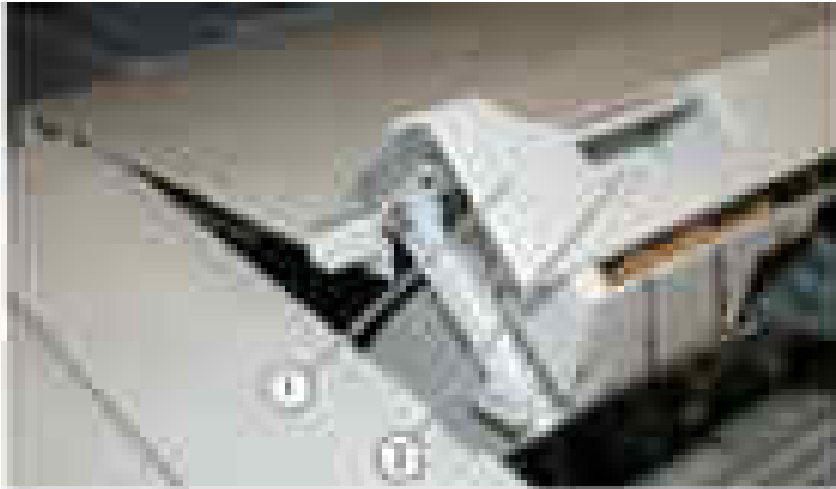
2. Position the eject cover (1) so that the latch (2) is inserted in the hole, [Figure 3](#).

NOTE: The Latch must be outside the hole.

Figure 3 Inserting the Latch

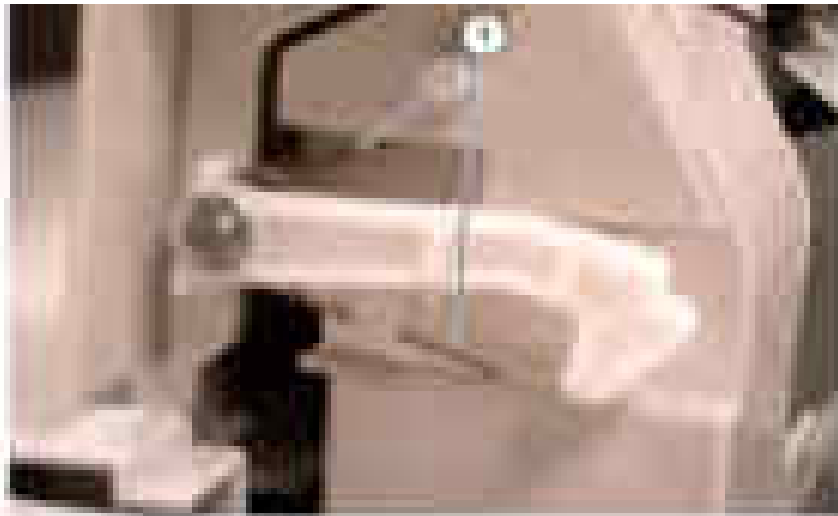
3. Position the latch spring (1) as shown, [Figure 4](#).

Figure 4 Latch spring position

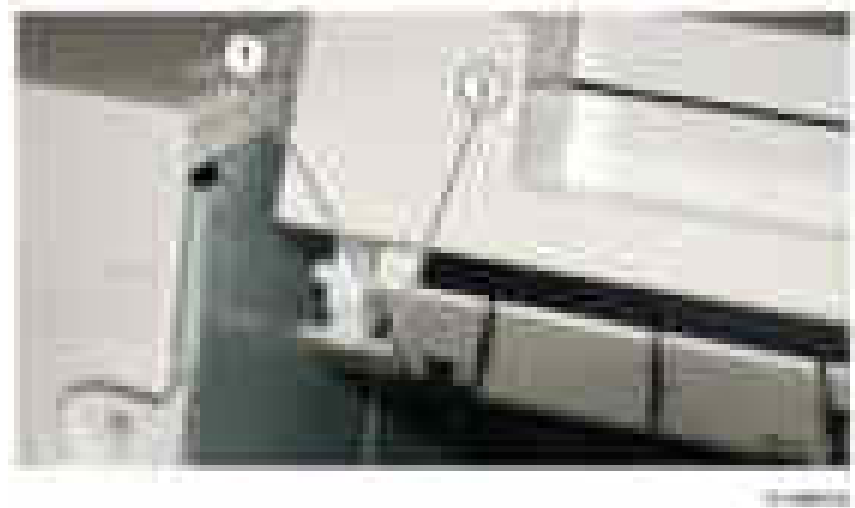
4. Position the latch hook (1) and latch pin (2) as shown, [Figure 5](#).

Figure 5 Latch hook and latch pin positioning

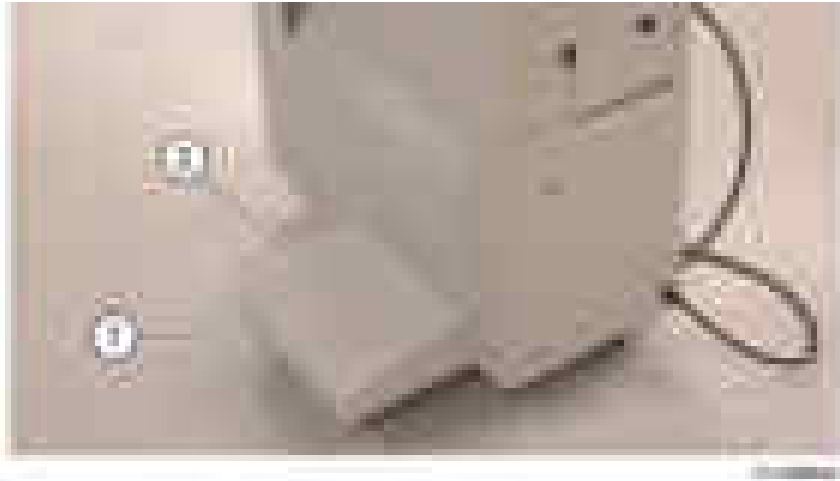
1. Remove the screw (1), then the foot cover (2), [Figure 1](#).

Figure 1 Foot cover removal

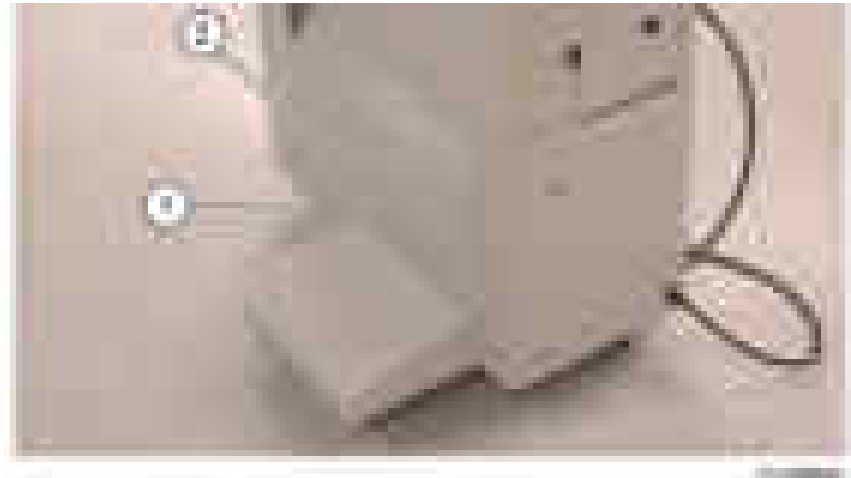
1. Remove the foot cover, [REP 13.10](#).
2. Remove the two screws (1), then the stacker lower cover (2), [Figure 1](#).

Figure 1 Stacker lower cover removal

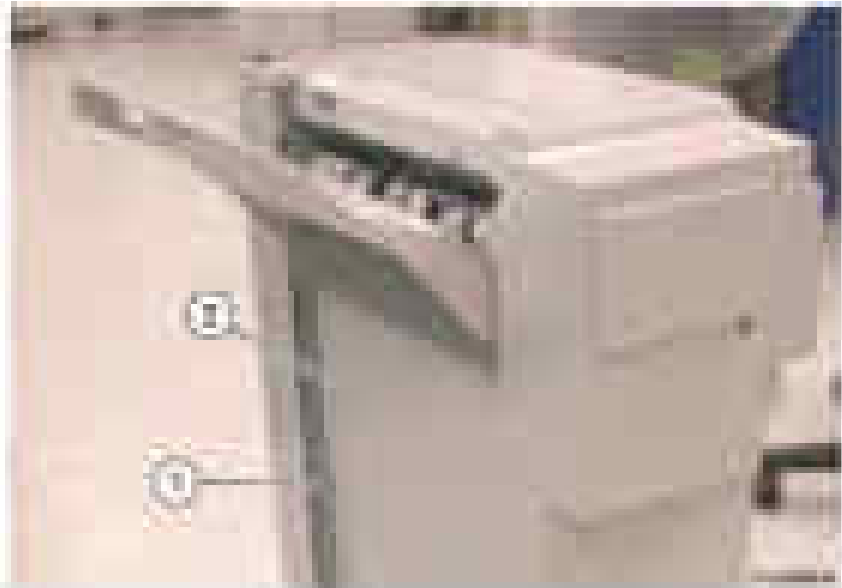
1. Remove the stacker tray, [REP 13.20](#).
2. Remove the stacker lower cover, [REP 13.11](#).
3. Remove six screws (1), then the stacker upper cover (2), [Figure 1](#).

Figure 1 Stacker upper cover removal

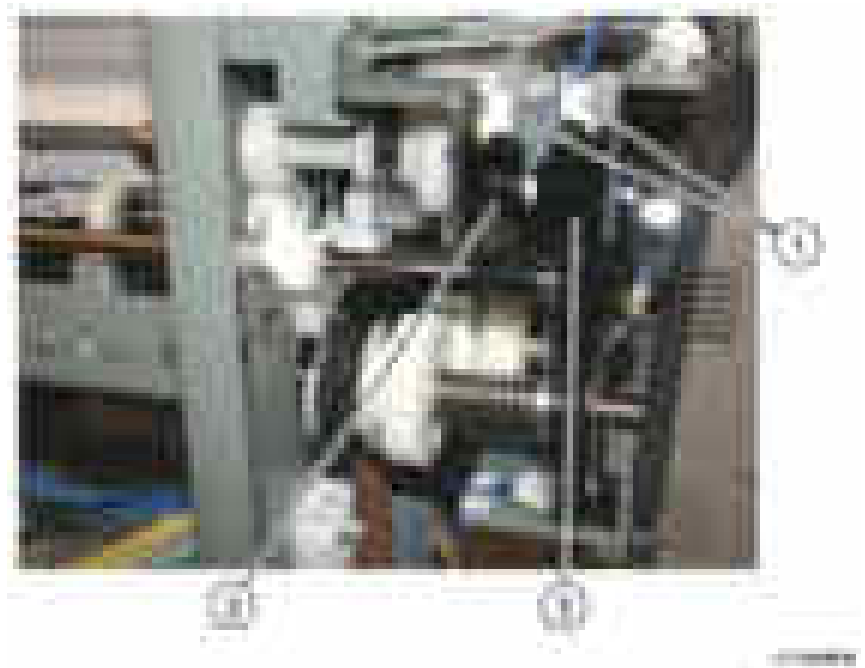
1. Remove the rear upper cover, [REP 13.7](#).
2. Remove the relevant stack height sensor, [Figure 1](#):
 - a. Disconnect the relevant connector (1).
 - b. Remove either stack height sensor 1 (2) or stack height sensor 2 (3).

Figure 1 Sensor removal

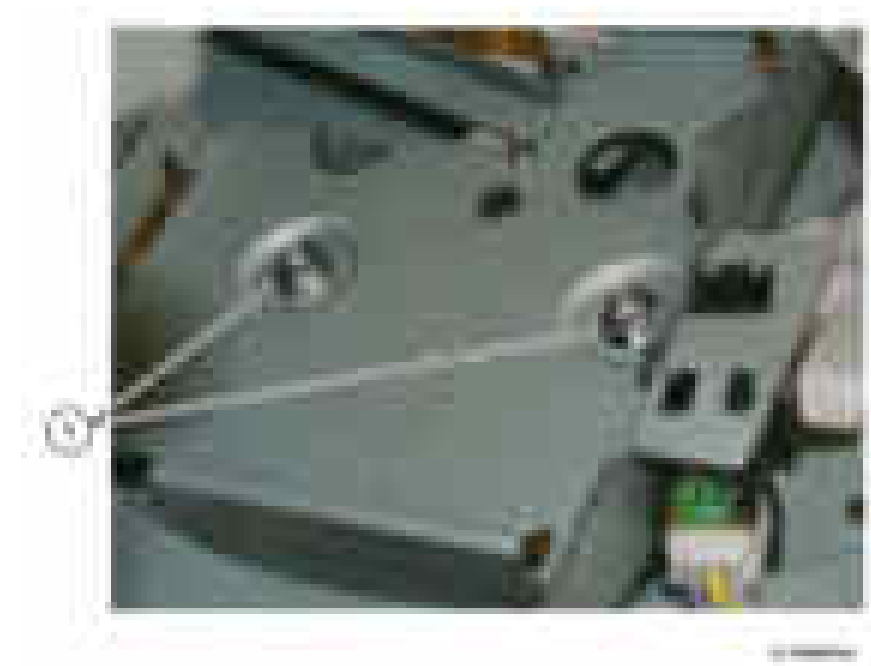
1. Remove the finisher stapler assembly, [REP 13.16](#).
2. Remove two screws (1), [Figure 1](#).

Figure 1 Screw removal

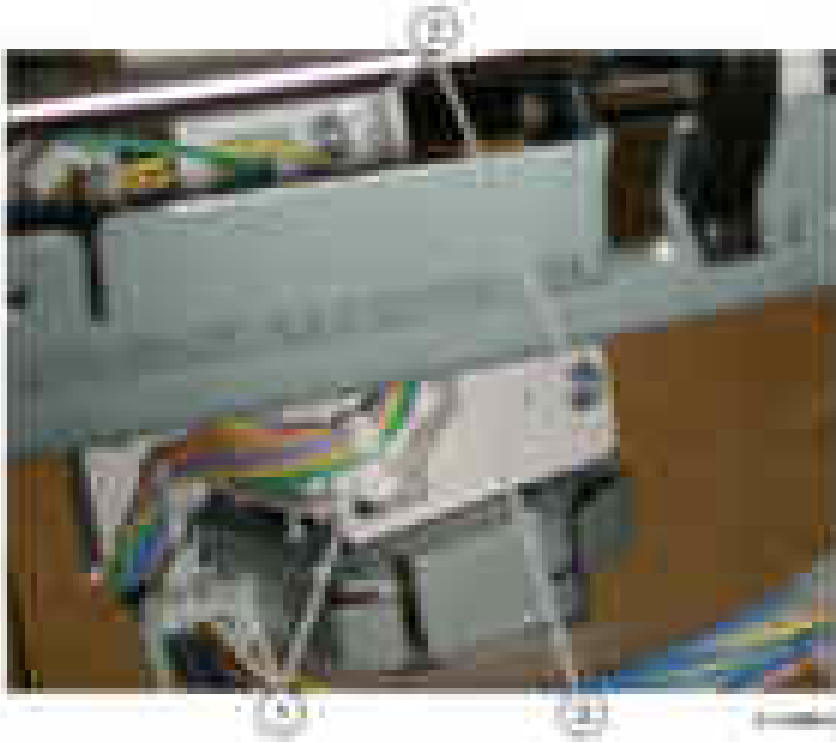
3. Remove the wire guide, **Figure 2**:
 - a. Pull out the cable clamps (1), then remove the wires from the wire guide.
 - b. Remove two screws (2).
 - c. Remove the wire guide (3).

Figure 2 Wire guide removal

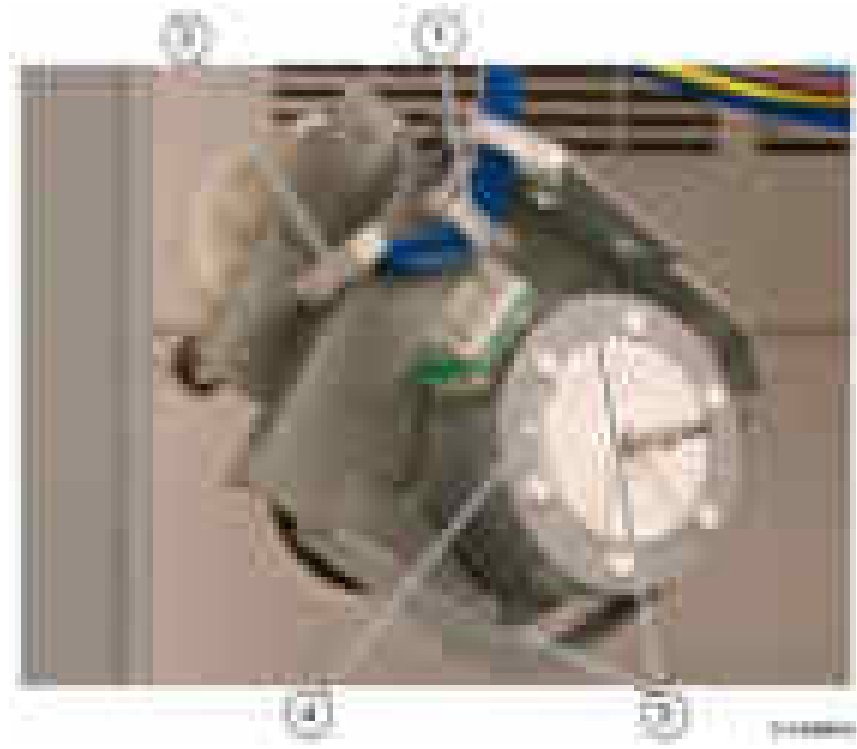
4. Remove the stapler motor, **Figure 3**:
 - a. Release the wires from the cable clamp (1).
 - b. Disconnect the connector (2).
 - c. Remove two screws (3).
 - d. Remove the stapler motor (4).

Figure 3 Stapler motor removal

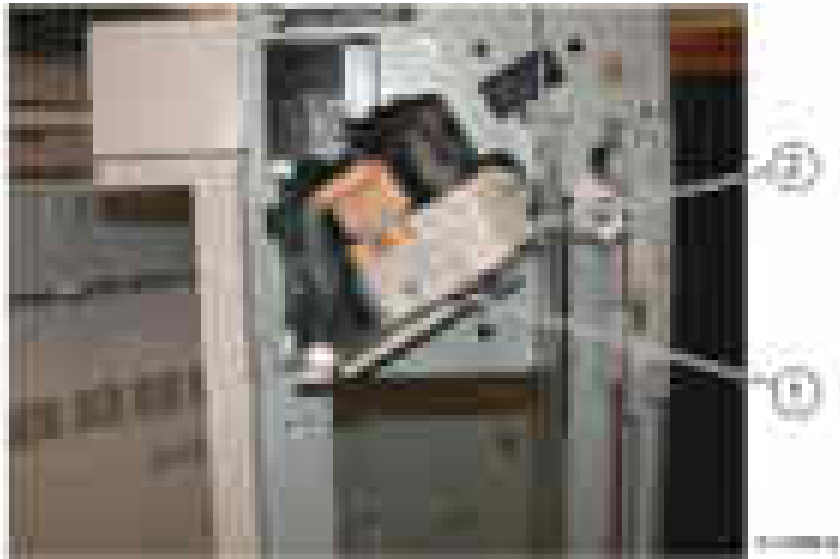
1. Remove the creaser knife assembly, [REP 13.18](#).
2. Remove the front cover assembly, [REP 13.6](#).
3. Remove the stapler cover, [Figure 1](#):
 - a. Remove the screw (1).
 - b. Remove the stapler cover (2).

Figure 1 Stapler cover removal

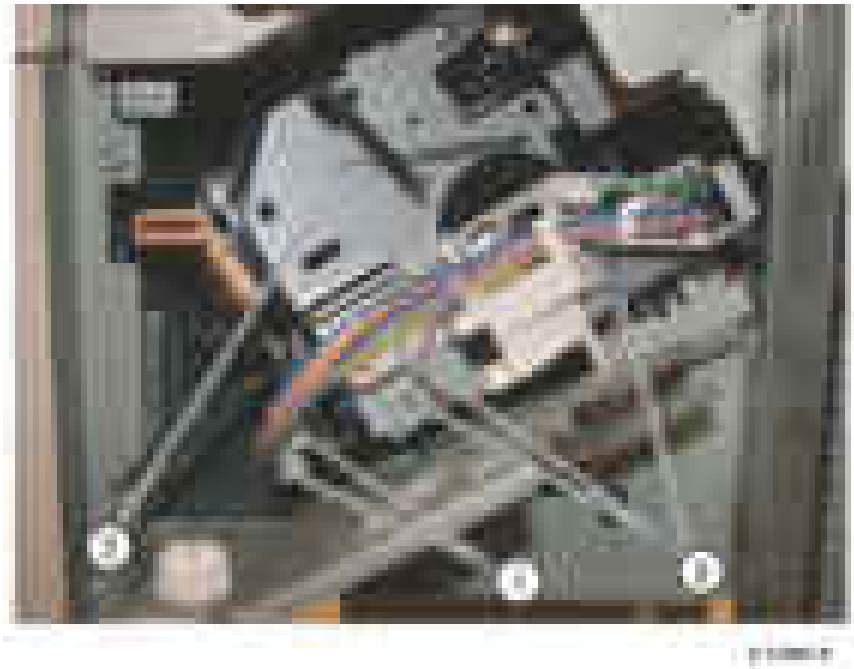
4. Remove the finisher stapler assembly, [Figure 2](#):
 - a. Disconnect the connectors (1).
 - b. Remove three screws (2).
 - c. Remove the finisher stapler assembly (3).

Figure 2 Finisher stapler assembly removal

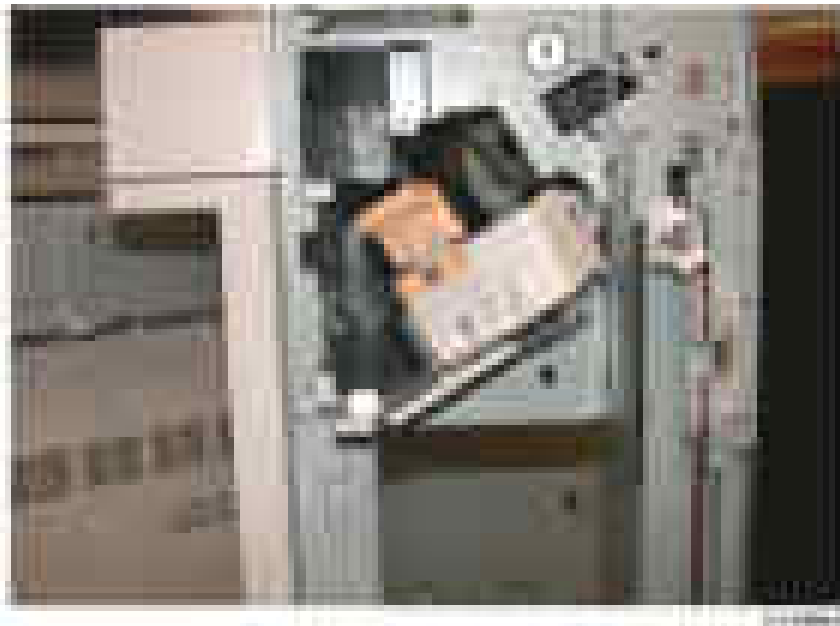
1. Undock the finisher, [REP 13.5](#).
2. Remove the front cover, [REP 13.6](#).
3. Remove the rear upper cover, [REP 13.7](#).
4. Remove the foot cover, [REP 13.10](#).
5. Remove the stacker lower cover, [REP 13.11](#).
6. Remove the stacker tray, [REP 13.20](#).
7. Remove the stacker upper cover, [REP 13.12](#).
8. Remove the eject cover, [REP 13.9](#).
9. Remove the E-ring and brass bearing from the front of the shaft (1), [Figure 1](#).

Figure 1 E-ring and bearing removal

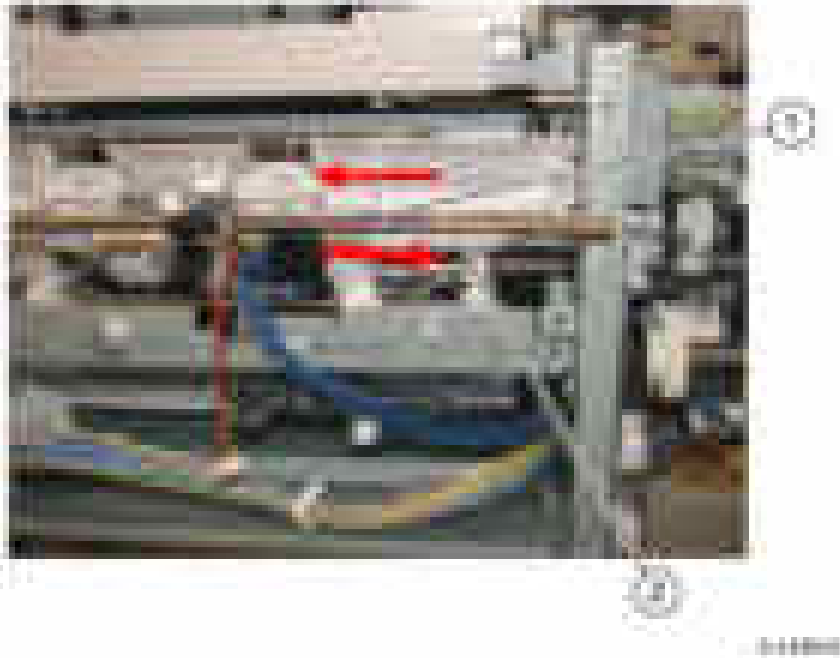
1. Route the harness through the wire guides and connect the proper connectors to the no paper sensor, tamper home sensors and tamper motors.
2. Place the compiler tray assembly into position.
3. Install the set clamp shaft front end into the front frame, [Figure 11](#):
 - a. Insert the front end of the shaft into the front frame (1).
 - b. Slide the shaft toward the front until the rear end of the shaft can be inserted into the rear frame (2).

Figure 11 Set clamp shaft installation

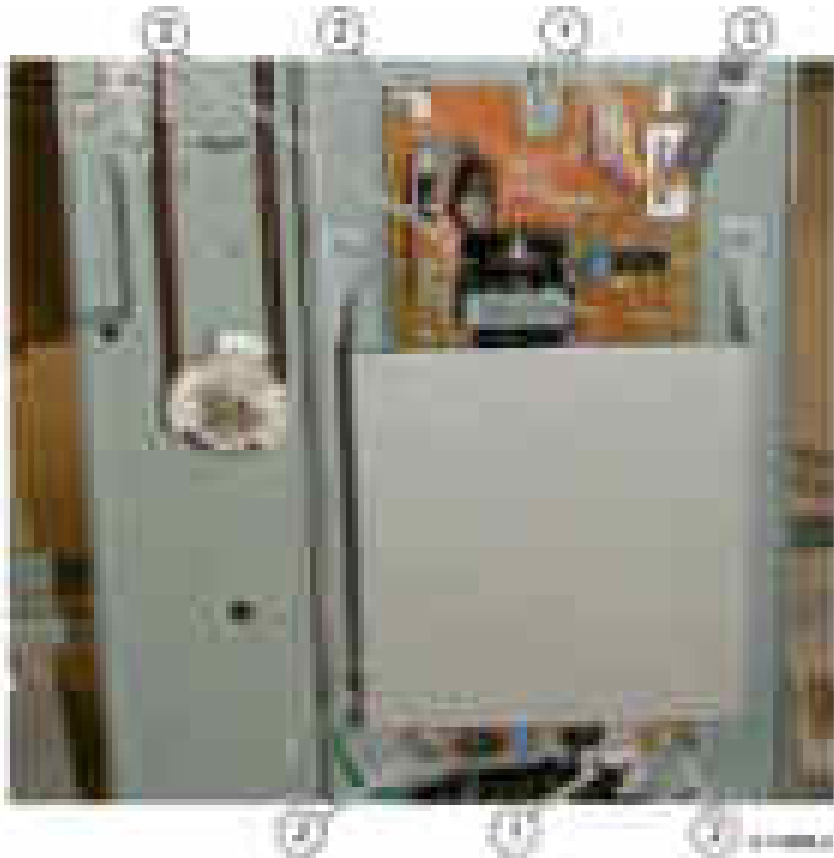
1. Remove the rear lower cover, [REP 13.8](#).
2. Remove the finisher LVPS, [Figure 1](#):
 - a. Disconnect both Connectors (1).
 - b. Remove four screws (2).
 - c. Remove the finisher LVPS (3).

Figure 1 Finisher LVPS removal

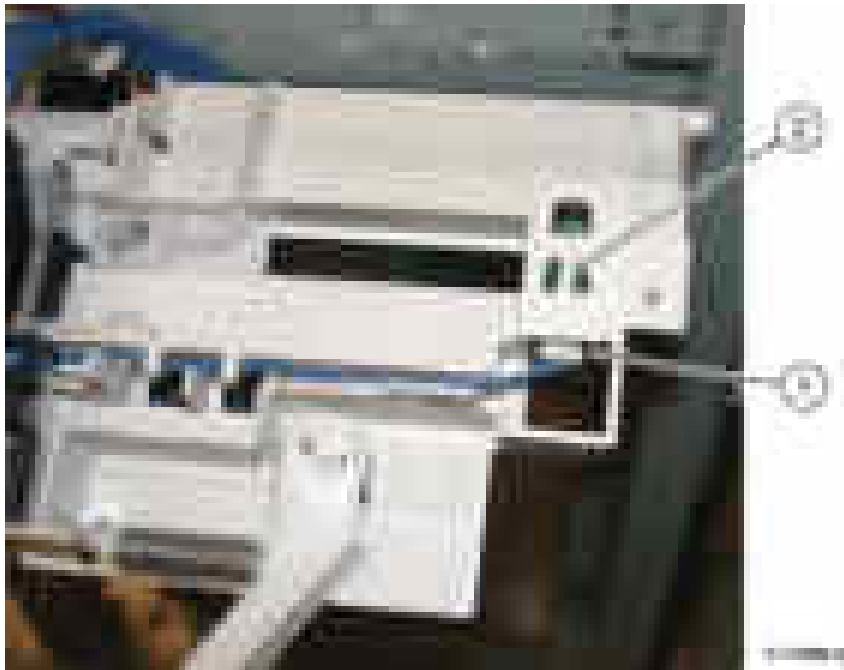
1. Remove the compiler tray assembly, [REP 13.17](#).
2. Place the compiler tray upside down on a work surface.
3. Remove the front or rear tamper home sensor, [Figure 1](#):
 - a. Disconnect the connector (1).
 - b. Remove the front or rear tamper home sensor (2).

NOTE: The removal of the rear tamper home sensor is shown in [Figure 1](#).

Figure 1 Tamper home sensor removal

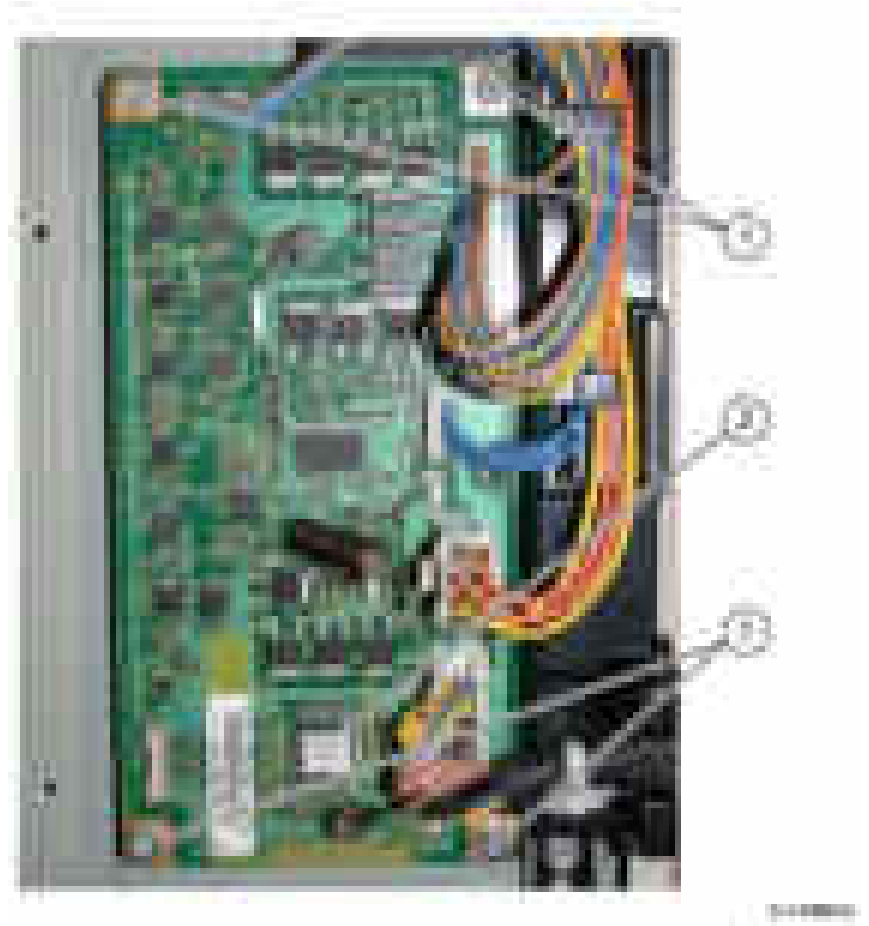
1. Remove the booklet PWB cover, [REP 13.35](#).
2. Remove the booklet PWB, [Figure 1](#):
 - a. Disconnect all connectors from the booklet PWB.
 - b. Remove four screws (1).
 - c. Remove the booklet PWB (2).

Figure 1 Booklet PWB removal

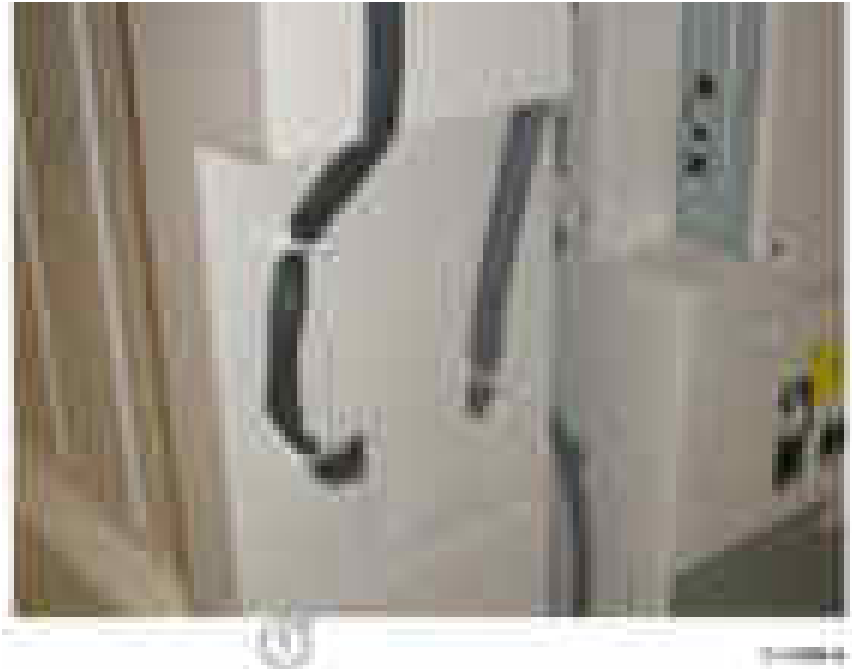
Figure 2 Connector cover

2. Remove the connector cover (1), [Figure 2](#).

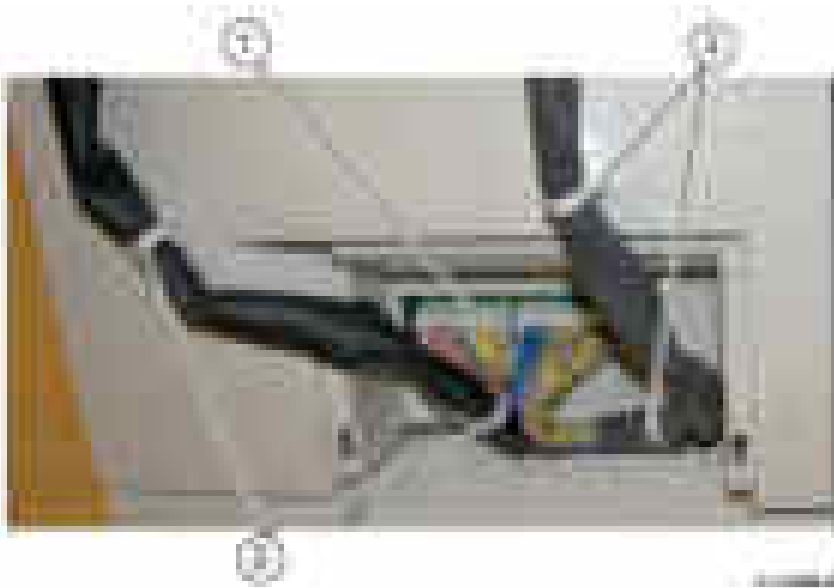
Figure 3 Booklet maker assembly disconnection

3. Disconnect the booklet maker assembly from the finisher, **Figure 3**:
 - a. Disconnect the connector (1).
 - b. Pull out the four cable ties (2).

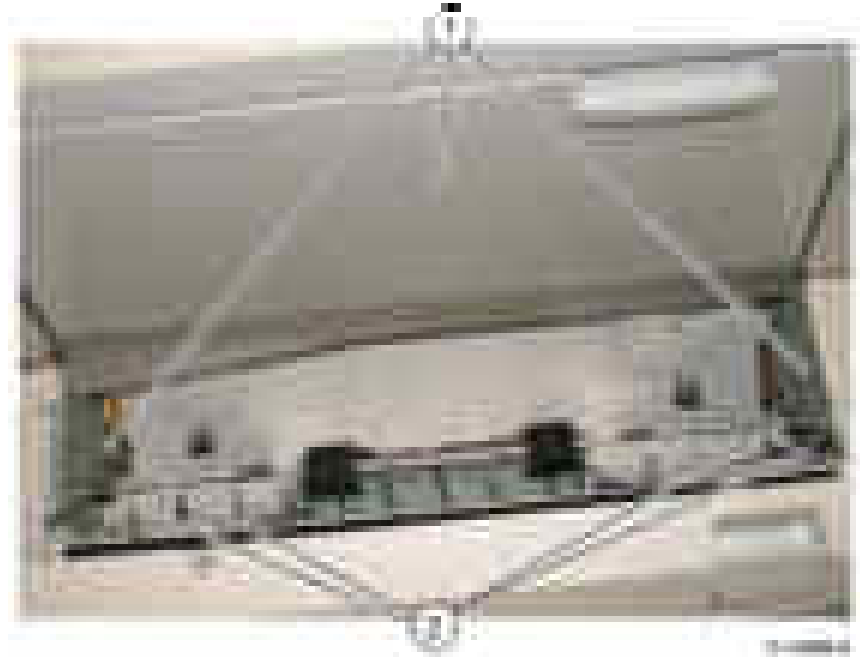
Figure 4 Booklet maker assembly removal

4. Lift the booklet maker assembly (1) off the four locating pins (4), then remove, **Figure 4**.

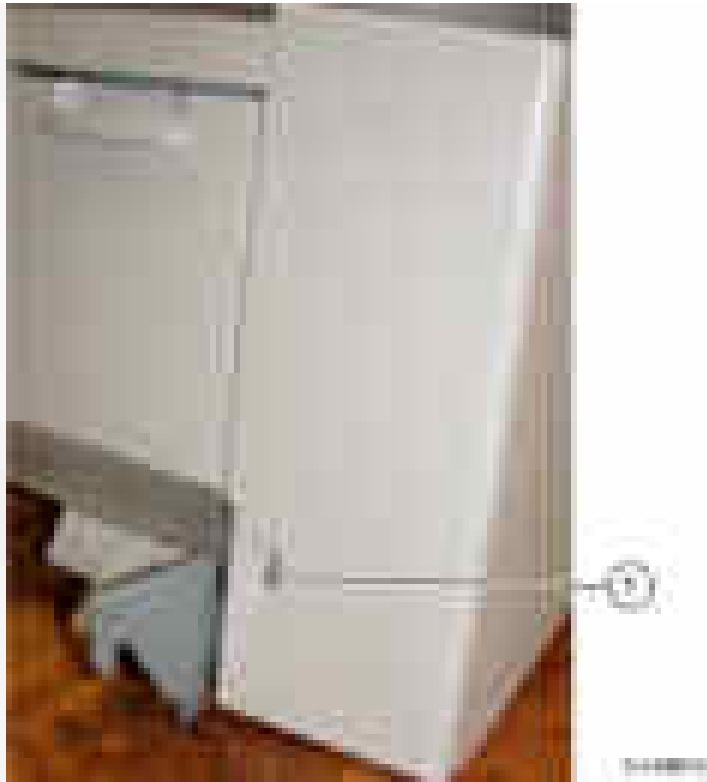
Figure 1 Screw removal

1. Remove the booklet maker assembly from the finisher, [REP 13.31](#).
2. Remove the screw (1), [Figure 1](#).

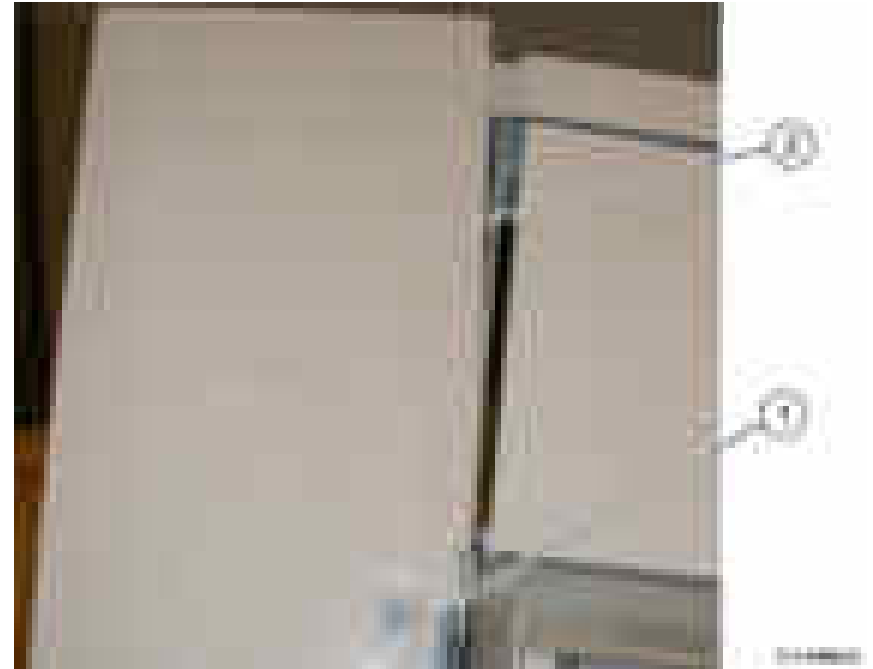
Figure 2 Booklet rear cover removal

4. Remove the screw (1), then the booklet rear cover (2), [Figure 2](#).

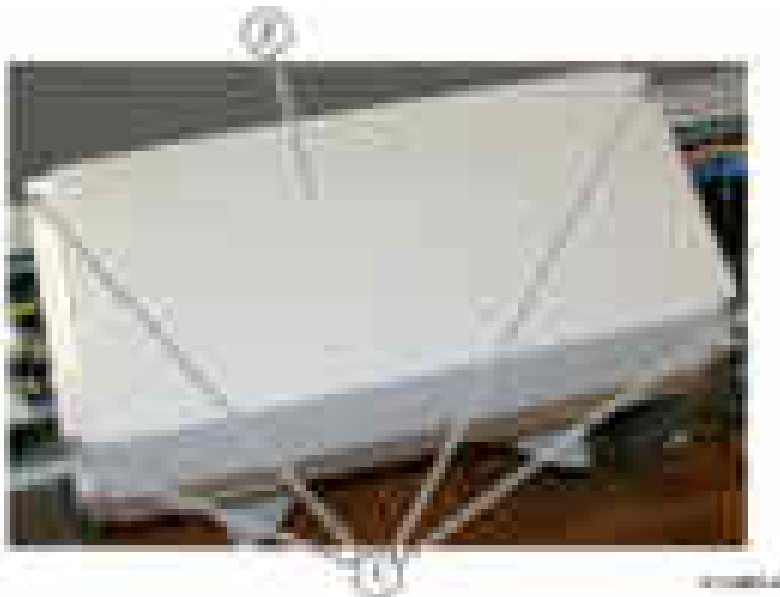
Figure 1 Booklet top cover removal

1. Remove the booklet front cover, [REP 13.32](#).
2. Remove the booklet rear cover, [REP 13.33](#).
3. Remove the booklet top cover, [Figure 1](#):
 - a. Remove four screws (1).
 - b. Remove the booklet top cover (2).

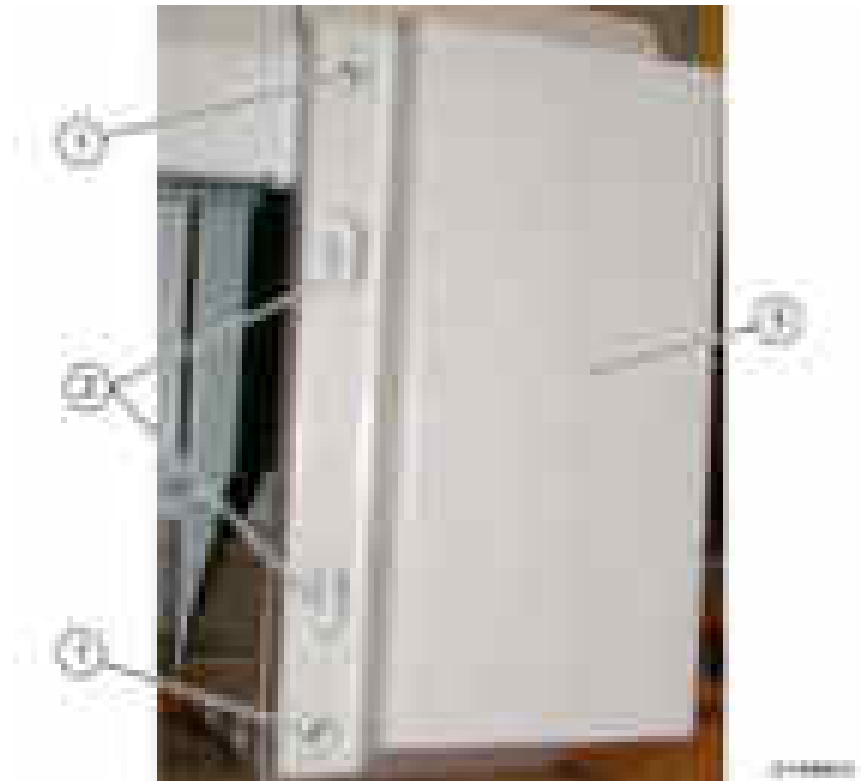
Figure 1 Booklet PWB cover removal

1. Remove the booklet PWB cover, [Figure 1](#):
 - a. Remove both self-tapping screws (1).
 - b. Remove both screws (2).
 - c. Remove the booklet PWB cover (3).

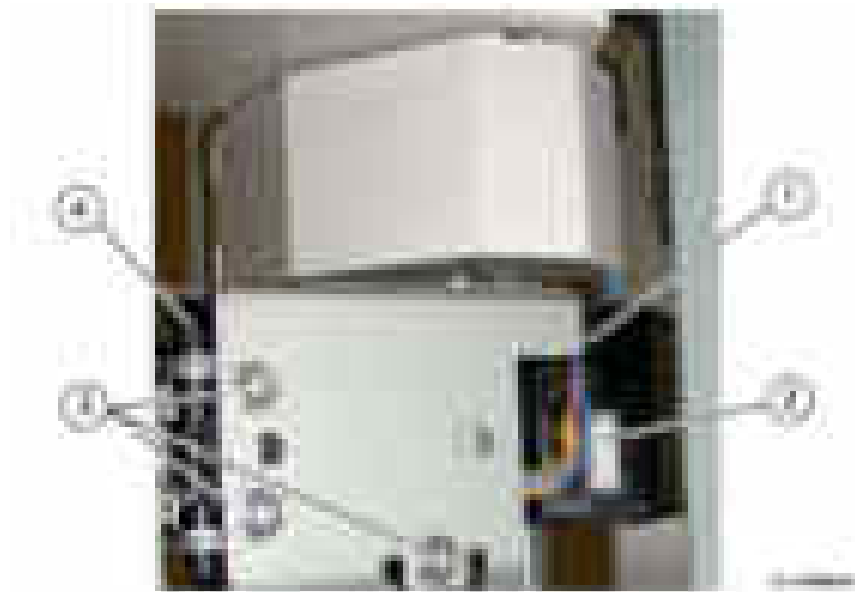
Figure 4 Stapler removal

5. Remove the stapler, [Figure 4](#):
 - a. Release the harness from the clamp (1).
 - b. Disconnect the connector (2).
 - c. Remove three screws (3).
 - d. Remove the stapler (4).

1. The replacement is the reverse of the removal procedure.
2. Perform [ADJ 13.2](#) Finisher LX Booklet Crease/Staple Position.

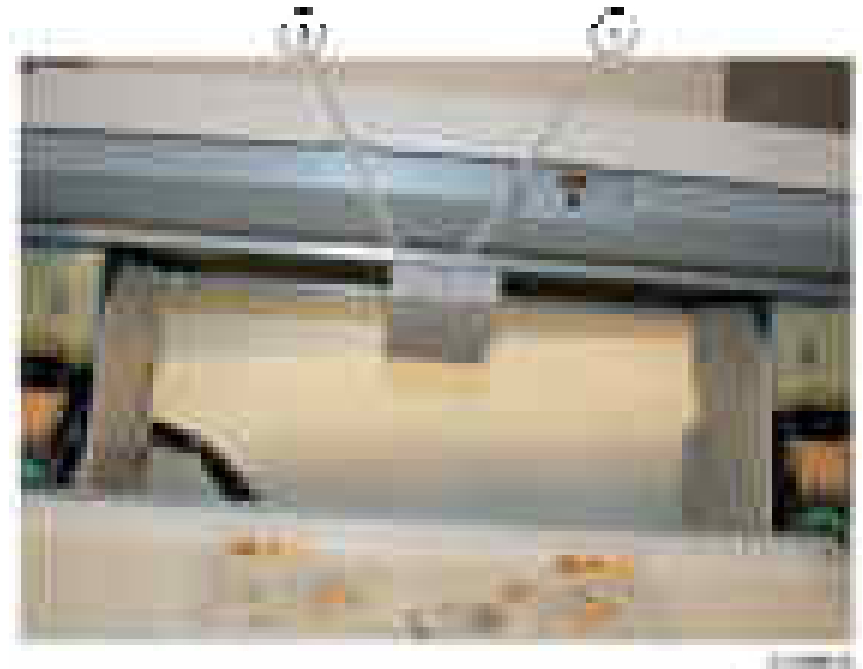
Figure 1 Cover removal

1. Remove the booklet maker assembly, [REP 13.31](#).
2. Remove the cover for the booklet stapler move motor, [Figure 1](#):
 - a. Remove the screw (1).
 - b. Remove the cover (2).

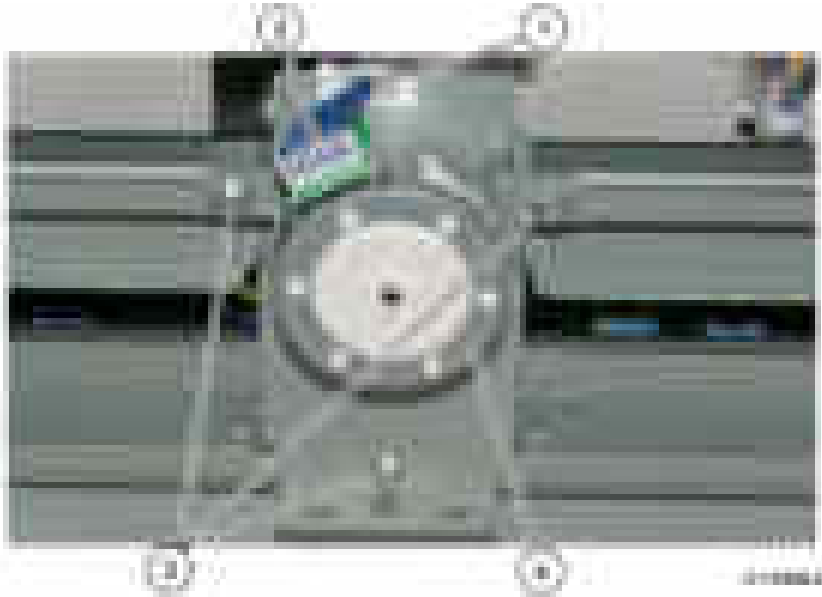
Figure 2 Booklet stapler move motor removal

3. Remove the booklet stapler move motor, [Figure 2](#):
 - a. Release the harness from the clamp (1).
 - b. Disconnect the connector (2).
 - c. Remove three screws (3).
 - d. Remove the booklet stapler move motor (4).

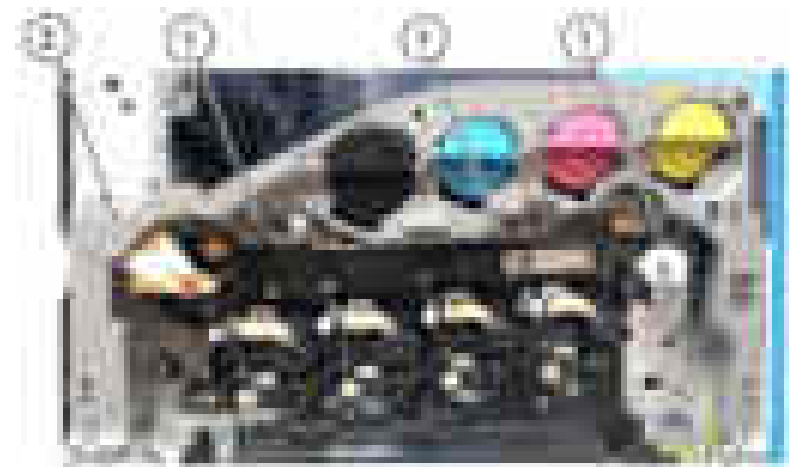
Figure 1 Inner cover removal

1. As necessary, remove the:
 - Integrated finisher, [REP 12.1](#).
 - Office finisher LX, [REP 13.5](#).
 - Horizontal transport, [REP 13.1](#).
2. Remove the front cover, [REP 28.1](#).
3. Remove the waste bottle, [REP 90.6](#).
4. Remove the pillar left cover, [PL 28.05 Item 13](#).
5. Remove the top cover, [REP 28.4](#).
6. Remove the inner cover, [Figure 1](#):
 - a. Remove the screws (1).
 - b. Remove the inner cover (2).

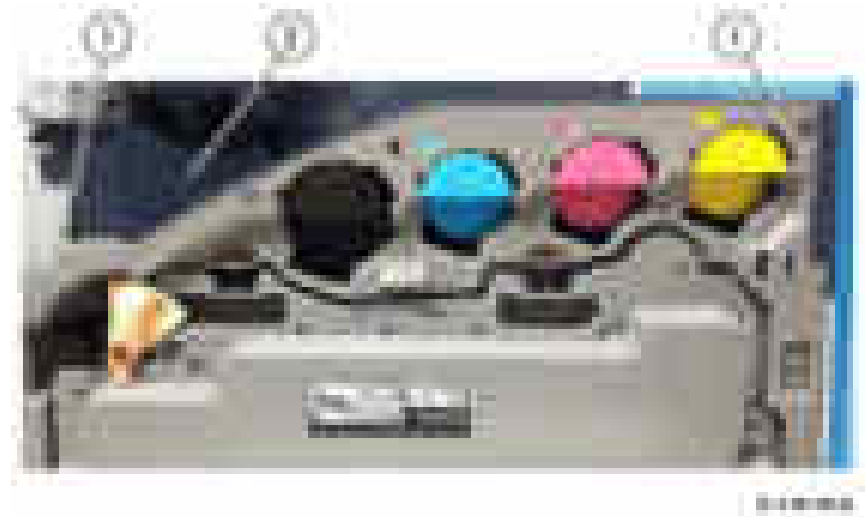
Figure 1 Top cover removal

1. As necessary, remove the:
 - Integrated finisher, [REP 12.1](#).
 - Office finisher LX, [REP 13.5](#).
 - Horizontal transport, [REP 13.1](#).
2. Open the front cover.
3. Remove the pillar left cover, [PL 28.05 Item 13](#).
4. Remove the exit front cover, [PL 28.05 Item 10](#).
5. Remove the top cover, [Figure 1](#):
 - a. Remove two screws (1).
 - b. Remove the top cover (2).

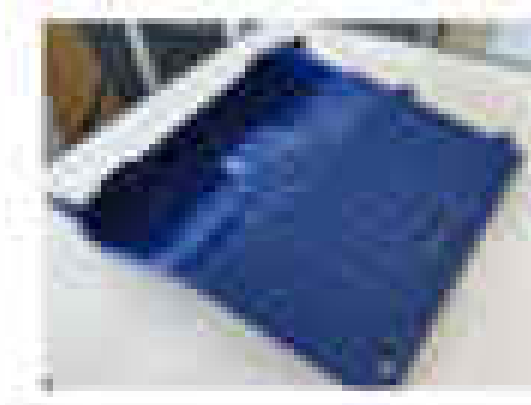
Figure 2 Removed top cover

NOTE: The removed top cover is shown in [Figure 2](#).

1. The replacement is the reverse of the removal procedure.
2. When installing the top cover, align the bosses on the rear of the top cover with the mounting holes.

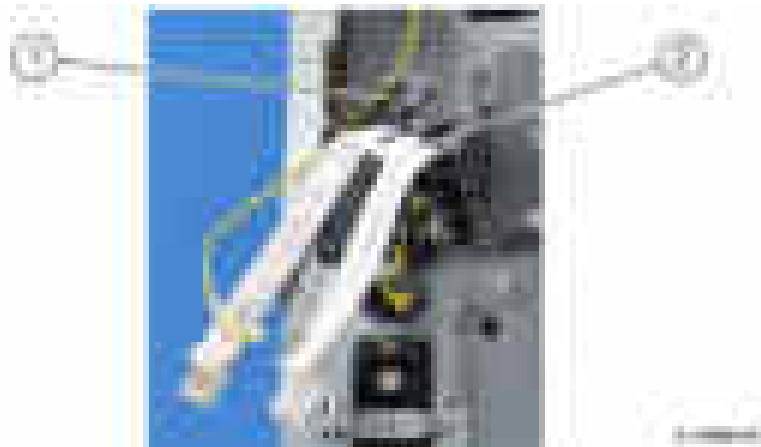
Figure 1 FCC cable guide and cables

1. Remove the upper rear cover, REP 28.5.
2. Remove the lower rear cover, REP 28.6.
3. Remove the right cover, REP 28.3.
4. Remove the ESS PWB chassis assembly, REP 3.2.
5. Remove the LVPS assembly, REP 1.4.
6. Remove the harness upper bracket PL 1.10 Item 6.
7. Remove the drive PWB assembly, REP 1.5.
8. Release the hook (1) to move the FCC cable guide, FCC cables and wire harness (2), Figure 1.

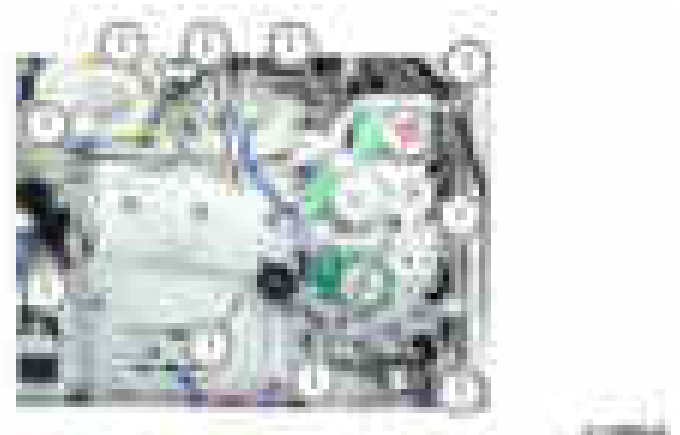
Figure 3 Drive assembly screw fittings

11. Remove ten screws (1) that secure the drive assembly, Figure 3.

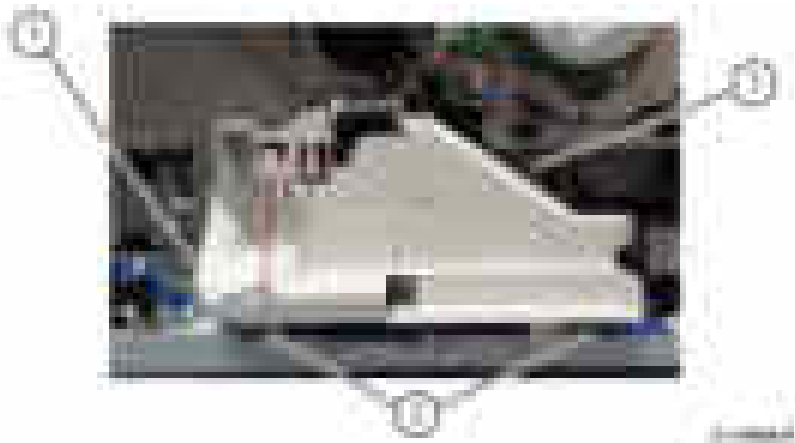
Figure 4 Rear duct marking removal

12. Remove the rear duct marking, [Figure 4](#).
 - a. Remove two screws (1).
 - b. Disengage the right and left hooks (2), then remove the rear duct marking.

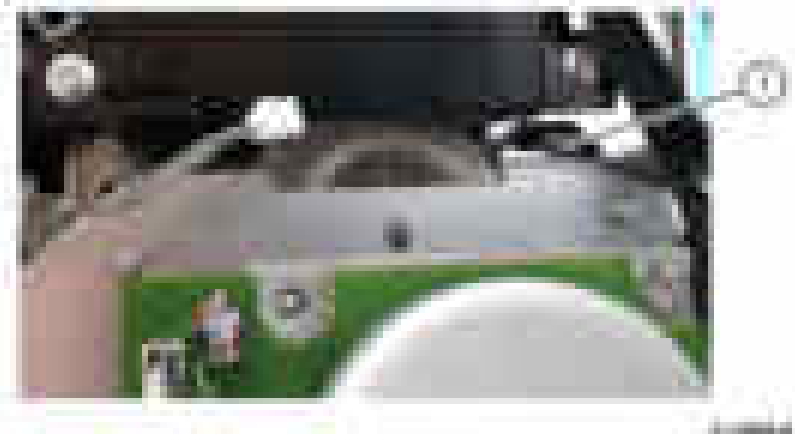
Figure 5 Drive assembly removal

13. Release the hook (1), carefully move the drive assembly down and remove the drive assembly, [Figure 5](#).

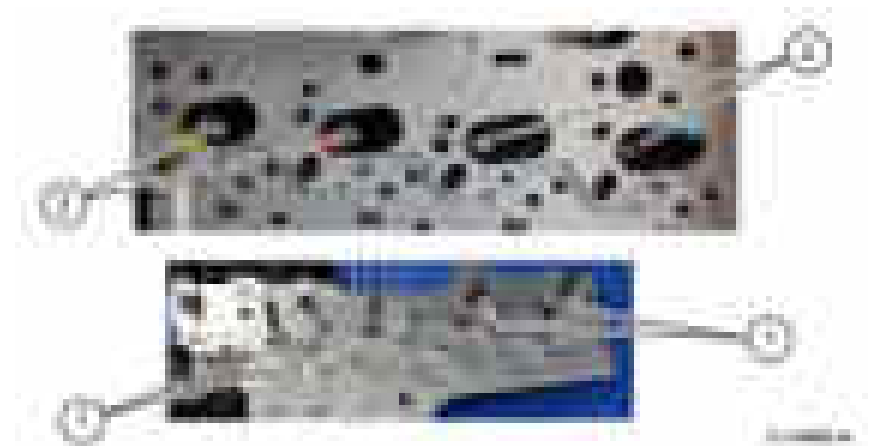
Figure 7 Drive assembly alignment

1. The replacement is the reverse of the removal procedure.
2. When installing the drive assembly, align each of the four bosses on the assembly with the receptacles in the chassis, [Figure 7](#).

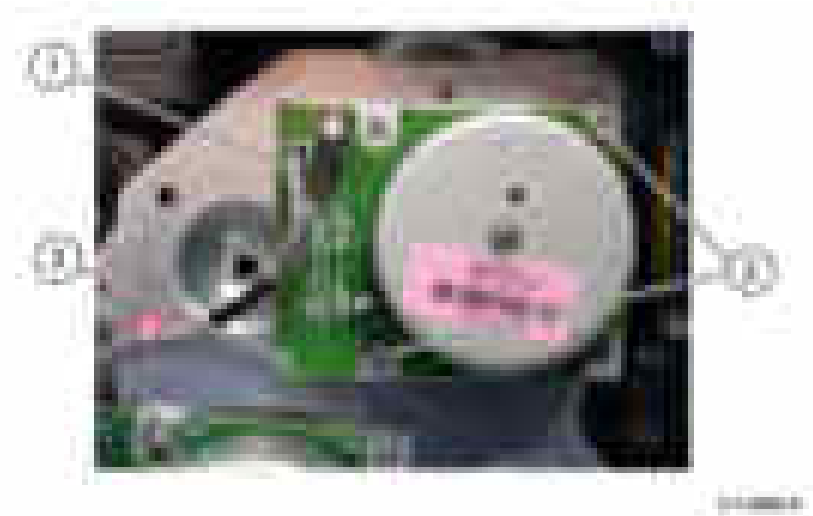
Figure 1 Fusing unit drive removal

- Remove the upper rear cover, [REP 28.5](#).
- Remove the lower rear cover, [REP 28.6](#).
- Remove the LVPS assembly, [REP 1.4](#).
- Remove the fusing unit drive motor PWB, [Figure 1](#).
 - Remove the connector (1).
 - Remove two screws (2).
 - Remove the fusing unit drive motor PWB (3).

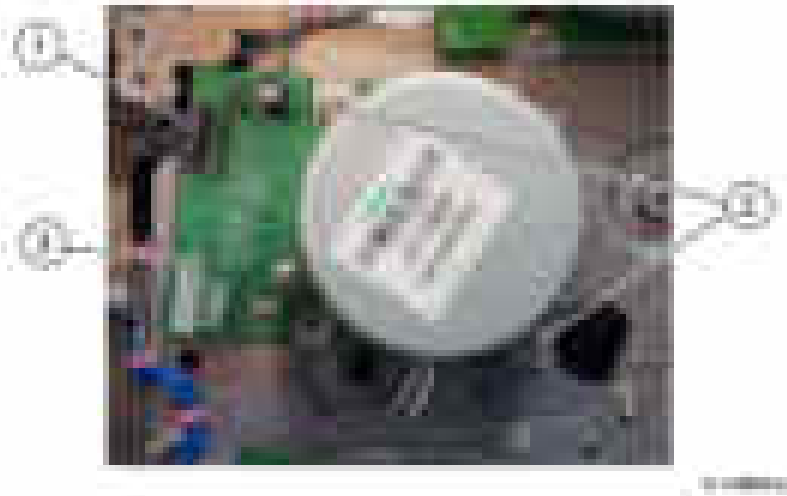
Figure 1 Main motor PWB removal

1. Remove the upper rear cover, [REP 28.5](#).
2. Remove the lower rear cover, [REP 28.6](#).
3. Remove the LVPS assembly, [REP 1.4](#).
4. Remove the main motor PWB, [Figure 1](#).
 - a. Remove the connector (1).
 - b. Remove two screws (2).
 - c. Remove the main motor PWB (3).

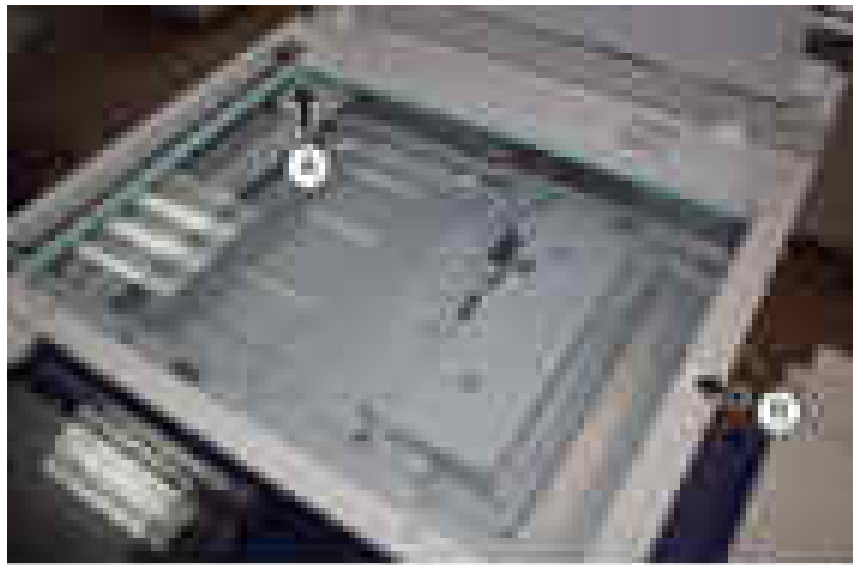
Figure 1 Alignment

1. The replacement is the reverse of the removal procedure.
2. Before tightening the two screws, align the document glass in the direction of arrow A and the right plate in the direction of arrow B, [Figure 1](#).

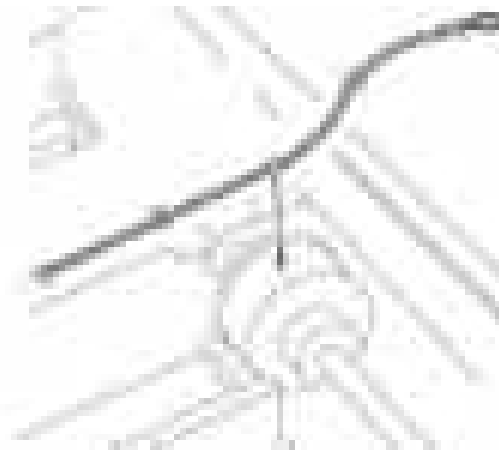
1. Insert the anchor ball of the carriage cable into the groove in the capstan, **Figure 6**.

Figure 6 Anchor ball

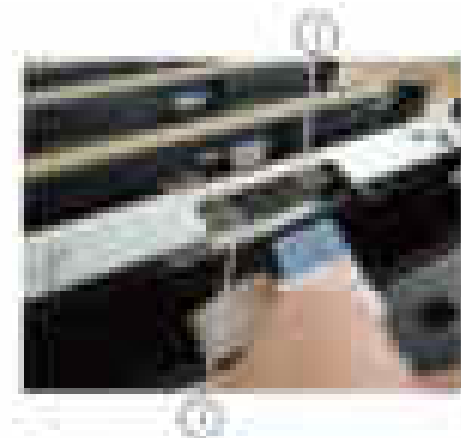
12. Push the two ends (2) simultaneously towards the direction of the arrow and remove the FFC cable, [Figure 5](#).

Figure 5 FFC cable

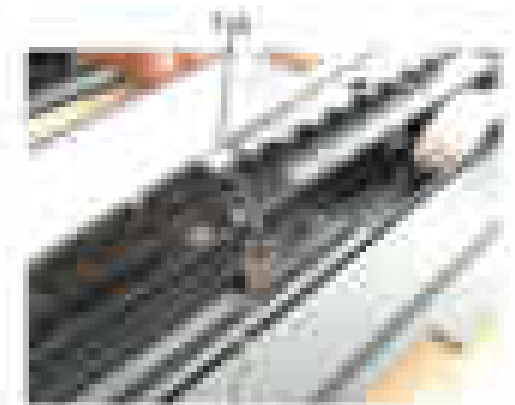
1. The replacement is the reverse of the removal procedure.
2. When installing the LPH, insert the tab at the bottom of the LPH into the installation hole of the marking guide, [Figure 7](#).

Figure 7 Block

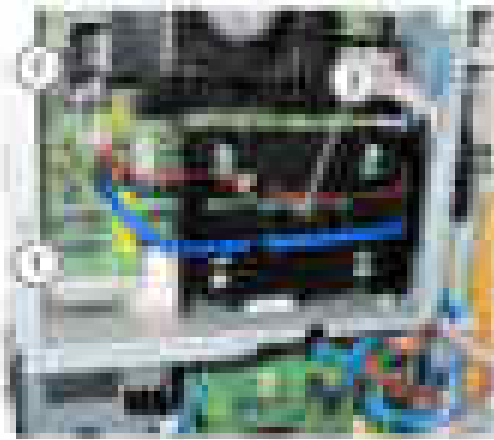
3. If the machine has an HDD assembly installed, remove the HDD assembly, [Figure 2](#):
 - a. Disconnect the connectors (1).
 - b. Remove the HDD assembly (2).

Figure 2 HDD removal

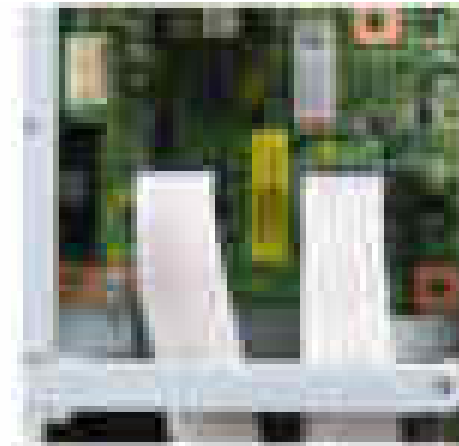
5. Disconnect the four FFC cables, [Figure 4](#):
 - a. Carefully disconnect the FFC cables (1) by releasing the side clips.
 - b. Pull down the FFC cables through the ESS chassis.

Figure 4 FFC cables
