Xerox® VersaLink® C7000 Color Printer & C7030 Family Color Multifunction Printer Service Manual

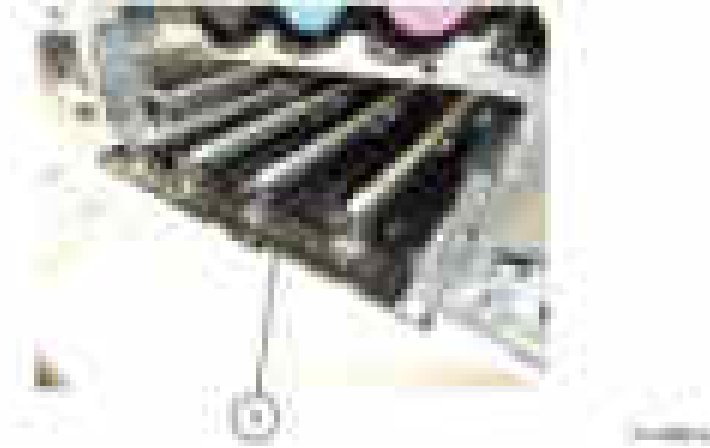
Figure 10 Marking guide

19. Pull out the marking guide (1) including the four LPHs by approximately 10cm (4 inches), [Figure 10](#).

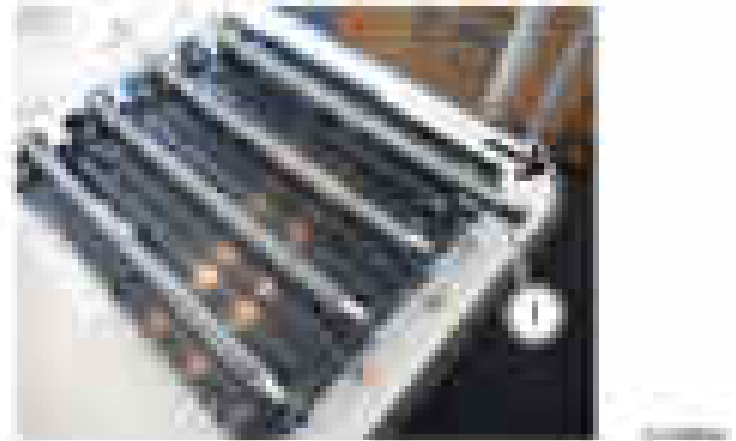
Figure 12 LPH

22. Move the LPH (Y) (1) to the front until it stops, [Figure 12](#).

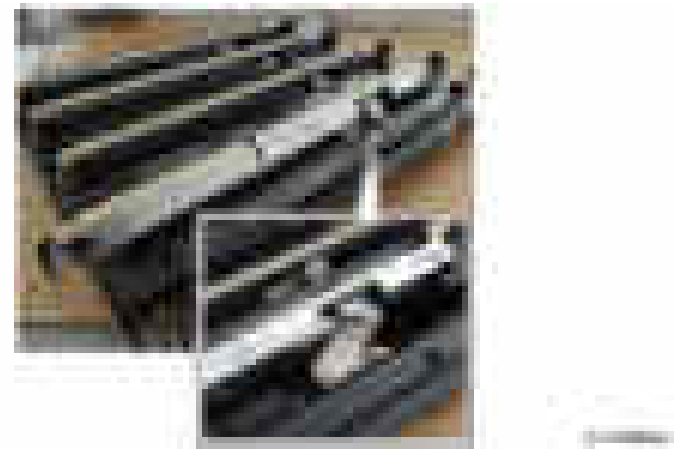
Figure 13 Alignment

23. Push the LPH (Y) towards the direction of the arrow, and place it so the right side of LPH (Y) is on the top, [Figure 13](#).

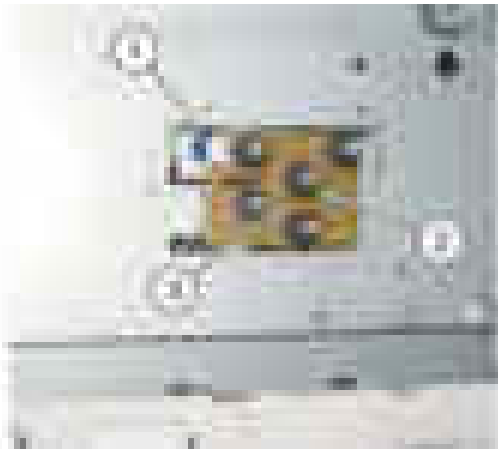
Figure 1 Tray 1 size sensor removal

1. Remove tray 1.
2. Remove the tray 1 size sensor, [Figure 1](#):
 - a. Disconnect the connector (1).
 - b. Remove the screw (2).
 - c. Remove the tray 1 size sensor (3).

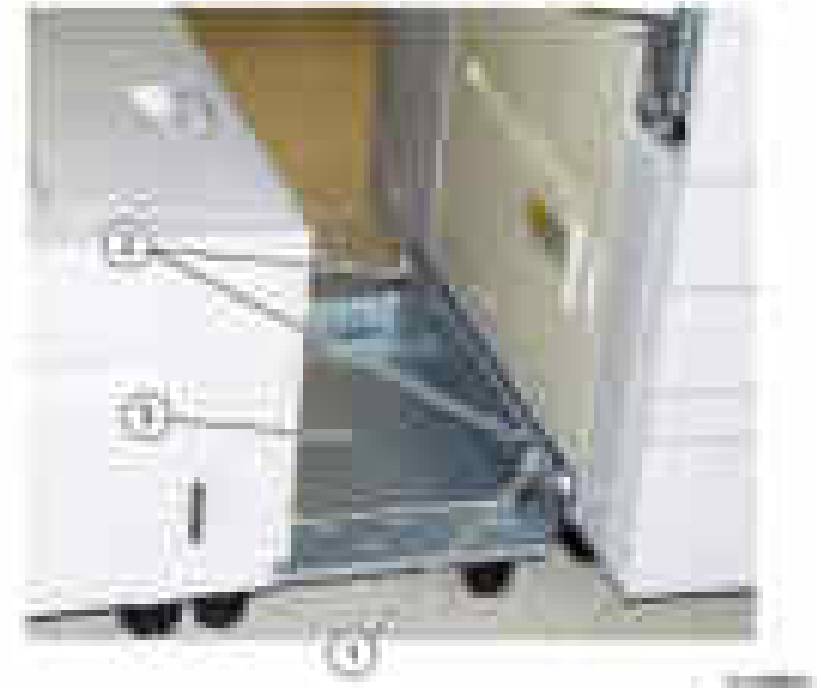
Figure 1 Docking base

1. Disconnect the HCF power cable from the machine.
2. Pull the HCF away from the machine.
3. Release the docking latch spring lever (1) on the right side of the docking base, [Figure 1](#).

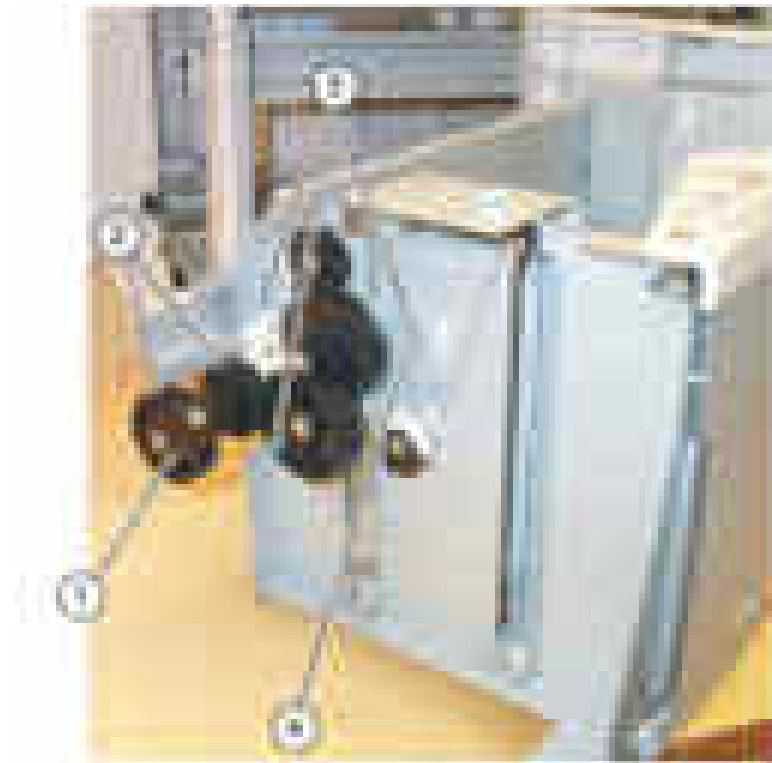
Figure 1 Gear bracket assembly

1. Remove the HCF tray, [REP 70.3](#).
2. Remove the gear bracket assembly, [Figure 1](#):
 - a. Remove the oval shaped plate (1).
 - b. Remove two gears (2).
 - c. Remove three screws (3).
 - d. Remove the gear bracket assembly (4).

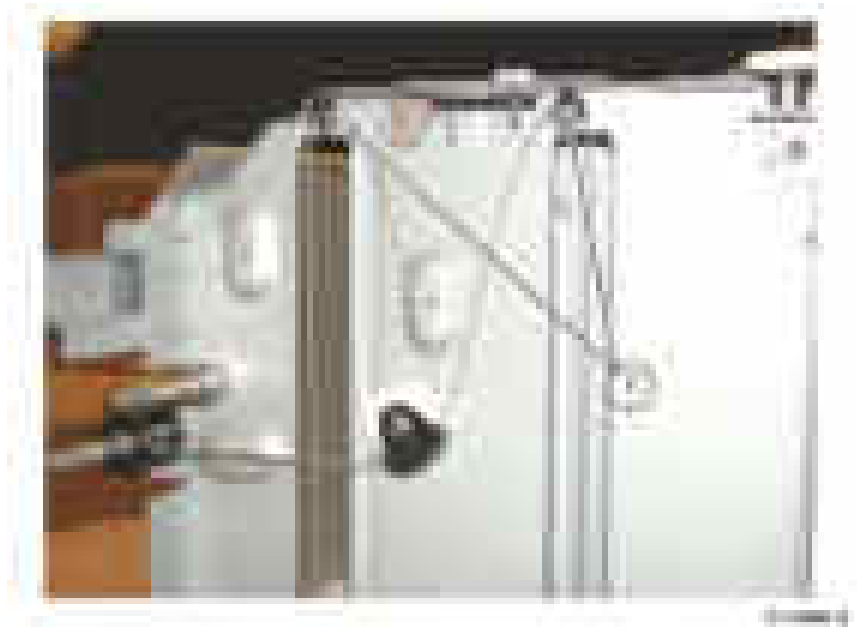
Figure 3 Preparation

4. Prepare to remove the tray rear cables. Remove two E-rings, wire guides and pulleys (1), **Figure 3**.

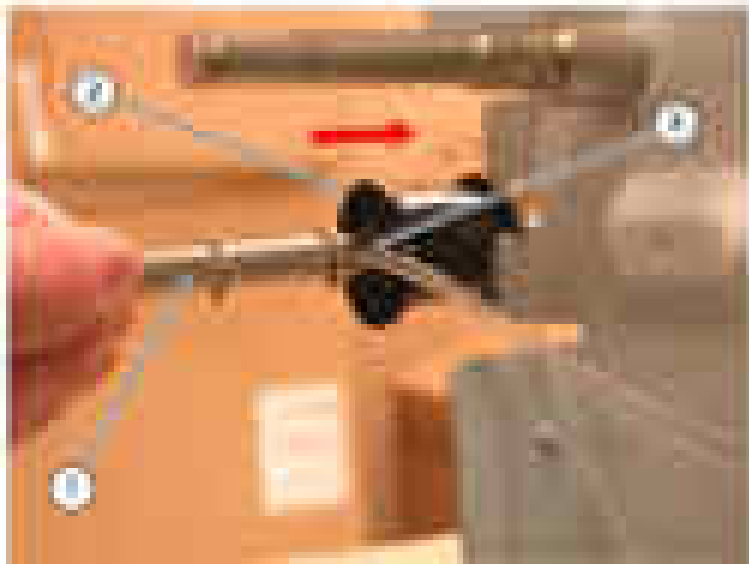
Figure 4 Releasing the cable ends

5. When both cables are slack, disengage the lift shaft (1) from the frame. Then slide the tray cable pulley (2) to the front of the lift shaft to release the rear lift cable ends (3) that are trapped in the pocket underneath the tray cable pulley, [Figure 4](#).

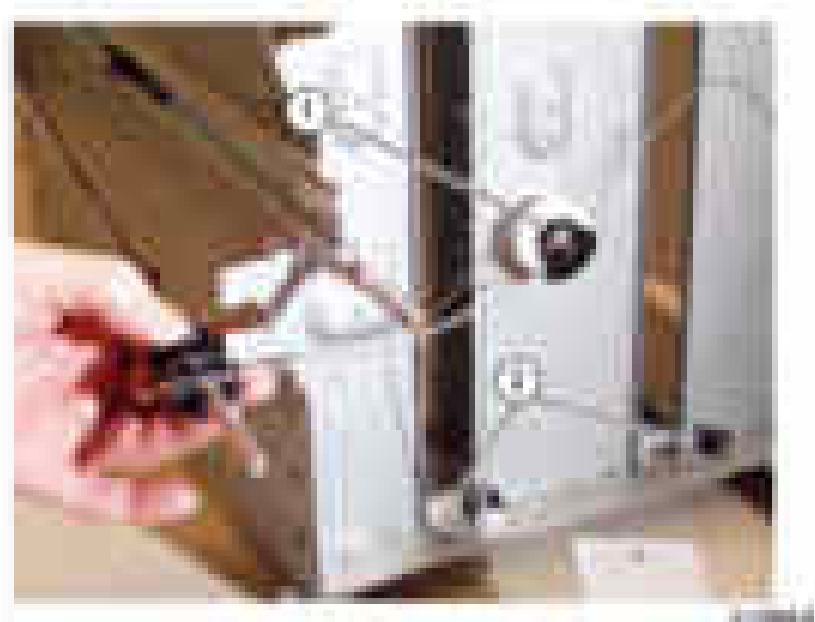
Figure 5 Rear cables removal

6. Remove the rear tray cables, [Figure 5](#):
 - a. Remove the E-ring, wire guide and pulley (1).
 - b. Remove the cables (2).

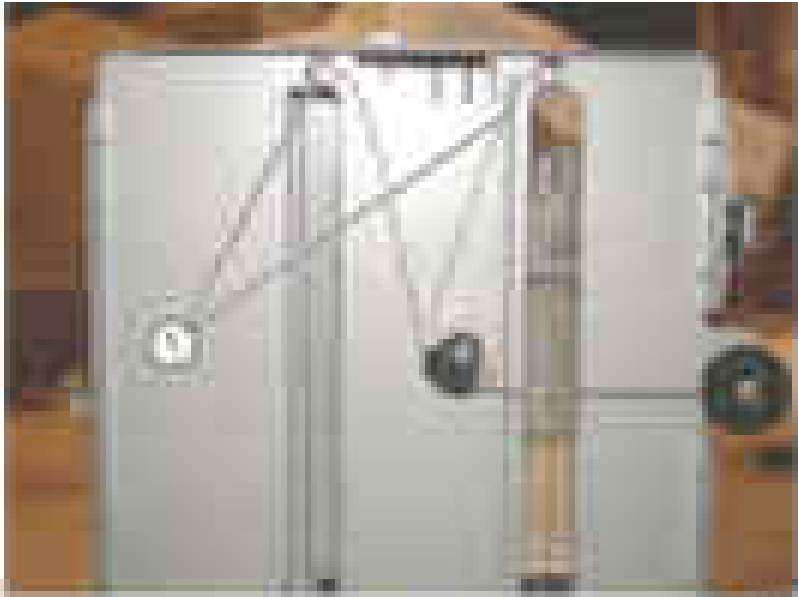
Figure 2 Preparation

3. Prepare to remove the tray front cables. Remove two E-rings, wire guides and pulleys (1) from the front of the HCF tray, [Figure 2](#).
4. When both cables are slack, disengage the lift shaft from the frame, Then slide the tray cable pulley to the front of the lift shaft to release the rear lift cable ends that are trapped in the pocket underneath the tray cable pulley, [Figure 3](#).

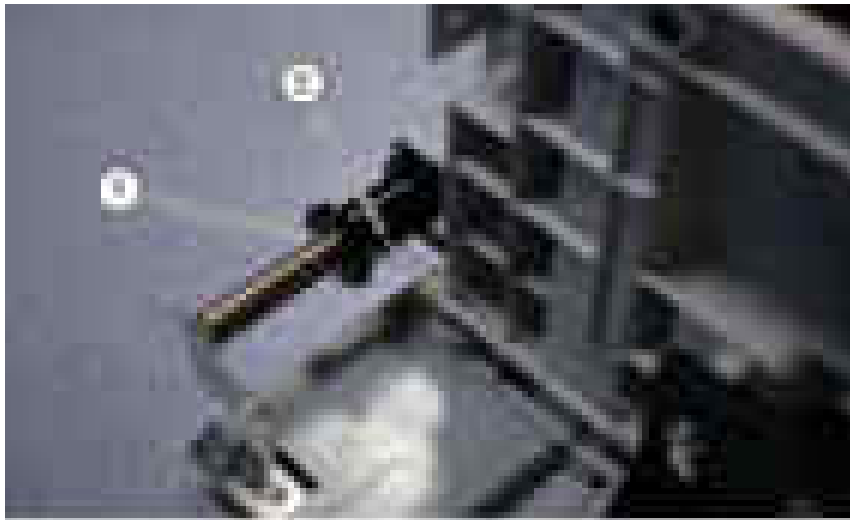
Figure 1 Front cables

1. Remove the paper from tray 3.
2. Fully pull out tray 3. Remove the paper from tray 3. Lift out tray 3.
3. Remove the tray 3 front cover, [PL 70.65 Item 18](#).
4. Release the front lift cables, [Figure 1](#):
 - a. Remove the E-clip (1).
 - b. Release the front lift cables (2).

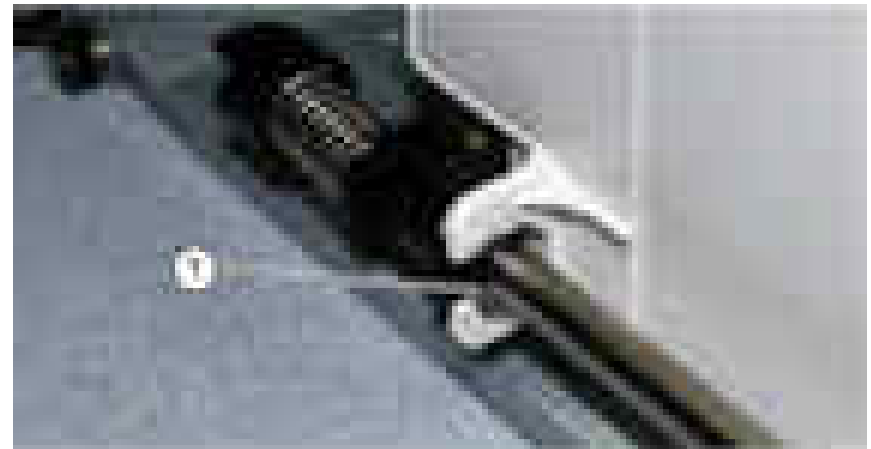
Figure 3 Rear E-clip

6. Remove the E-clip (1), [Figure 3](#):

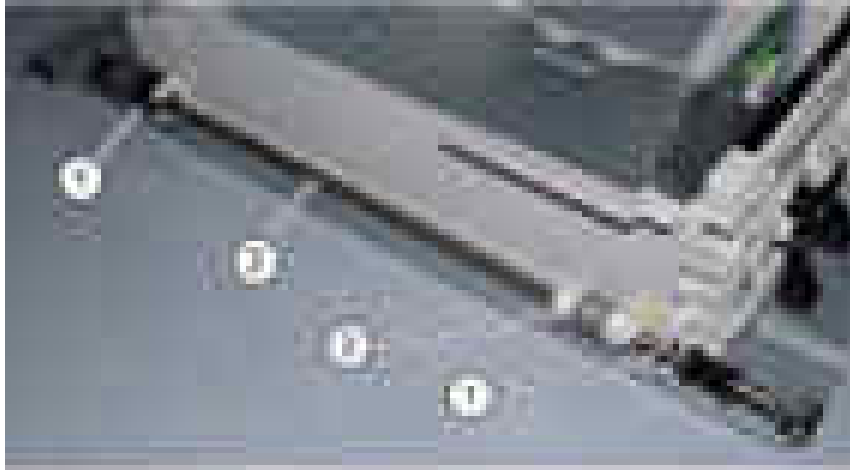
Figure 4 Lift shaft removal

The lift shaft brake, item 3 in Figure 4, is secured on the lift shaft by a pin. Do not lose the pin when the lift shaft is removed.

7. Remove the lift shaft, Figure 4:
 - a. Release the front and rear bearings (1).
 - b. Remove the lift shaft (2).

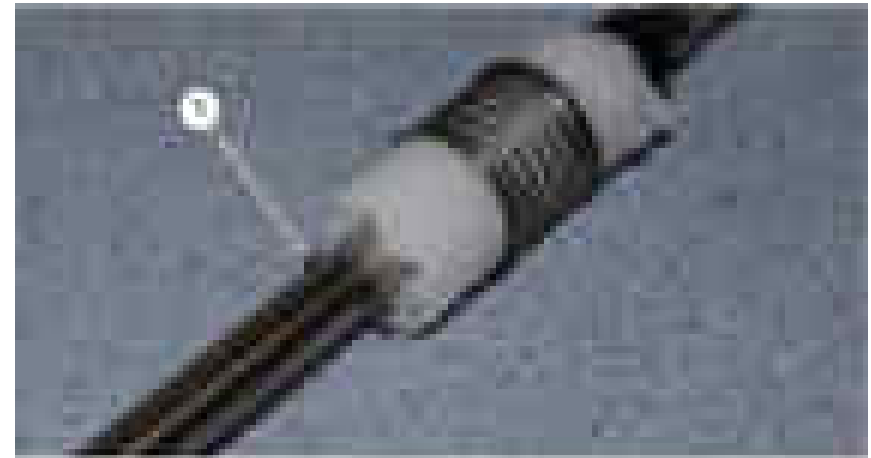
Figure 5 Pin

2. Ensure the brake securing pin (1) is installed correctly, Figure 5.

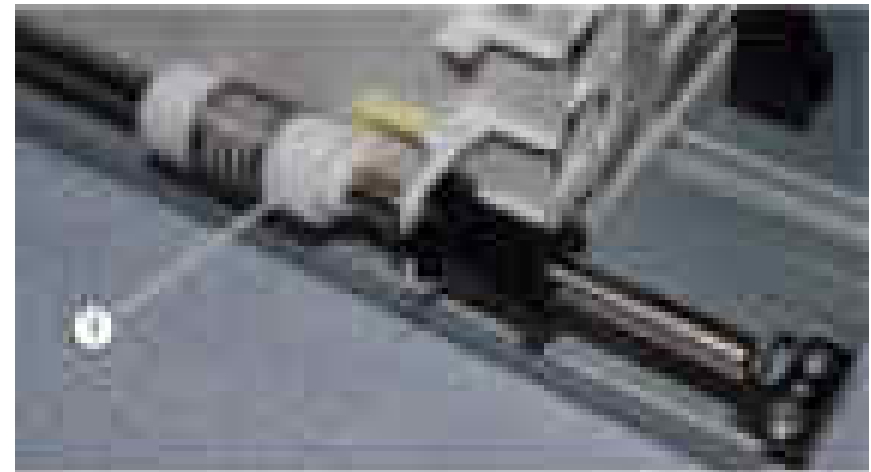
Figure 6 Brake

3. Ensure the brake (1) is correctly positioned against the tray frame, Figure 6.

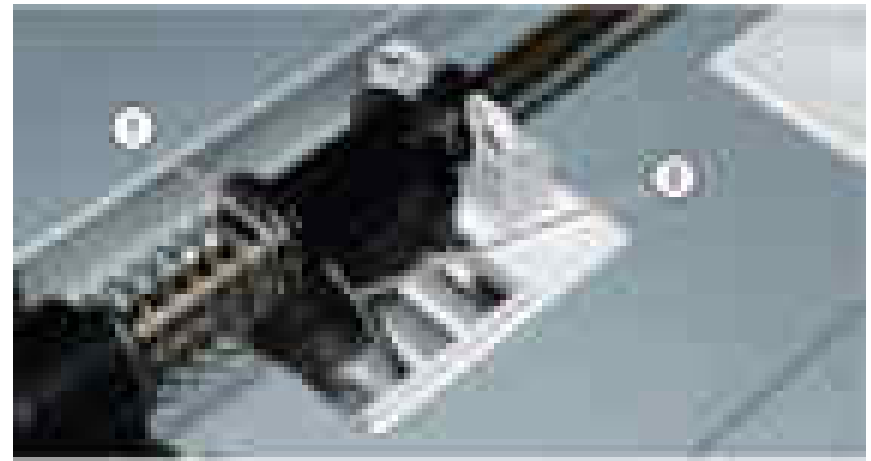
Figure 2 Rear cables

6. Release the rear lift cables, [Figure 2](#):
 - a. Pull the spring away from the pulley, then remove the E-clip (1).
 - b. Release the rear lift cables (2).

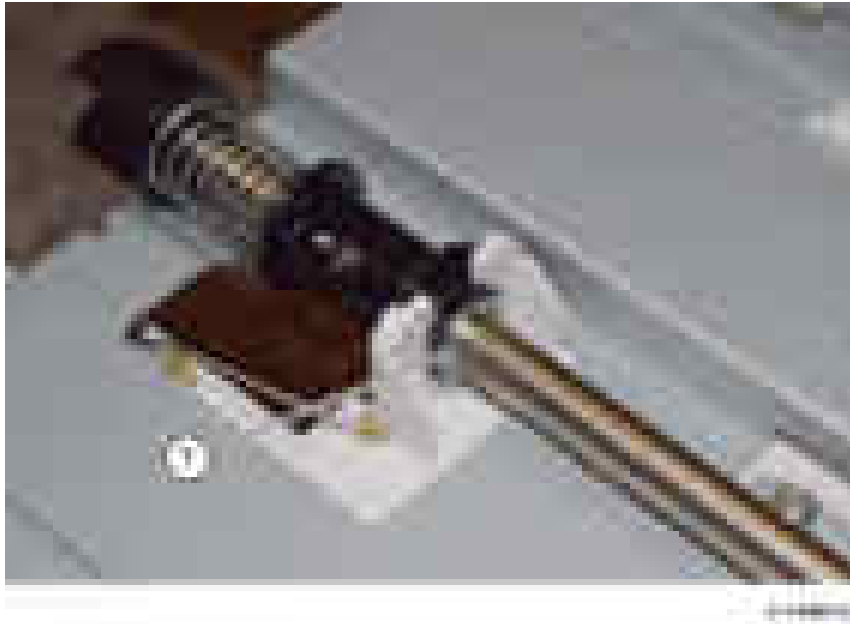
Figure 3 Rear E-clip

7. Remove the E-clip (1), **Figure 3**:

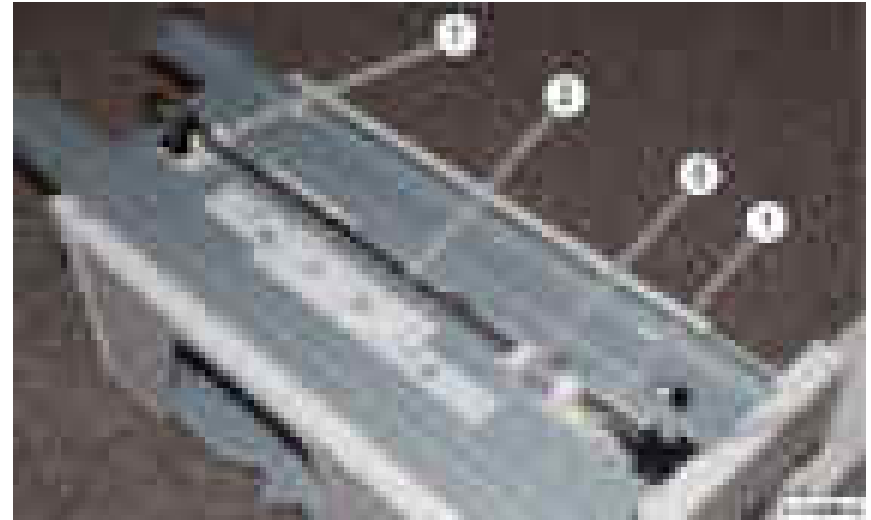
Figure 4 Lift shaft removal

*The lift shaft brake, item 3 in **Figure 4**, is secured on the lift shaft by a pin. Do not lose the pin when the lift shaft is removed.*

8. Remove the lift shaft, **Figure 4**:
- Release the front and rear bearings (1).
 - Remove the lift shaft (2).

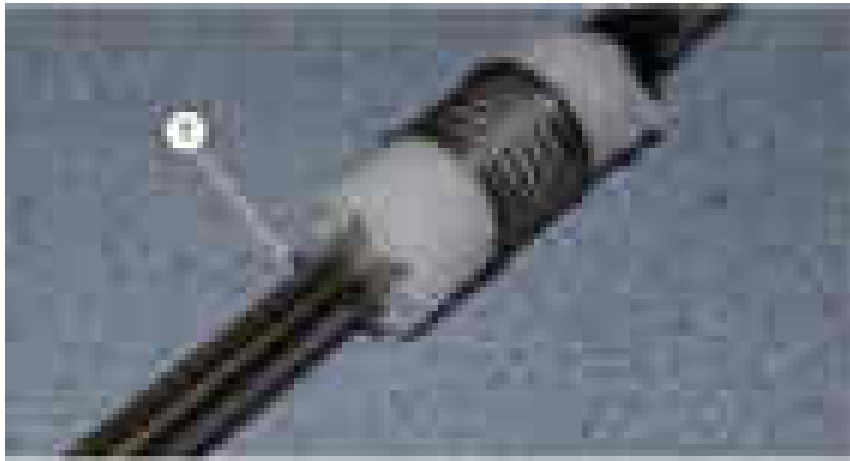
Figure 5 Pin

2. Ensure the brake securing pin (1) is installed correctly, [Figure 5](#).

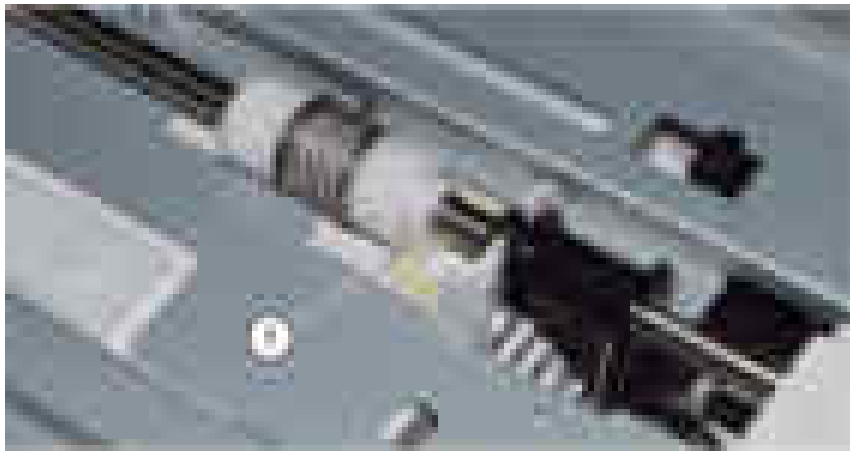
Figure 6 Brake

3. Ensure the brake (1) is correctly positioned against the tray frame, [Figure 6](#).

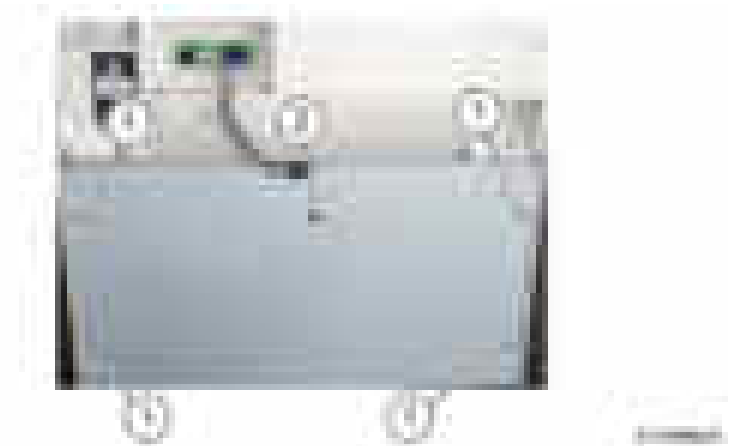
Figure 2 Rear cover removal

1. Remove the rear cover, [Figure 2](#):
 - a. Remove four screws (1).
 - b. Remove the rear cover (2).

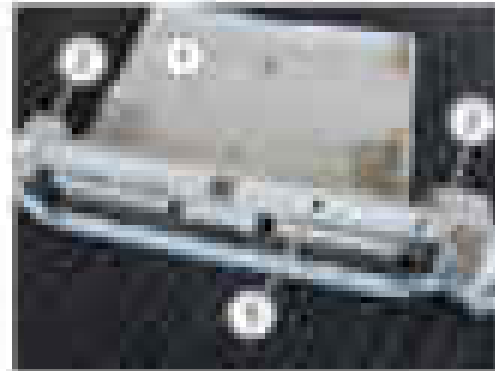
Figure 1 Upper frame removal

1. Remove the bypass tray, [REP 70.2](#).
2. Remove the upper frame, [Figure 1](#):
 - a. Remove the spring (1).
 - b. Remove two crews (2).
 - c. Remove the upper frame (3).

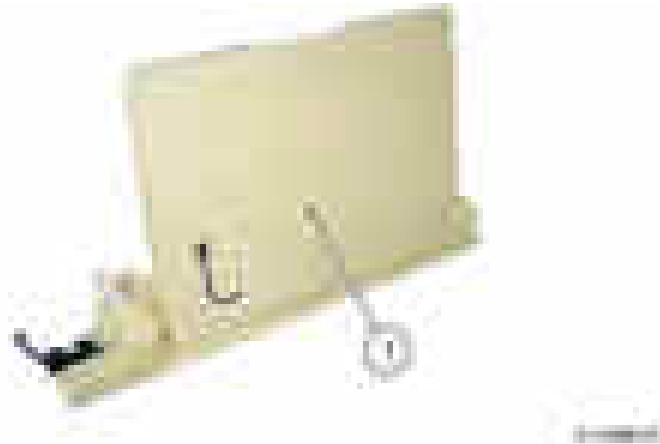
Figure 2 Tray assembly removal

3. Remove the bypass tray assembly in the direction of the arrow, [Figure 2](#).

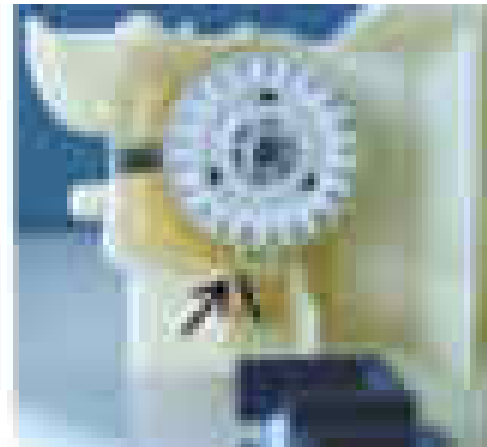
Figure 9 Feed clutch alignment

1. The replacement is the reverse of the removal procedure.
2. When installing the bypass tray feed clutch, align the cutout of the bypass tray feed clutch with the tab, [Figure 9](#).

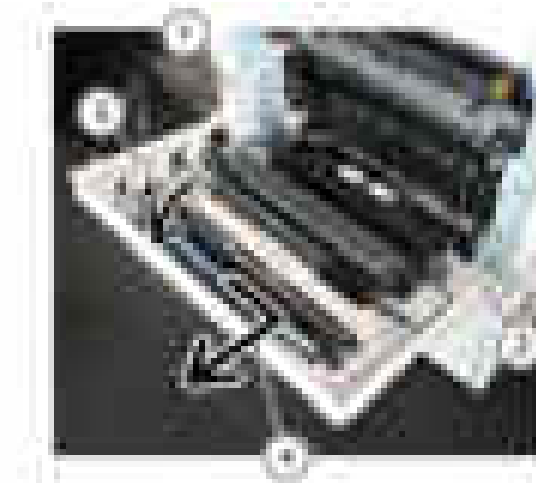
5. Remove the L/H cover, [Figure 4](#):
 - a. Open the LH cover.
 - b. Rotate by 90 degrees, then disconnect the rear support (1).
 - c. Rotate by 90 degrees, then disconnect the front support (2).
 - d. Hold the L/H cover (3) open at 90 degrees.
 - e. Remove the L/H cover in the direction of the arrow (4).

Figure 4 LH cover removal

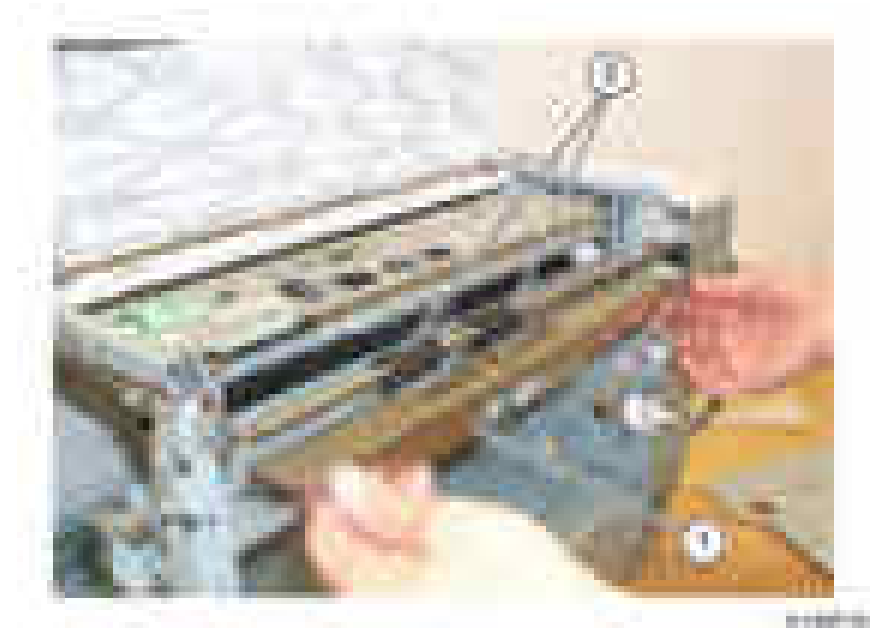
1. Remove the HCF feed motor, [REP 80.27](#).
2. Remove the takeaway roll, [Figure 1](#):
 - a. Remove two screws, then the lower chute (1).
 - b. Slide the takeaway roll (2) to the rear until the front end is released, then lower the roll to remove.

Figure 1 Lower chute removal

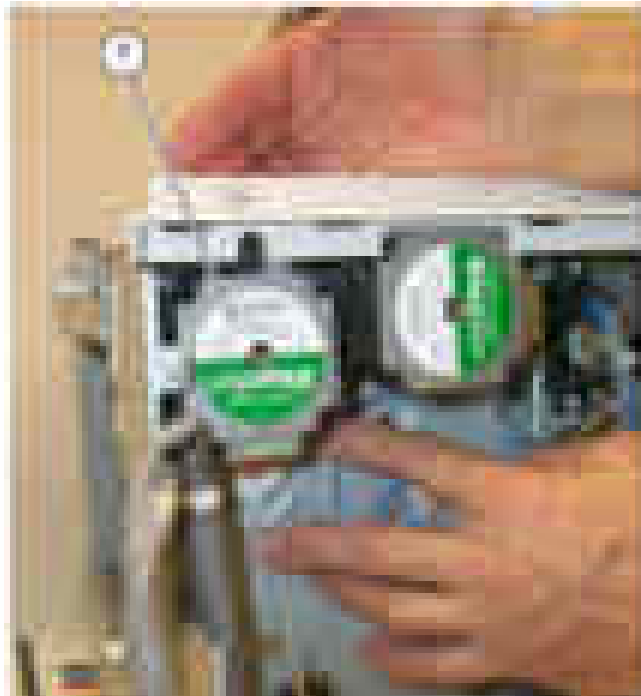
NOTE: Be careful when removing the motor as it is meshed to a hidden gear.

4. While supporting the motor with one hand, remove two screws then the HCF feed/lift motor (1), [Figure 1](#).

Figure 1 HCF feed/lift motor removal

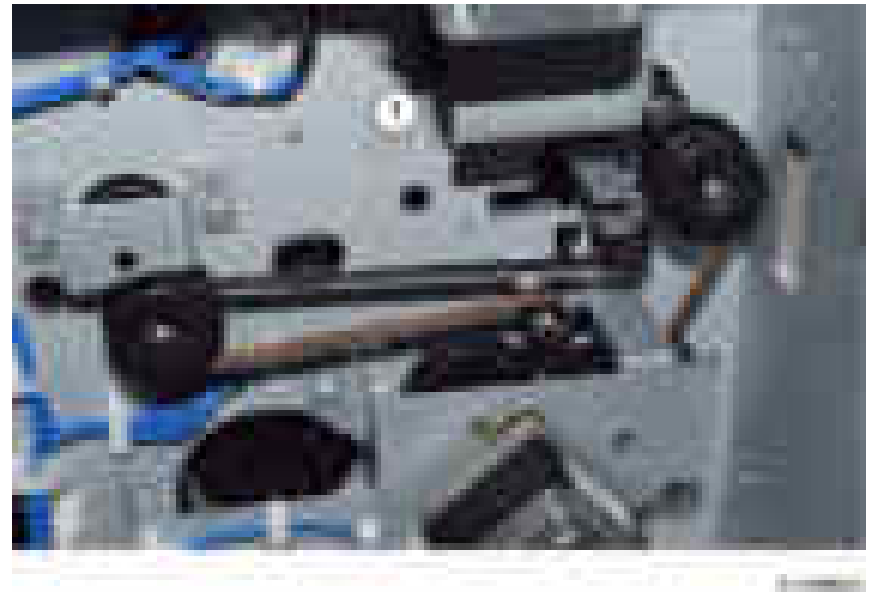
1. The replacement is the reverse of the removal procedure.
2. Ensure that the drive belt (1) is installed as shown in [Figure 1](#).

Figure 1 Belt installation

1. The replacement is the reverse of the removal procedure.
2. Ensure that the drive belt is correctly installed, refer to [REP 80.28](#).

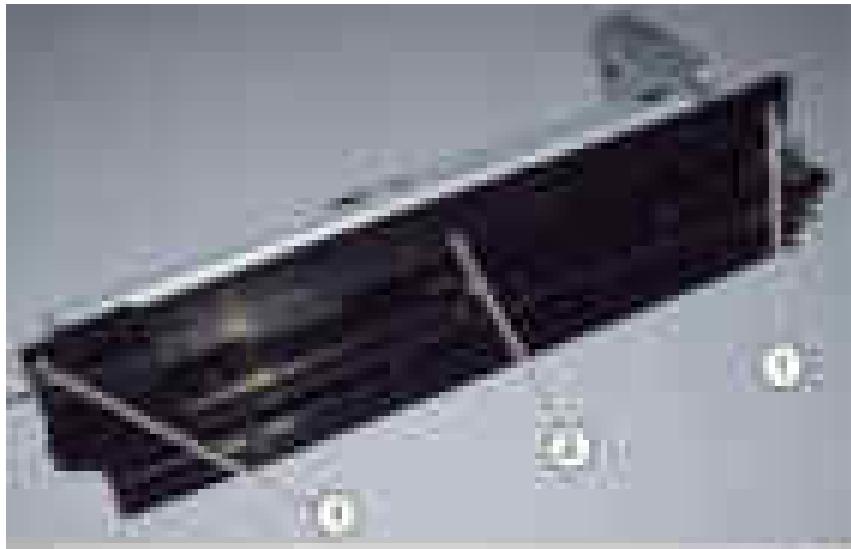
1. Remove the tray 4 feeder assembly, [REP 80.35](#).
2. Turn the tray 4 feeder assembly upside down.
3. Remove the lower feed chute, [Figure 1](#):
 - a. Remove two screws (1).
 - b. Remove the lower feed chute (2).

Figure 1 Lower feed chute removal

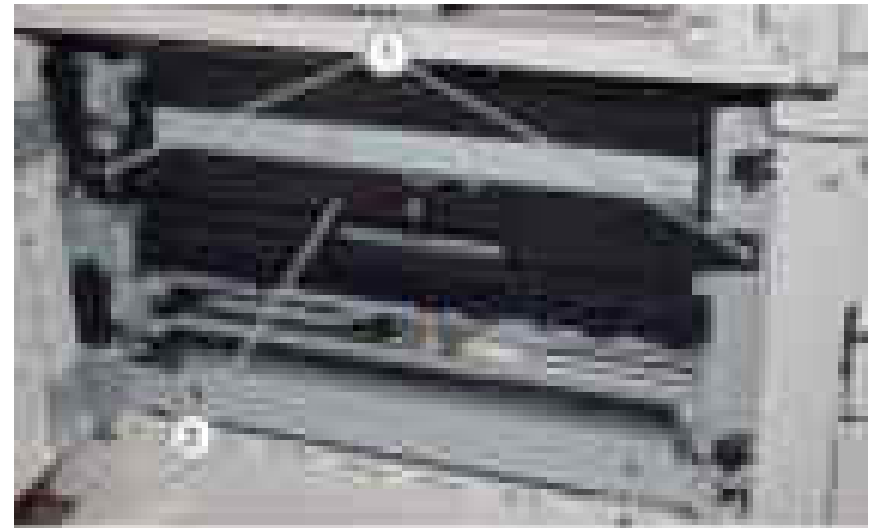
1. Remove the lower (tray 3 and 4) takeaway roll, [REP 80.41](#).
2. Remove the TTM chute, [Figure 1](#):
 - a. Remove two screws (1).
 - b. Move the TTM chute (2) towards the rear, then remove the TTM chute.

NOTE: The TTM chute is secured in the centre by a clip feature.

Figure 1 TTM chute removal

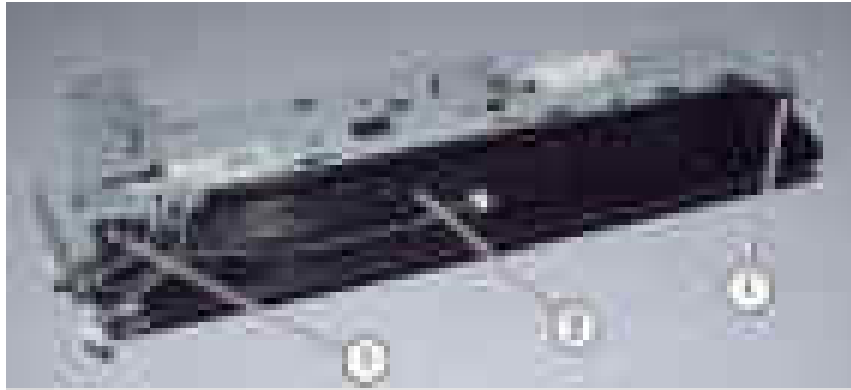
1. Remove the tray 4 feeder assembly, [REP 80.35](#).
2. Remove the upper feed chute, [Figure 1](#):
 - a. Remove two screws (1).
 - b. Remove the lower feed chute (2).

Figure 1 Upper feed chute removal

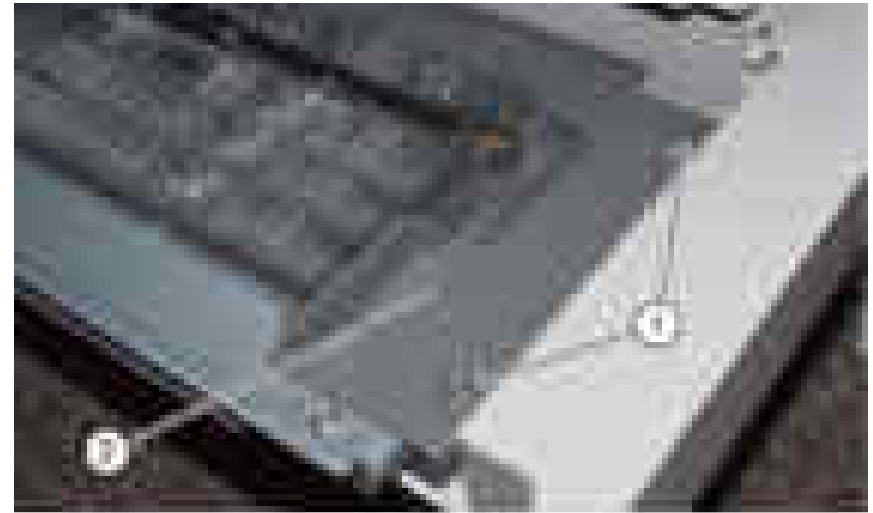
1. Fully pull out tray 4. Lift out the tray 4 assembly, [PL 70.65 Item 1](#).
2. Remove the tray 4 transport assembly from the tray 4 assembly, [Figure 1](#):
 - a. Remove two screws (1).
 - b. Remove the tray 4 transport assembly (2).

Figure 1 Transport assembly removal

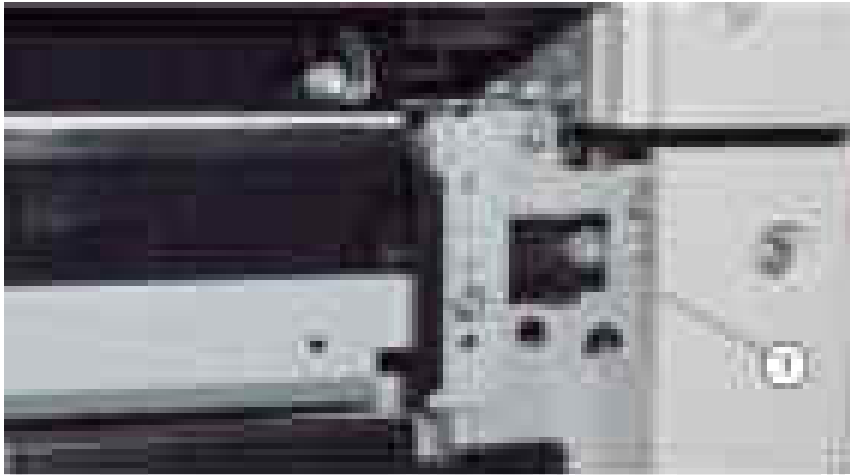
6. Remove the upper door catch (1), [Figure 3](#).

Figure 3 Door catch

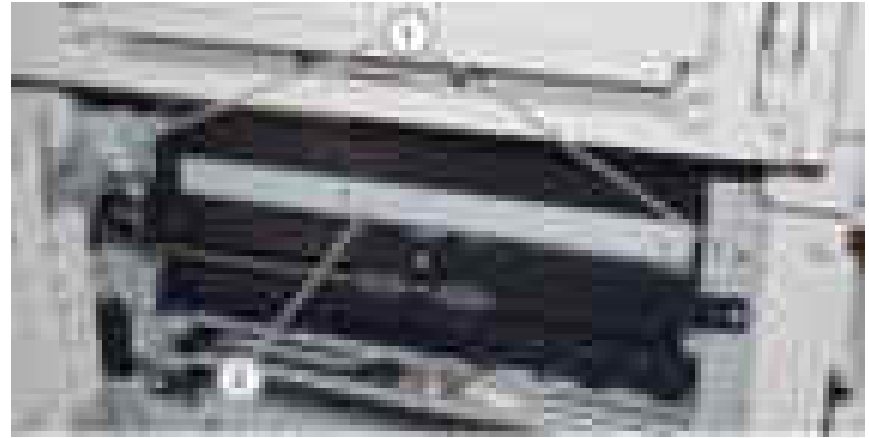
7. Remove the tray 2 feeder assembly, [Figure 4](#):
 - a. Remove two screws (1).
 - b. Remove the tray 2 feeder assembly (2).

Figure 4 Tray 2 feeder assembly removal

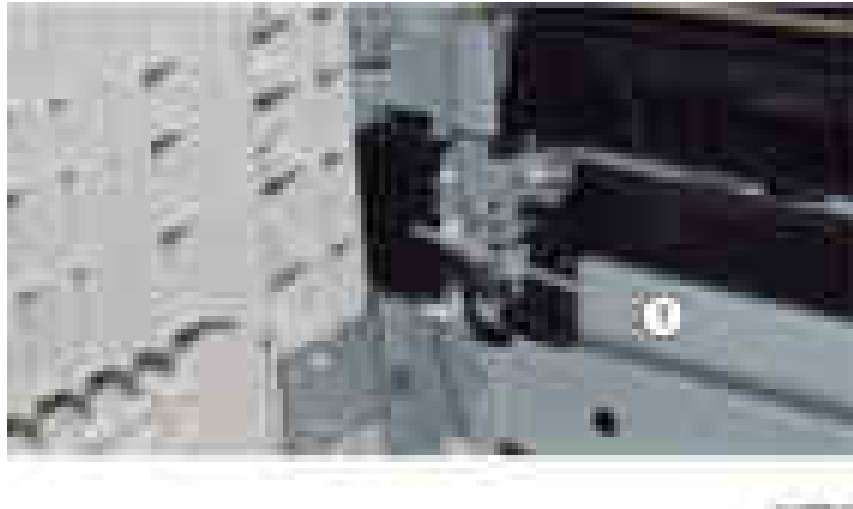
1. Pull out tray 3. Remove the paper.
2. Lift out tray 3.
3. Open the left cover assembly, [PL 70.70 Item 7](#).
4. Remove the ESD cover (1) [Figure 1](#):

Figure 1 ESD cover removal

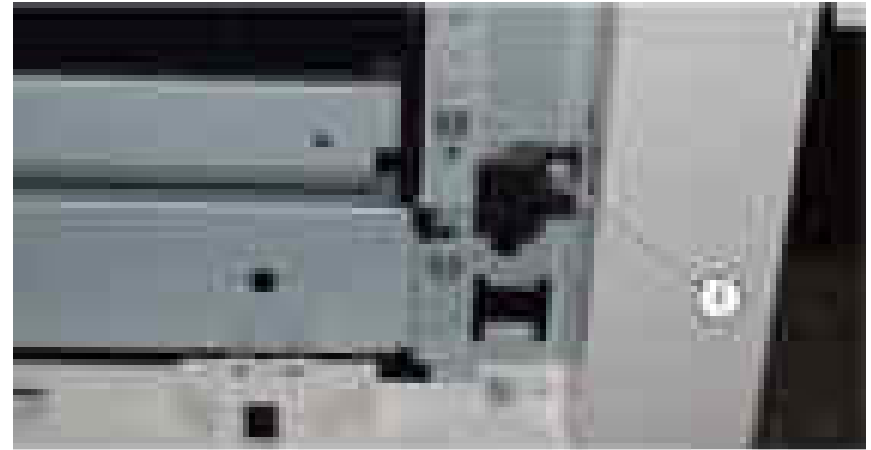
6. Remove the lower door catch (1), [Figure 3](#).

Figure 3 Door catch

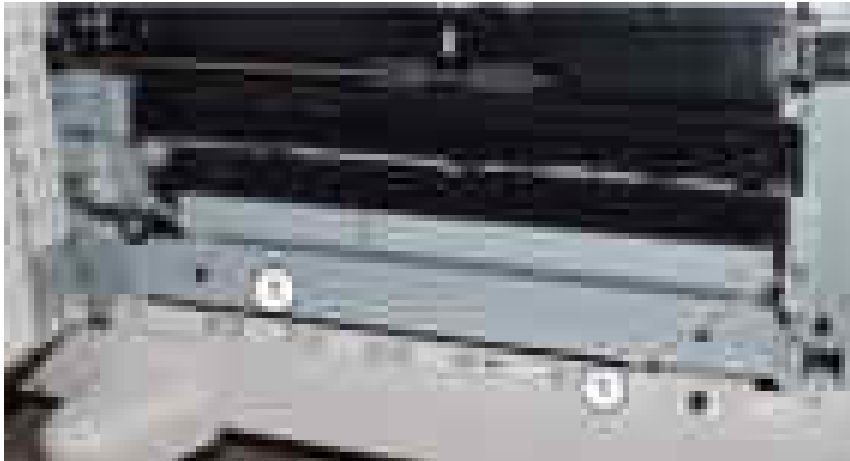
7. Remove two screws (1), [Figure 4](#):

Figure 4 Tray 3 feeder assembly left side fittings

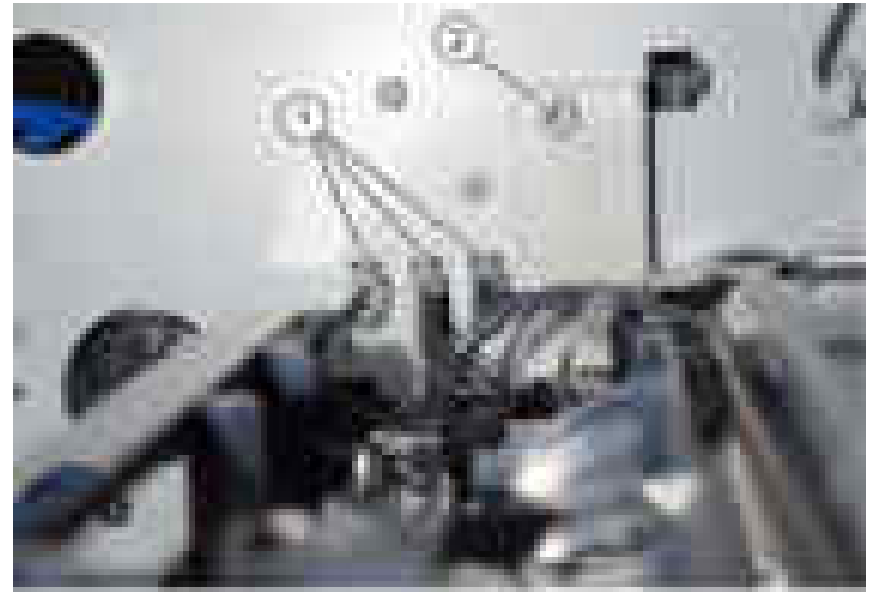
4. Prepare to remove the tray 4 feeder assembly, [Figure 2](#):
 - a. Disconnect 3 connectors (1).
 - b. Remove the screw (2).

Figure 2 Preparation

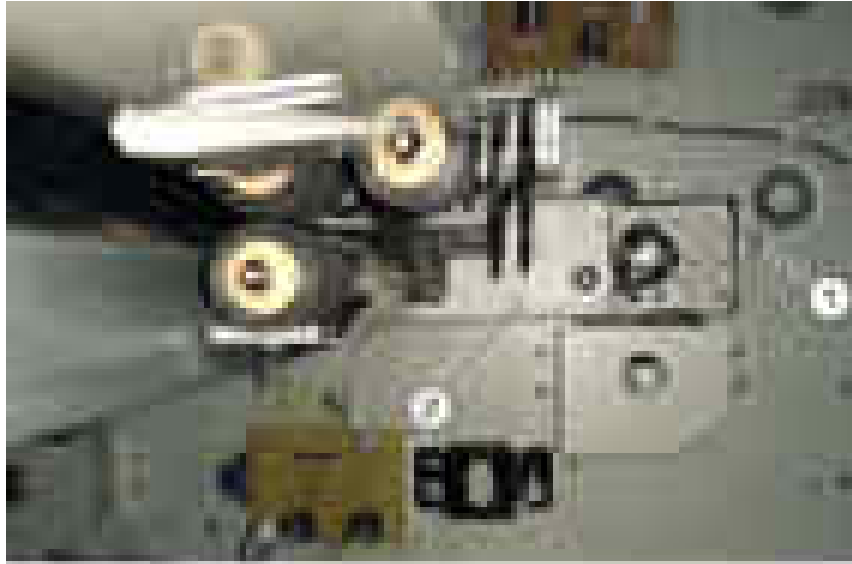
5. Remove the tray 4 feeder assembly, [Figure 3](#):
 - a. Remove the screw (1).
 - b. Remove the tray 4 feeder assembly (2).

Figure 3 Tray 4 feeder assembly removal

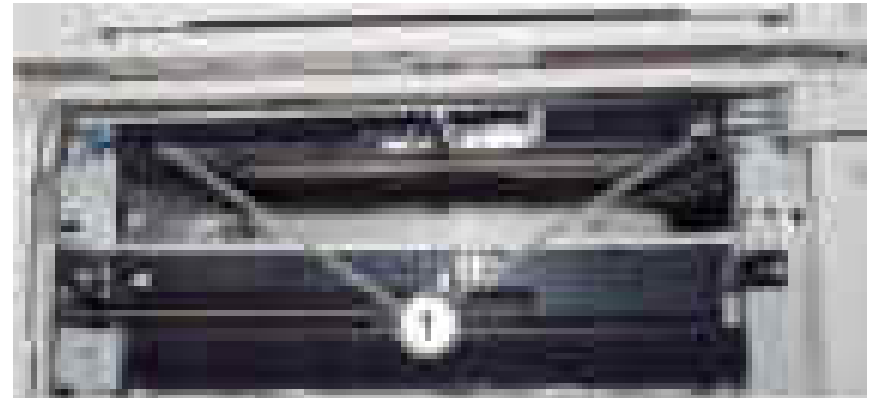
1. Remove the upper (tray 2) takeaway roll, [REP 80.41](#).
2. Remove two screws (1), [Figure 1](#).

Figure 1 Screw removal

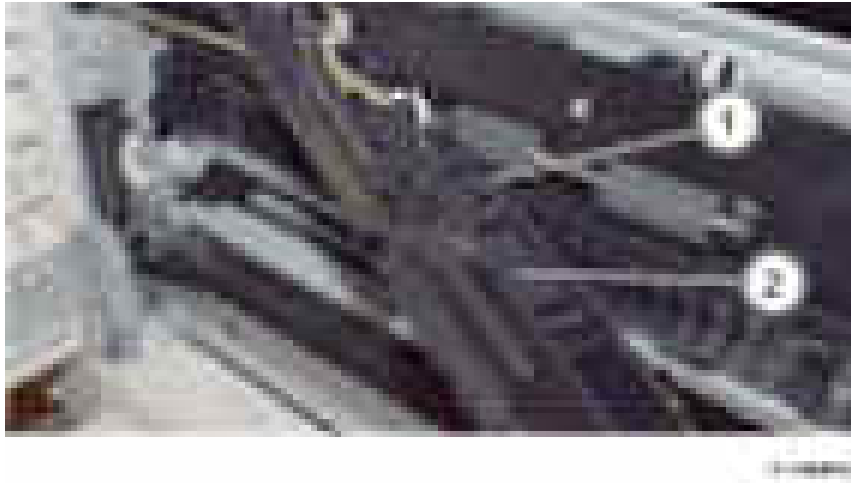
3. Remove the takeaway chute, [Figure 2](#):
 - a. Move the takeaway chute to the rear to release the hook (1).
 - b. Disconnect the connector at the rear of the takeaway chute.
 - c. Remove the takeaway chute (2).

Figure 2 Takeaway chute removal

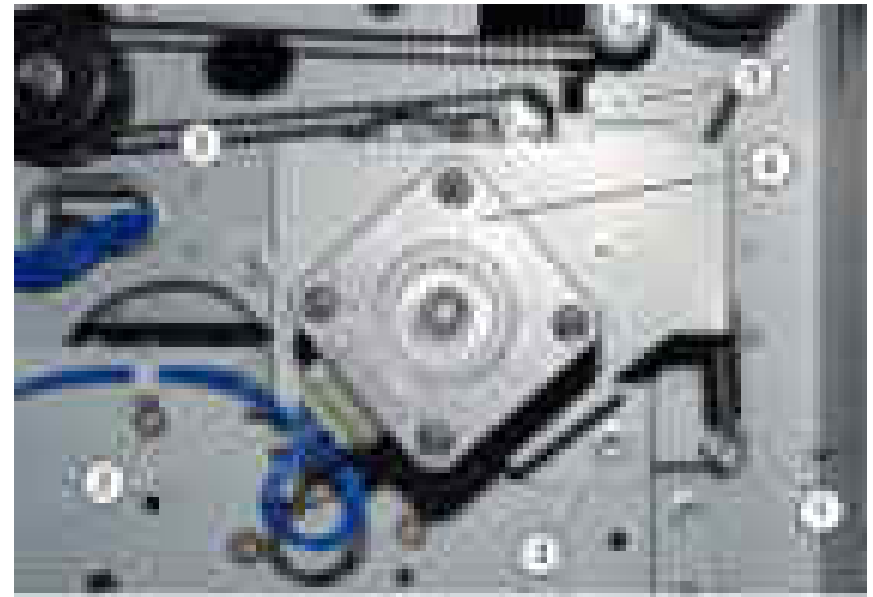
1. Remove the TTM rear cover, [PL 70.95 Item 8](#).
2. Remove the takeaway motor, [Figure 1](#):
 - a. Unhook the spring (1).
 - b. Disconnect the PJ and release the harness (2).
 - c. Remove three screws (3).
 - d. Remove takeaway motor 2 (4).

Figure 1 Motor removal

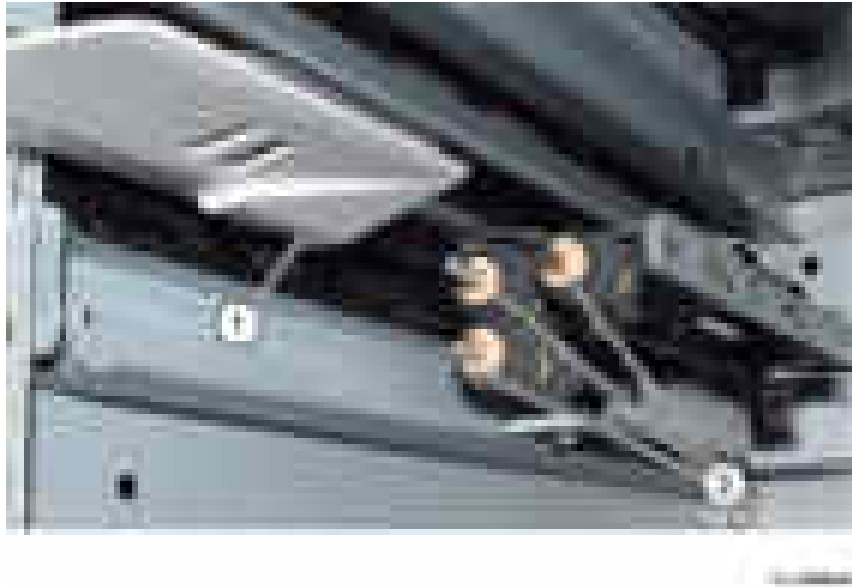
1. Pull out trays 2, 3 and 4. Remove the paper.
2. Remove trays 2, 3 and 4.
3. Open the left cover assembly, [PL 70.70 Item 7](#).
4. Remove the tray 2 or 3 feed, retard and nudger rolls, [Figure 1](#):
 - a. Slide the chute (1) forwards.
 - b. Release the clip, then remove the tray 2 or 3 feed, retard and nudger rolls (2).

Figure 1 Roll removal

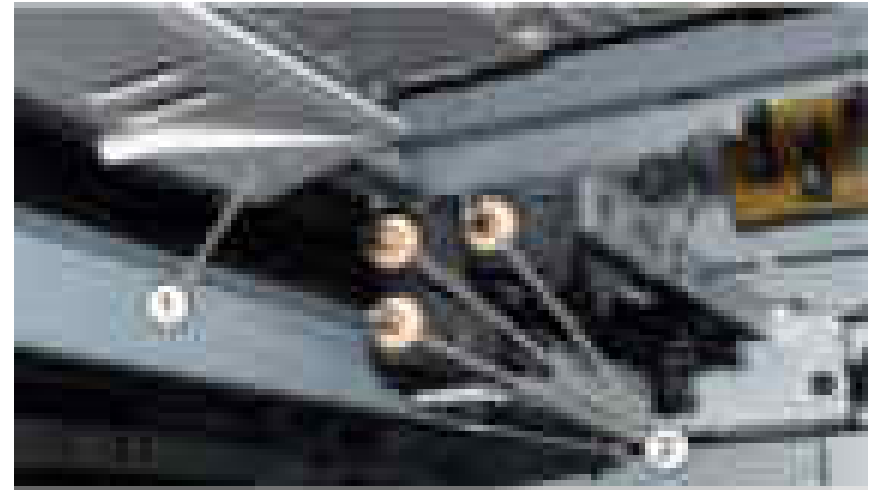
1. Pull out trays 2, 3 and 4. Remove the paper.
2. Remove trays 2, 3 and 4.
3. Open the left cover assembly, [PL 70.70 Item 7](#).
4. Remove the tray 4 feed, retard and nudger rolls, [Figure 1](#):
 - a. Slide the chute (1) forwards.
 - b. Release the clip, then remove the tray 4 feed, retard and nudger rolls (2).

Figure 1 Roll removal

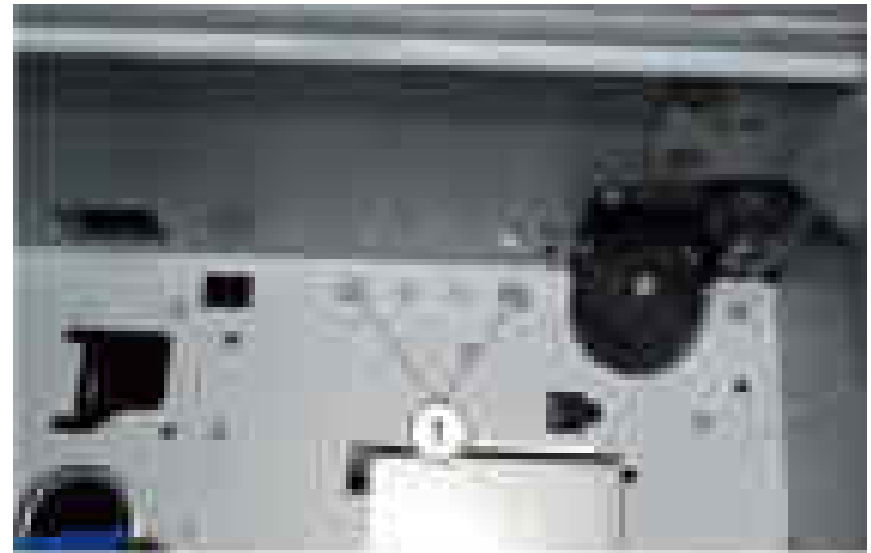
1. Pull out trays 2, 3 and 4. Remove the paper.
2. Remove trays 2, 3 and 4.
3. Remove the tray 2 feeder assembly, [REP 80.33](#).
4. Remove the rear cover, [PL 70.95 Item 8](#).
5. Remove the takeaway motor assembly, [PL 70.85 Item 1](#).
6. Remove two rear screws (1), [Figure 1](#).

Figure 1 Rear screw removal

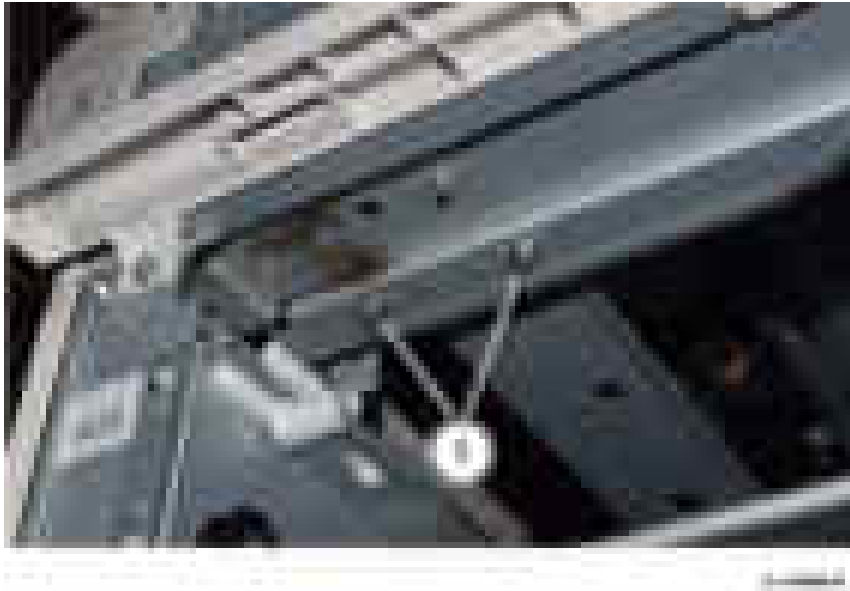
7. Remove two front screws (1), [Figure 2](#).

Figure 2 Front screw removal

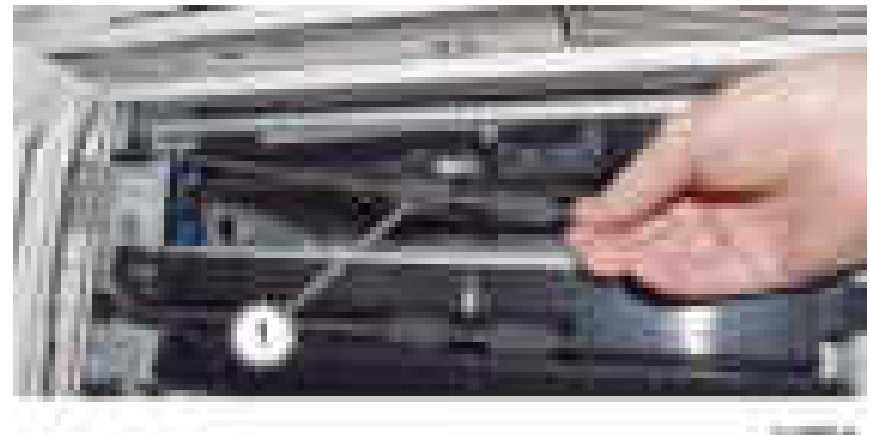
9. Remove the takeaway roll (1), [Figure 4](#).

Figure 4 Takeaway roll removal

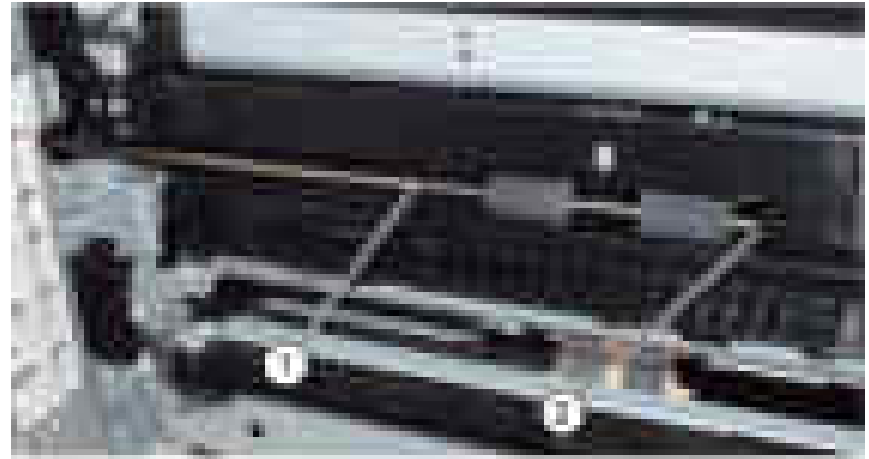
5. Remove the lower takeaway roll (1) and bearing (2), Figure 7.

Figure 7 Roll removal

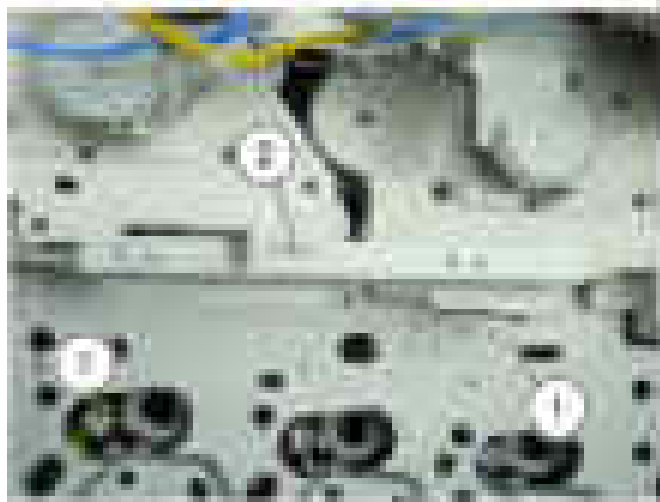
1. Remove the C and K toner cartridges, [PL 90.05](#).
2. Remove the upper rear cover, [REP 28.5](#).
3. Remove the lower rear cover, [REP 28.6](#).
4. Remove the right cover, [REP 28.3](#).
5. Remove the ESS PWB chassis assembly, [REP 3.2](#).
6. Remove the LVPS assembly, [REP 1.4](#).
7. Remove the harness upper bracket [PL 1.10 Item 6](#).
8. Remove the drive PWB assembly, [REP 1.5](#).
9. Remove the rear duct A, [REP 10.4](#).
10. Remove two screws (1) then the drive PWB bracket, [Figure 1](#).

Figure 1 Drive PWB bracket
