Xerox® VersaLink® C7000 Color Printer & C7030 Family Color Multifunction Printer Service Manual

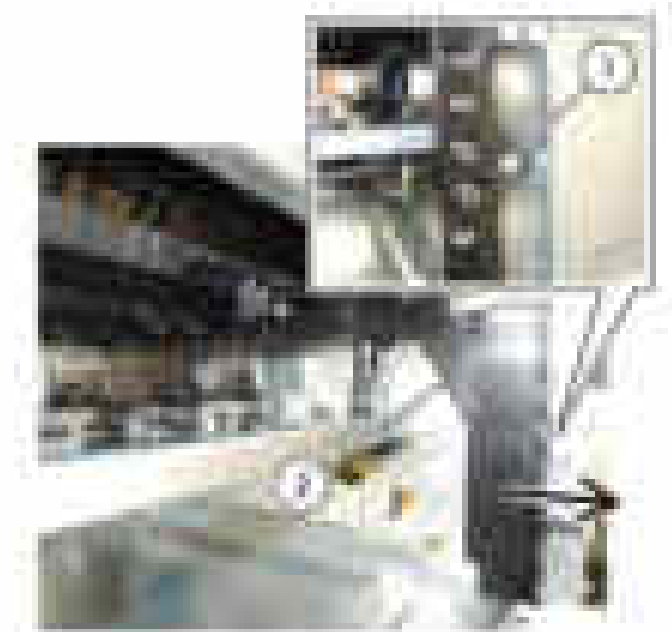
1. Prepare a sheet of black paper or a black bag.
2. Remove the toner cartridge (K). [PL 90.05 Item 13](#).
3. Remove the Y, M, C, K drum cartridges, [REP 90.12](#).
4. Remove developer unit (K), [REP 90.1](#)
5. Remove the IBT belt unit, [REP 90.7](#).
6. Remove the front cover, [REP 28.1](#).
7. Remove the inner cover, [REP 28.2](#).
8. Remove the top cover, [REP 28.4](#).
9. Remove the right cover, [REP 28.3](#).
10. Remove the HVPS, [REP 1.1](#).
11. Remove the conductor housing assembly, [Figure 1](#).
 - a. Remove the screw (1).
 - b. Remove the conductor housing assembly (2) in the direction of the arrow.

Figure 1 Conductor housing assembly removal

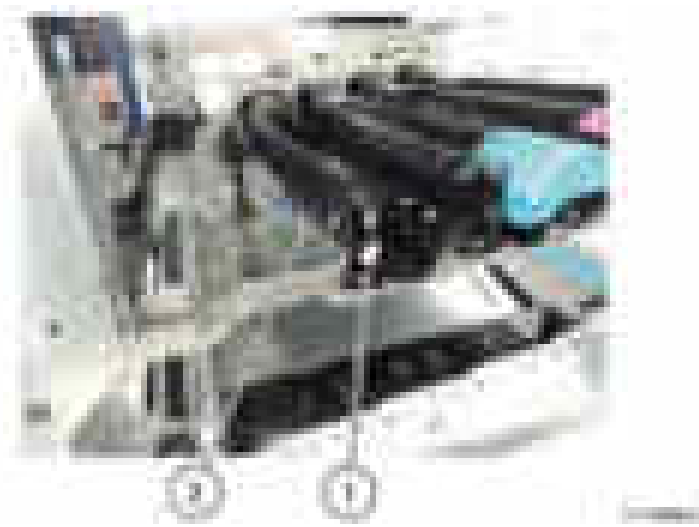
12. Remove dispenser (K), [Figure 2](#).

- a. Remove the screw (1).
- b. Remove dispenser (K) (2).

Figure 2 Dispenser K

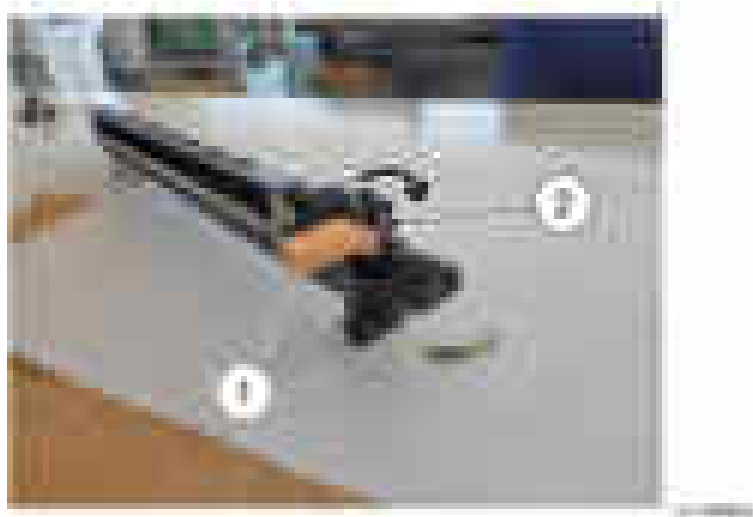
1. Remove the relevant developer unit, [REP 90.1](#).
2. Remove the developer front cover, [Figure 1](#).
 - a. Lower the lever (1).
 - b. Remove the developer front cover (2) in the direction of the arrow.

Figure 1 Developer front cover removal

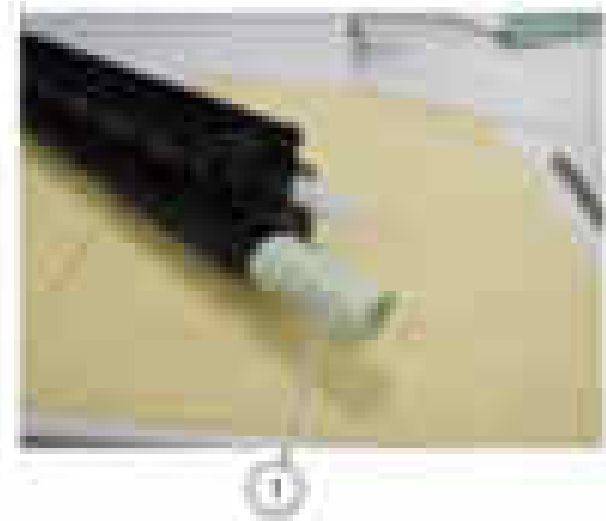
3. Cover the pipe opening of developer rear cover with paper and tape (1), [Figure 2](#).

Figure 2 Pipe opening cover

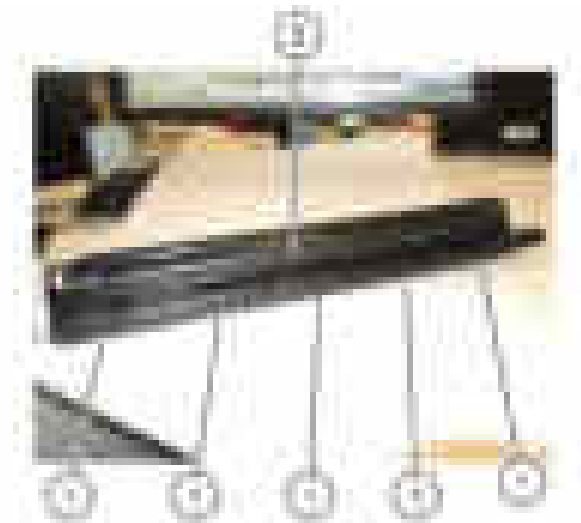
4. Store the developer unit in the collection bag.
5. Cover the pipe opening of developer rear cover of the new developer unit with paper and tape.
6. Remove the new upper SUB cover assembly, [Figure 3](#).
 - a. Release the five hooks (1).
 - b. Remove the upper SUB cover assembly (2).

Figure 3 New upper SUB cover assembly

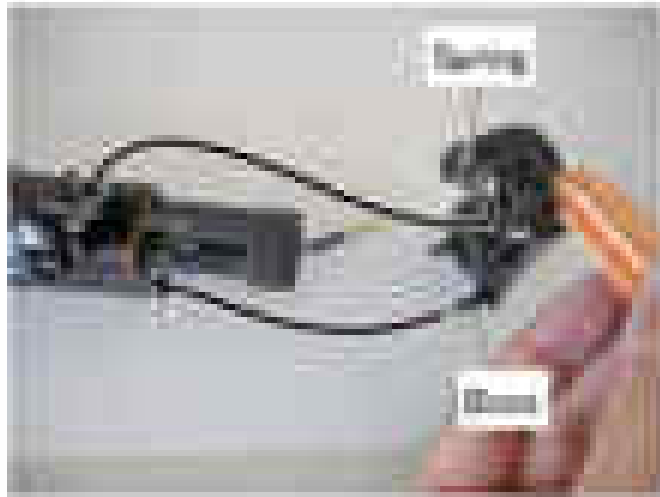
7. Install the developer front cover to the new developer assembly in order to use as a stand, [Figure 4](#).

Figure 4 Developer front cover

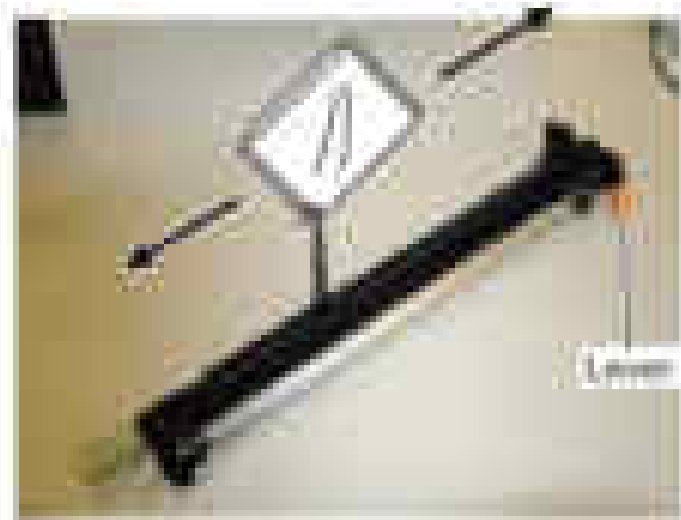
9. Use the lever of developer front cover as a stand and place the developer assembly with its right side facing up.
10. Put in the developer, [Figure 6](#).

Figure 6 Developer

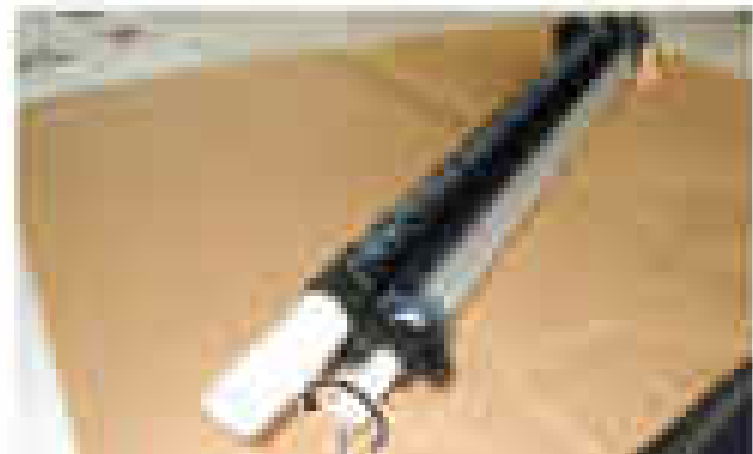
11. Uniform the developer, [Figure 7](#).
 - a. Rotate the coupling in the direction of the arrow.

Figure 7 Coupling rotation

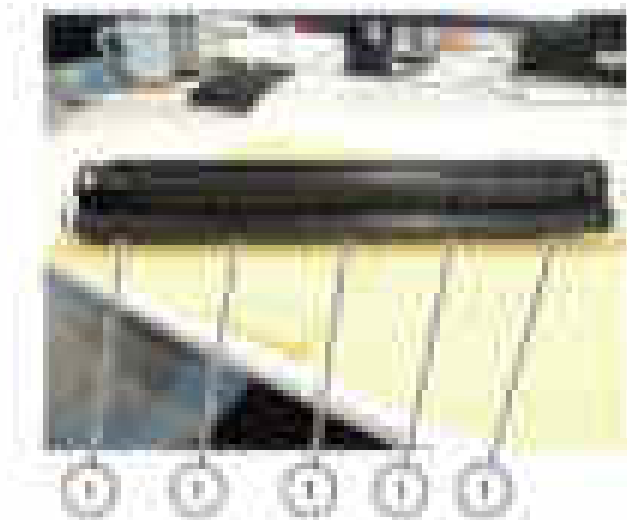
15. Secure the upper SUB cover assembly, [Figure 9](#).
 - a. Press the openings (1).

Figure 9 Secure the upper SUB cover assembly

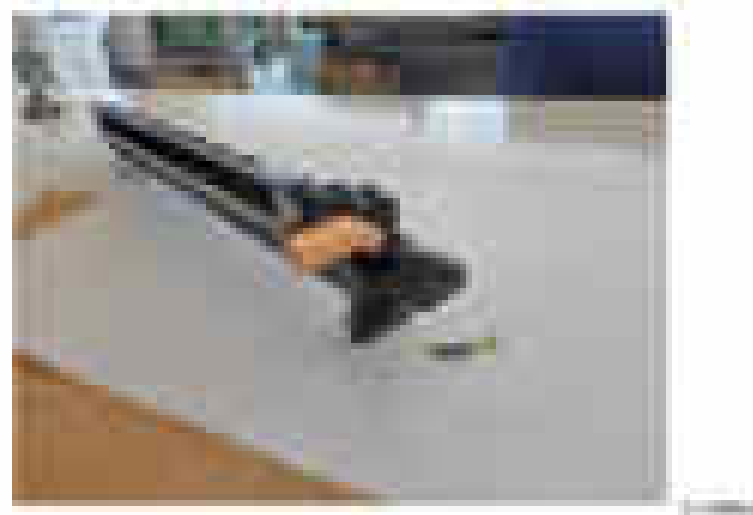
1. Install the developer front cover, [Figure 11](#).

Figure 11 Developer front cover

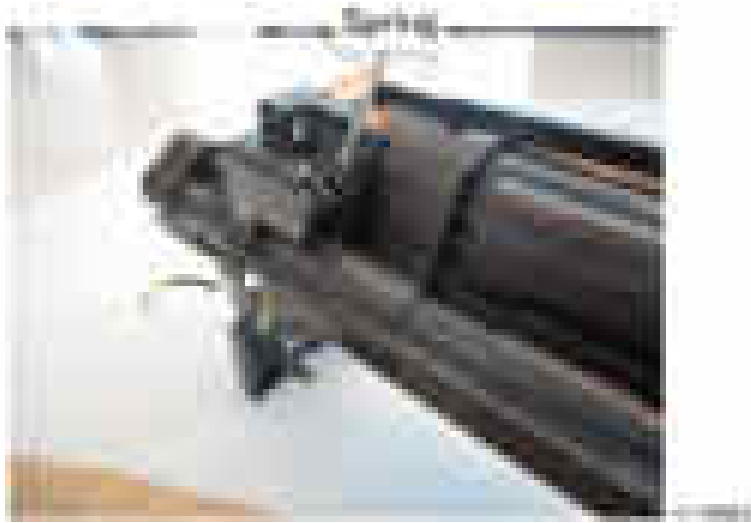
Figure 12 Spring

2. Ensure that the spring of developer front cover should be contacting the upper SUB cover assembly, [Figure 12](#).

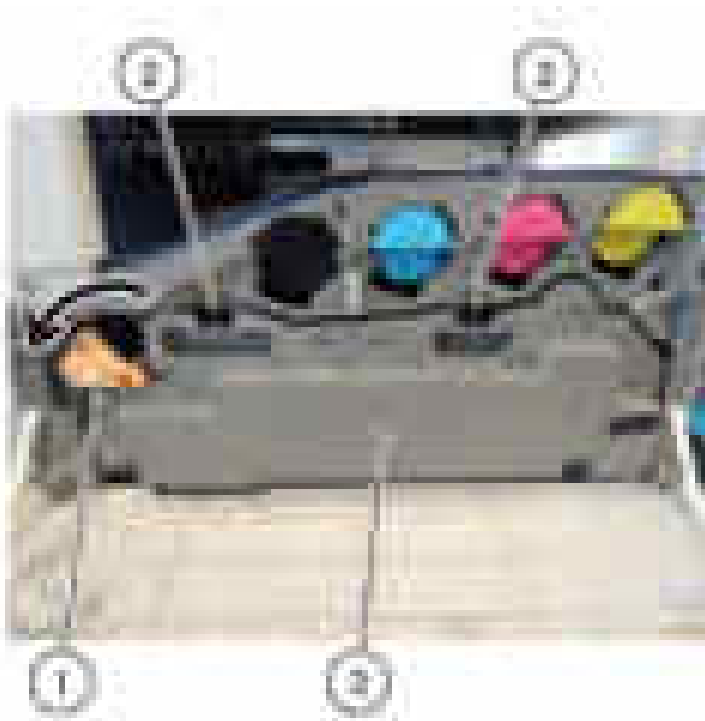
Figure 1 Waste bottle removal

1. Open the front cover.
2. Turn the retract handle (1) in a counterclockwise direction, [Figure 1](#).
3. Push down the two levers (2) and remove the waste bottle (3).

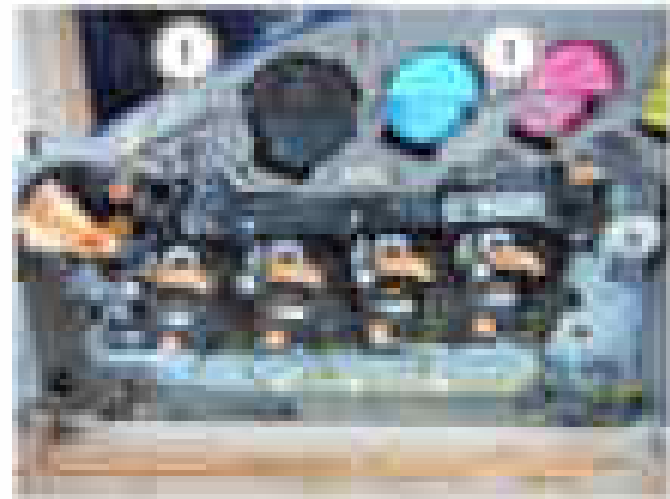
Figure 1 IBT belt unit thumbscrews

1. Open the front cover.
2. Remove the waste bottle, [REP 90.6](#).
3. Open the LH transport assembly.
4. Loosen the screws (1) that secure the IBT belt unit, [Figure 1](#).

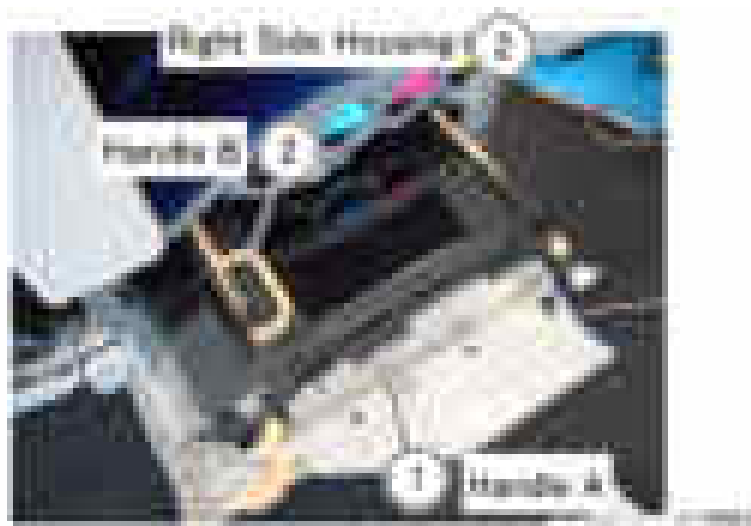
Figure 2 IBT belt unit removal

5. Remove the IBT belt unit, [Figure 2](#).
 - a. Hold Handle A and pull out the IBT belt unit until Handle B can be seen.
 - b. Hold Handle B and the right side housing and remove the IBT belt unit.

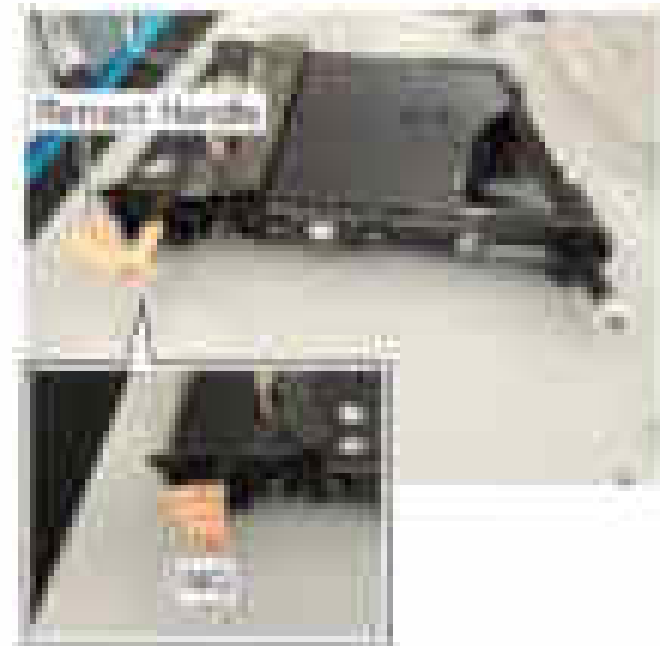
Figure 3 Correct retract handle position

1. The replacement is the reverse of the removal procedure.
2. When installing the IBT belt unit, make sure the retract handle is at the position shown in [Figure 3](#).

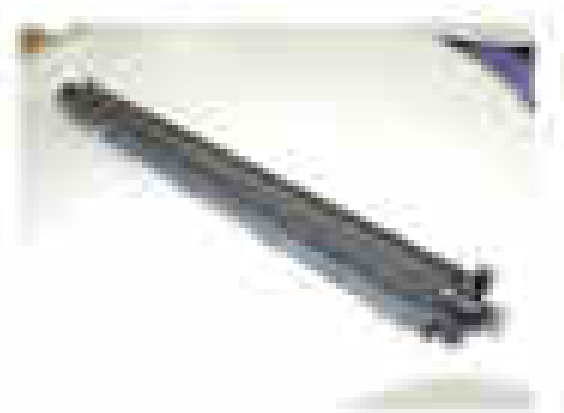
Figure 2 Removed BTR roll

Reference: [Figure 2](#) shows the removed 2nd BTR Roll.

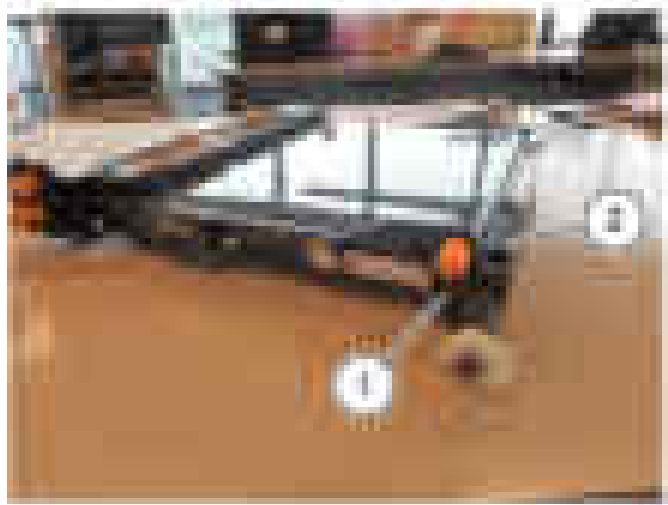
Figure 1 IBT cleaner assembly

1. Open the front cover.
2. Open the L/H cover.
3. Remove the IBT belt unit, [REP 90.7](#).
4. Remove the IBT cleaner assembly, [Figure 1](#).
 - a. Remove the screw (1).
 - b. Remove the IBT cleaner assembly (2).

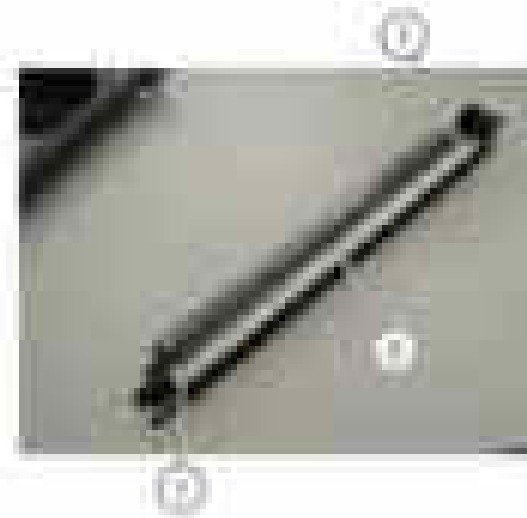
Figure 2 Blade assembly

5. Remove two screws (1) and remove the blade assembly (2), [Figure 2](#).

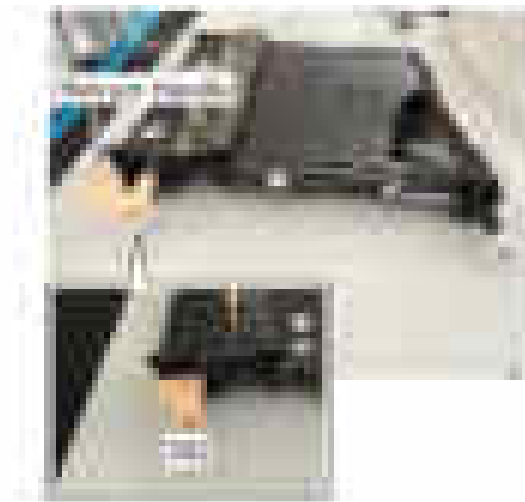
Figure 3 Correct retract handle position

1. The replacement is the reverse of the removal procedure.
2. Do not over tighten when installing the blade assembly.
3. When installing the IBT belt unit, make sure the retract handle is in the position as shown, [Figure 3](#).

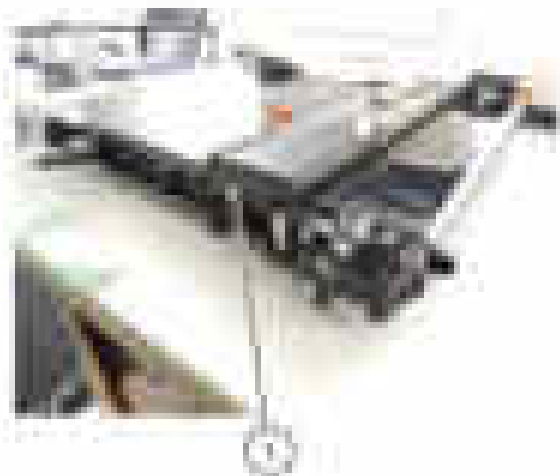
Figure 1 Handle holder rear screw

1. Open the front cover.
2. Remove the IBT belt unit, [REP 90.7](#).
3. Remove the belt cleaner blade, [REP 90.10](#).
4. Remove the screw (1) securing the handle holder at the rear, [Figure 1](#).

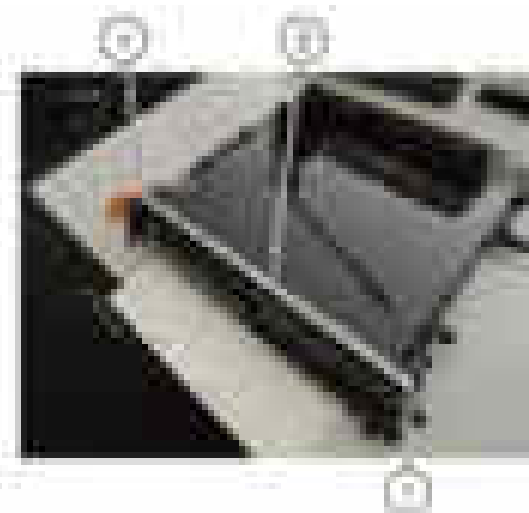
Figure 3 IBT belt unit bottom guide

6. Remove two screws (1) and remove the IBT belt unit bottom guide, [Figure 3](#).

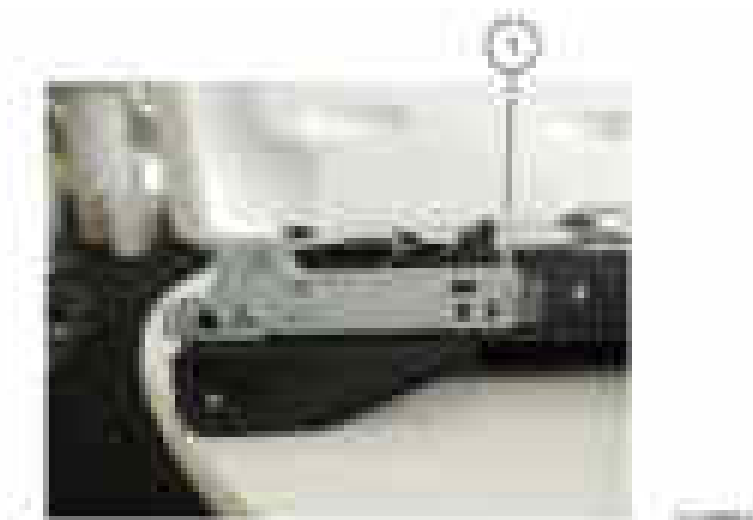
Figure 5 Front tension plate

8. Move the front tension plate towards the direction of the arrow and maintain a loose IBT belt tension. Put the removed screw in the frame hole, [Figure 5](#).

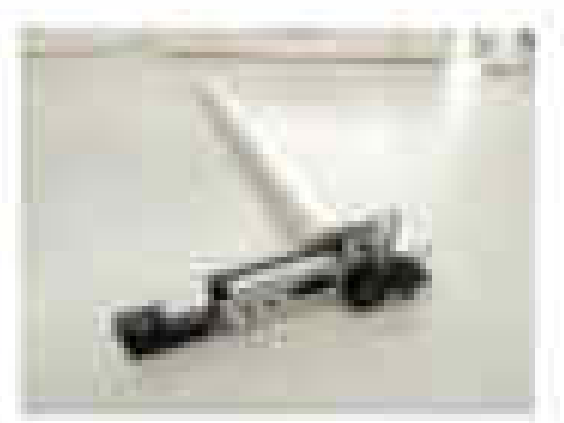
Figure 11 Rear holder and tension roll

Reference: This shows the removed rear holder and tension roll, [Figure 11](#).

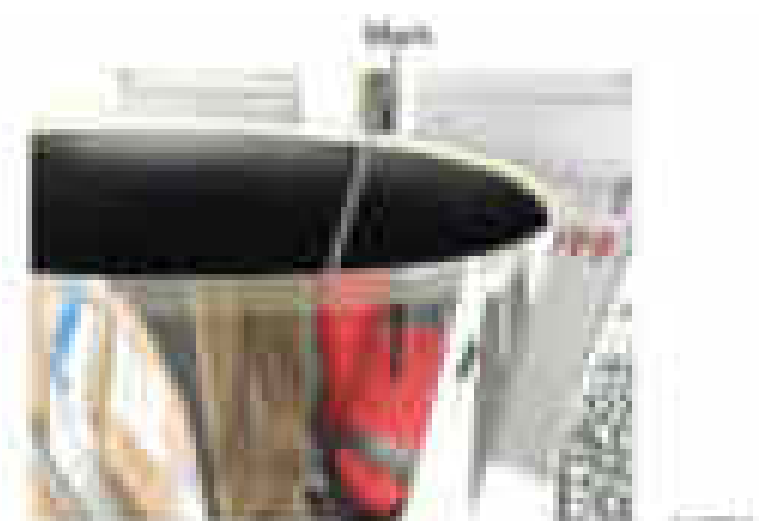
Figure 13 IBT belt mark

NOTE: Assemble so the mark is facing up when assembling the IBT belt.

1. The replacement is the reverse of the removal procedure.
2. Install so the IBT belt mark is on the rear side, [Figure 13](#).

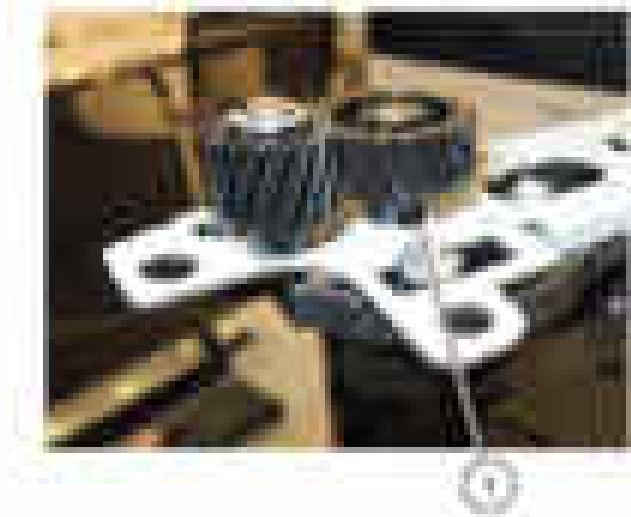
Figure 15 Tension roll tab alignment

- When installing the rear holder and the tension roll, align the tab of the bearing to the cut-out of the bearing installation hole, [Figure 15](#).

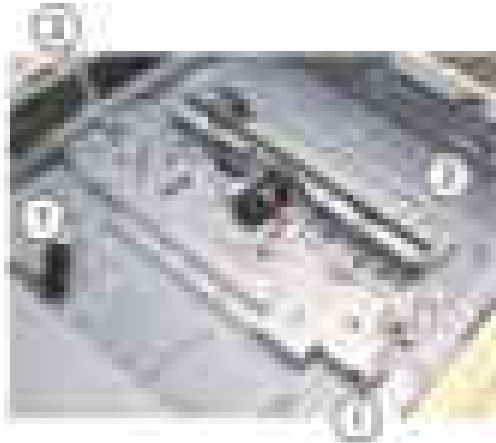
Figure 1 Jig pins

3. Remove the alignment pins from the lens assembly, Figure 1:
 - a. Remove two screws (1).
 - b. Remove the alignment pins (2).

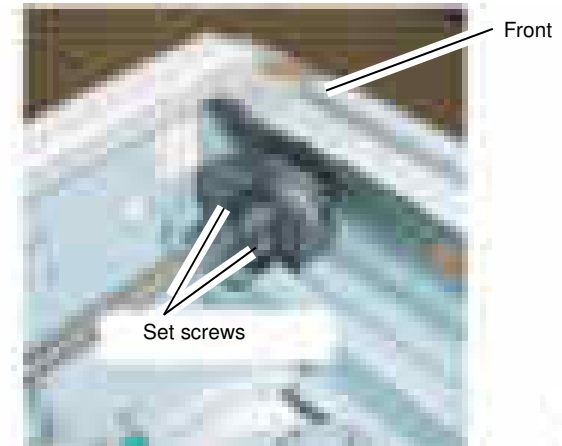
Figure 2 Front set screws

4. Check that the pulley at the front side is firmly secured. If the pulley is loose, tighten both set screws, Figure 2.

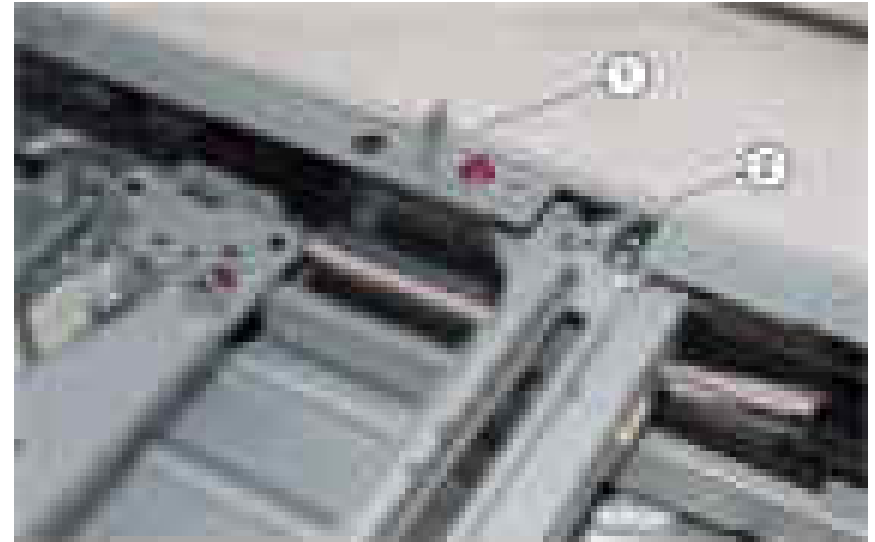
Figure 6 Carriage setting

8. Secure the rear cable to the full rate carriage, [Figure 6](#):
 - a. Remove the alignment pin from the front of the half rate carriage. Install the alignment pin (1) to the rear of the full rate carriage.
 - b. Tighten the rear cable securing screw (5).

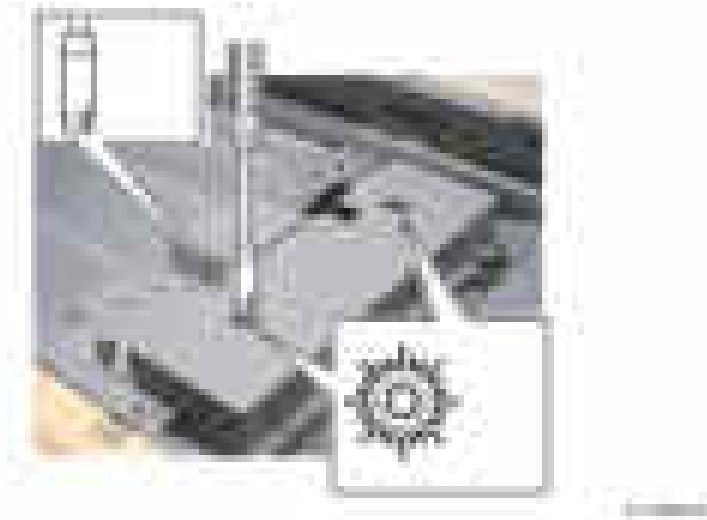
Figure 1 Nut adjustment

NOTE: It may be necessary to mark the nut runner to track the rotation.

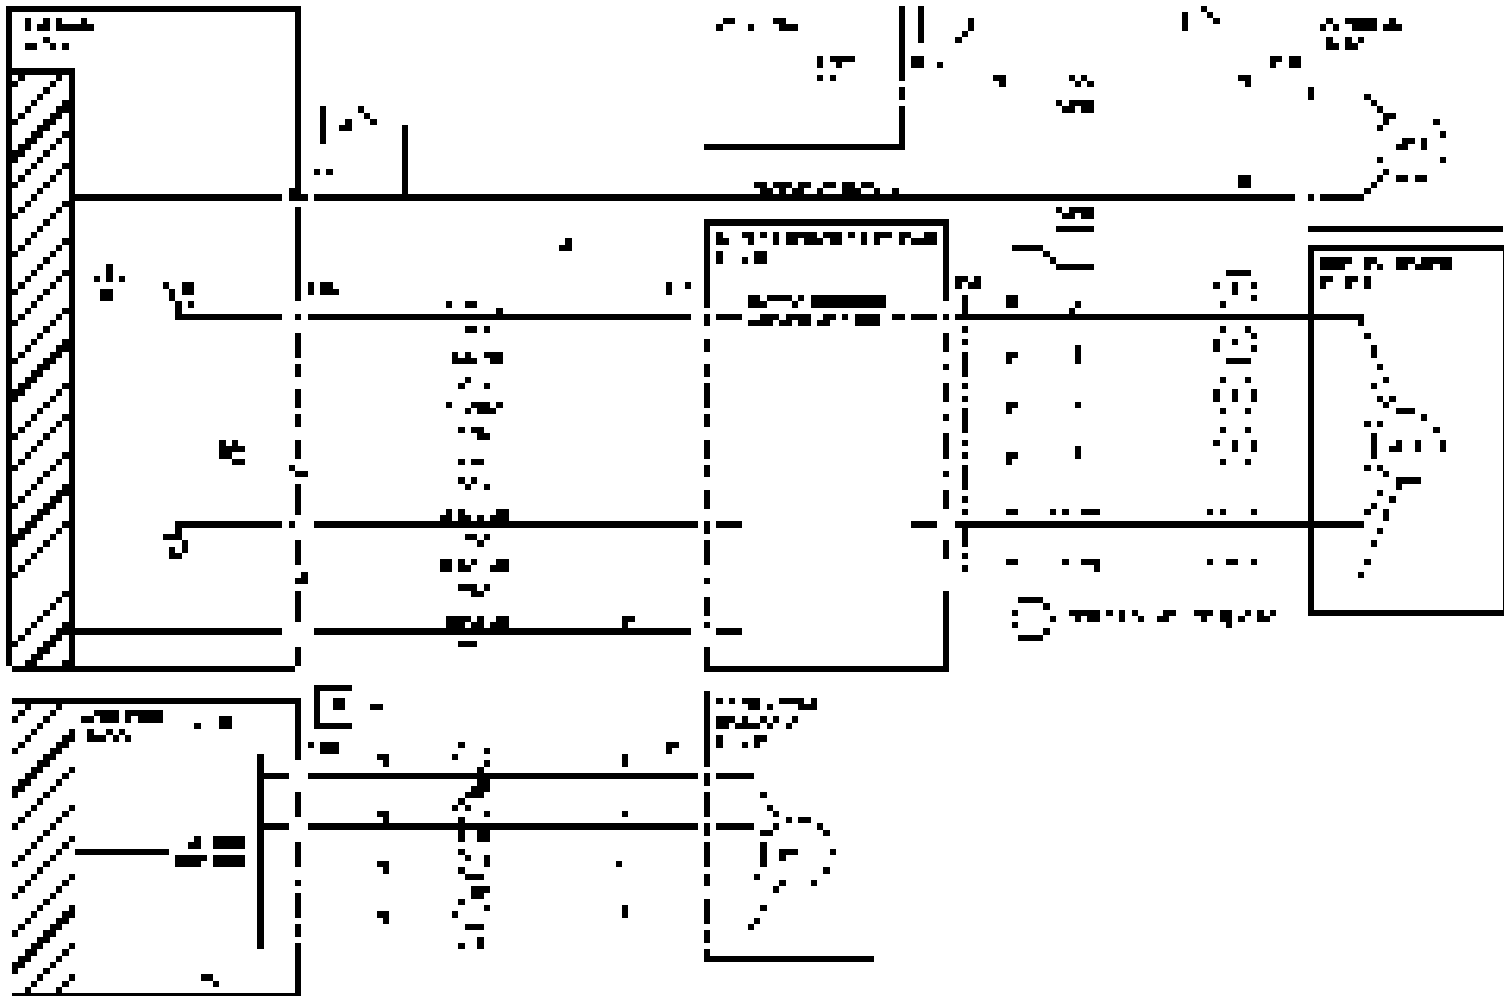
Figure 1 Wiring diagram

- Disconnect PJF (Flag 5). Check the +24V supply and the motor on pulses when the component control code for the motor is entered.
- Disconnect PJD (Flag 4). Check the +24V, +5V and 0V supplies.
- Check the clock pulses (Flag 4).
- Check that the signal on PJD pin 13 (Flag 4) changes when the component control code for the motor is entered.
- Check the wiring and the connectors for the motor circuit.

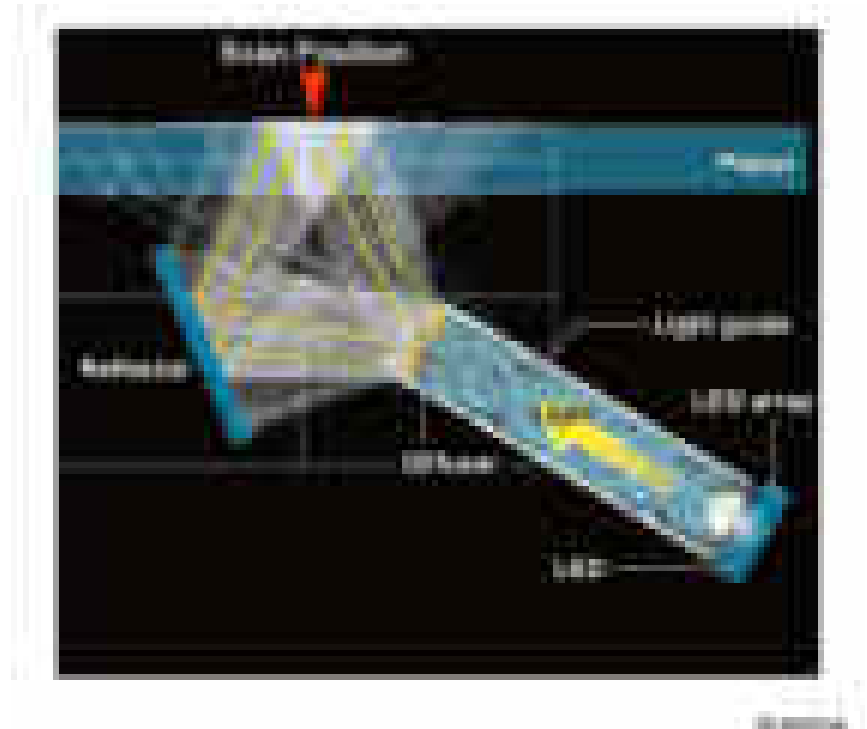
Figure 4 Light diffusion

The light guide and diffuser convert the light from the LED array into a uniform pattern that closely parallels the output from a fluorescent lamp. Refer to [Figure 4](#).

The benefits of this design include uniform and stable light output at lower energy cost, reduced heat output, and faster start up.

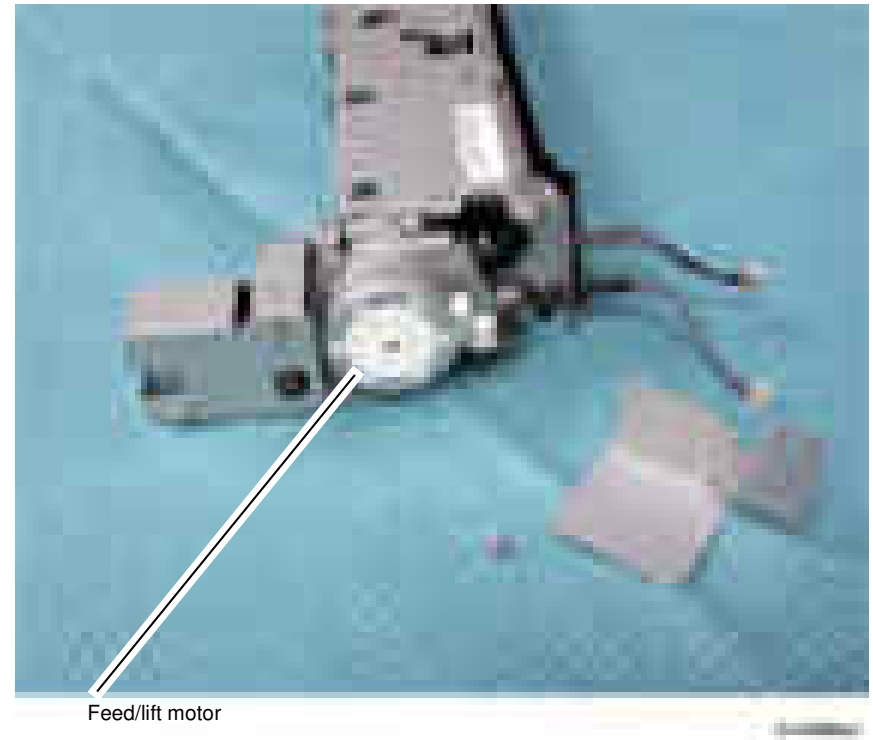
Figure 8 Feed/lift motor

The tray level sensor, no paper sensor and pre feed sensor are all integral to the feeder assembly, [Figure 7](#). The feed/lift motor is part of the feeder assembly, [Figure 8](#). Only paper tray 1 has a pre feed sensor. This sensor is use to detect paper mis feeds and paper jams.

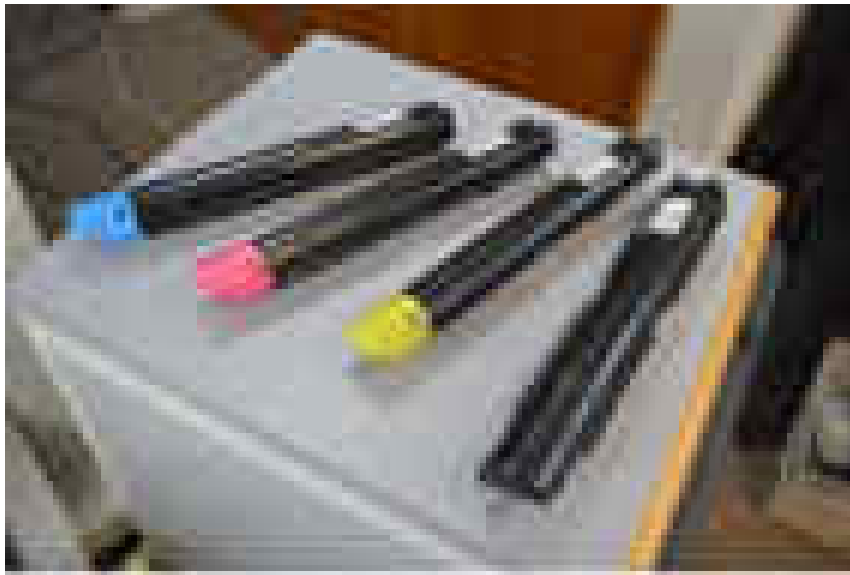
Figure 2 Toner Cartridges

The toner cartridges, PL 26.05 are customer replaceable units (CRU). The larger black toner cartridge carries a higher capacity of toner than the yellow, cyan and magenta cartridges due to the expected higher use of black toner. Refer to [Figure 2](#).

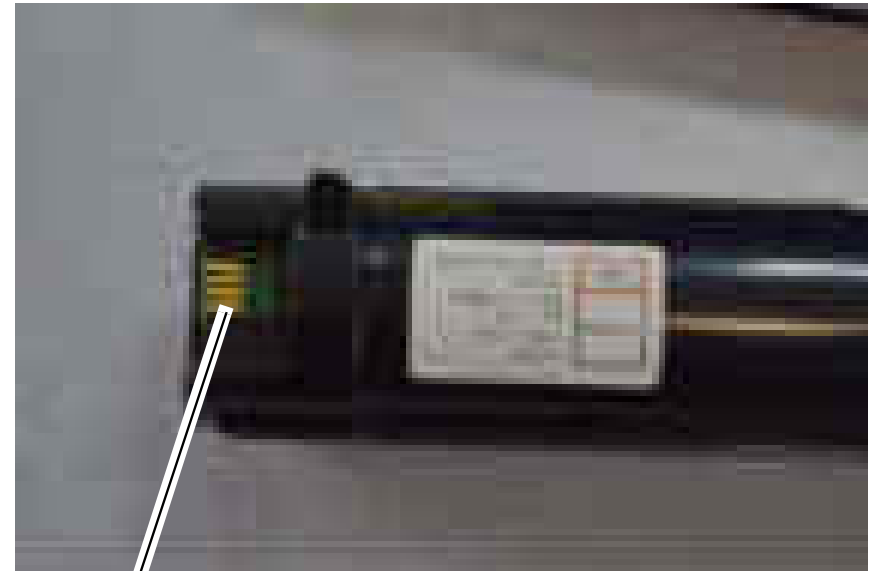
Figure 3 Toner cartridge CRUM PWB

The CRUM consists of two components - a CRUM reader and a CRUM PWB. The CRUM PWB is mounted at the rear of the toner cartridge. Refer to [Figure 3](#).

Toner cartridge CRUM PWB

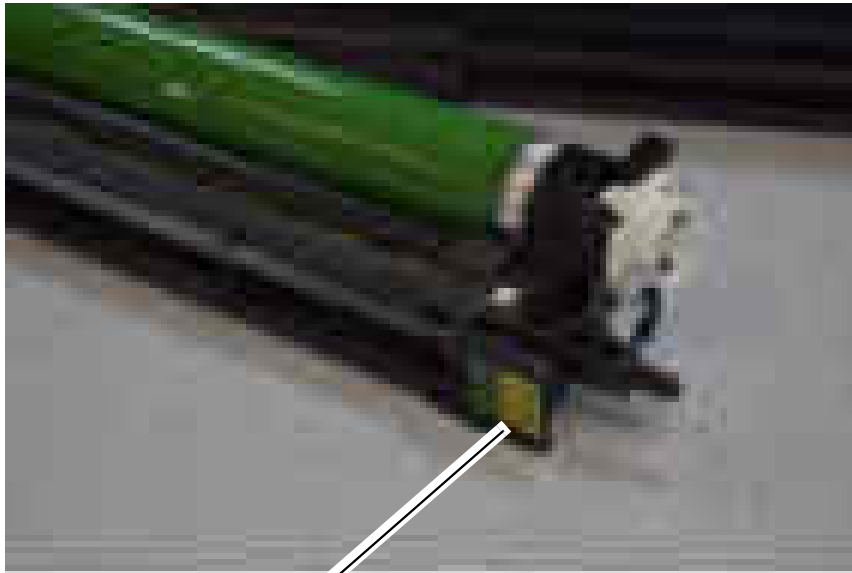
Figure 6 Drum cartridge CRUM

The CRUM consists of two components - a CRUM reader and a CRUM PWB. The CRUM PWB is mounted at the rear of the drum cartridge. Refer to [Figure 6](#).

Drum cartridge CRUM PWB

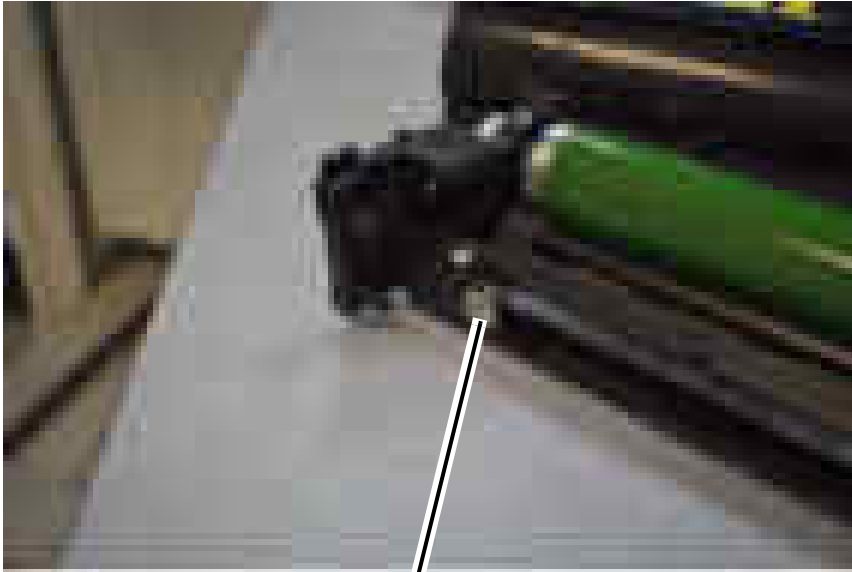
Figure 8 Drum cartridge electrical contact

The high voltages required by the drum cartridge for charging are provided by the high voltage power supply (HVPS), PL 1.05 Item 7, via a high voltage contacts on the guide assembly that supports the cartridge. Refer to Figure 7, Figure 8 and Figure 9.

BCR (charge) high voltage contact

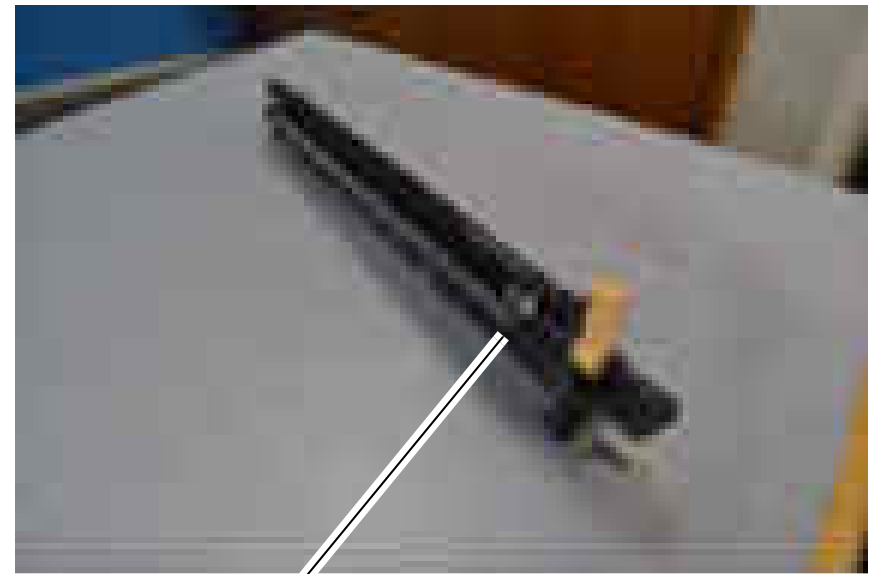
Figure 13 Developer unit

The four developer units, PL 90.05, are engineer replaceable units (ERU) with an operational life expectancy of approximately 400 000 feeds for 20/25ppm speed machines or 480 000 feeds for 30/35ppm speed machines. The machine will stop operation when developer unit end of life is reached and will generate a fault code.

- Developer roll
- Augers (supply and toner reclamation/cleaning augers)
- Automatic toner control (ATC) sensor

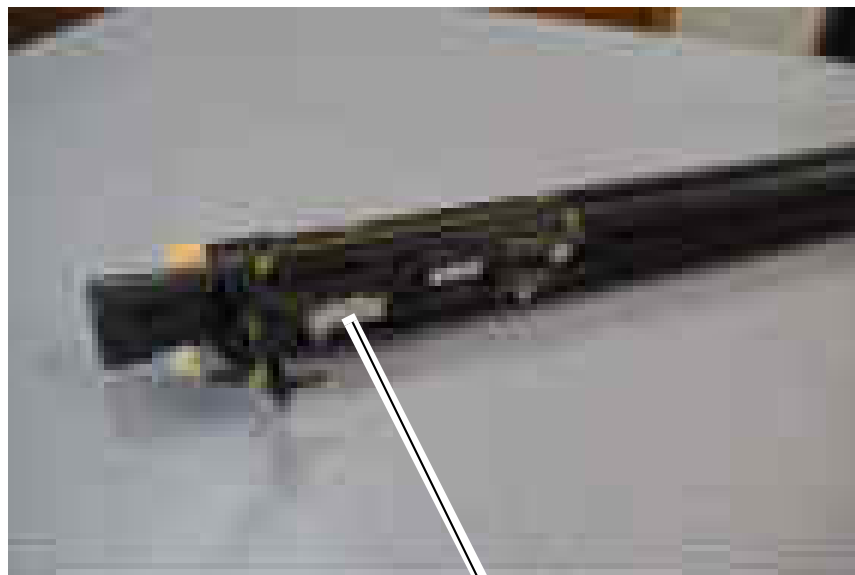
Figure 14 Developer unit electrical contact

The high voltages required by each developer unit to energize the developer rolls are provided by the high voltage power supply (HVPS), [PL 1.05 Item 7](#), through two high voltage contacts on the guide assembly that supports the developer unit. Refer to [Figure 14](#) and [Figure 15](#).

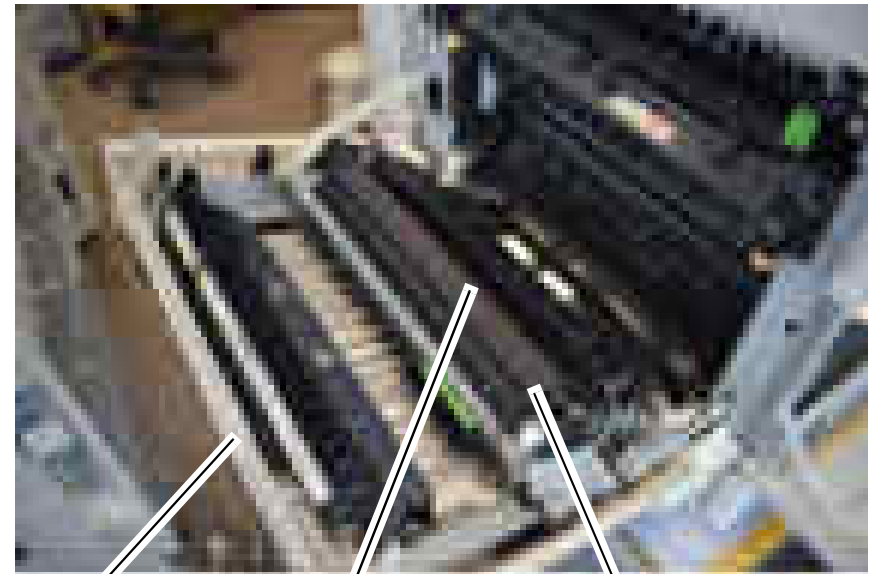
The paper is released from the transfer belt by the detack saw. A voltage is applied to the detack saw to eliminate the charge on the paper. Refer to [Figure 21](#).

NOTE: The detack saw is part of the 2nd roll assembly, [PL 90.40 Item 5](#).

L/H cover

2nd Bias transfer
roll

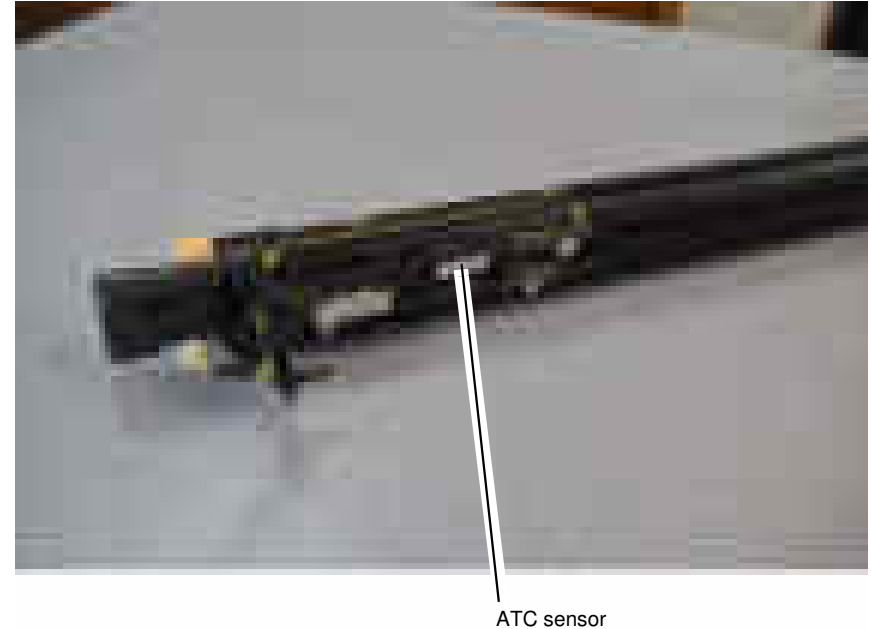
Figure 25 ATC Sensor

- The ATC sensor output is read at predetermined intervals.
- The read values, excluding some of the highest and lowest, are averaged.
- The difference between maximum and minimum values is calculated.
- The average read value is corrected to determine the ATC output value (current toner concentration).

After an ATC sensor check, the ATC target value is calculated. To calculate the ATC target value, the temperature and humidity correction values calculated from the environment sensor value in the machine and the developing material deterioration correction value calculated from the cumulative drum rotation time are added to the standard ATC target value. Refer to [Figure 25](#).

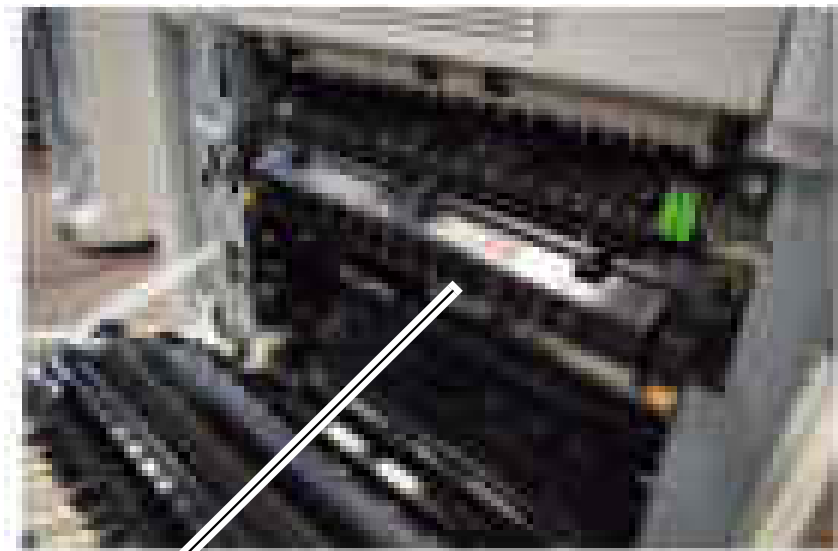
Figure 1 Fuser

NOTE: There are no spare parts in the fuser assembly. The fuser is replaced as an assembly.

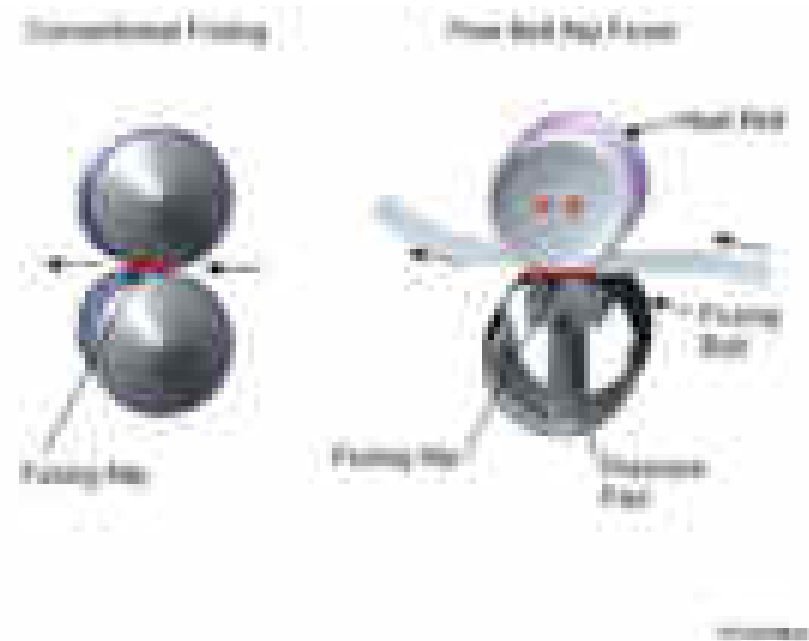
Figure 2 Free belt nip fuser

Fusing works using a free belt nip fusing mechanism consisting of a heat roll, and with a fusing belt in place of a pressure roll. The heat roll consists of a thin steel tube coated with teflon to control the build-up of static and an anti-wear agent. The heat roll and fuser belt are in constant contact during fusing, [Figure 2](#). The stripper blade physically removes the paper from the heat roll during processing. The heat roll receives drive from the main motor through a system of gears. The fusing belt is driven by the friction applied from the heat roll.

The heat roll is heated by main and sub heat rods. The two rods are used in various combinations depending on the operating conditions to achieve an even temperature along the entire length of the heat roll.

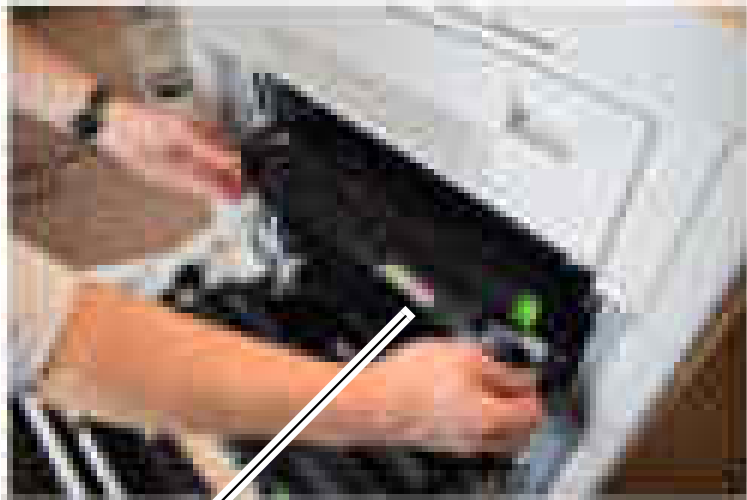
Figure 6 Fuser replacement

The fuser assembly will also age/degrade due to extended usage time. The ON time HFSI counter (chain-link 954-851) keeps track of machine ON time in seconds. When this HFSI reaches a count of 18,000,000 seconds (approximately 208 days), the CSE will be notified on the HFSI counter UI diagnostics screen that the fuser should be replaced. Note that the machine and fuser will continue to run if the fuser is not replaced at this time.

After installing a new fuser, the HFSI counters are reset automatically. Refer to [Figure 6](#).

Each A4 LEF fed sheet is counted as 10 HFSI counts. When the HFSI counter (chain-link 954-850) reaches a value of 1,000,000 (100,000 x 10), the CSE will be notified on the HFSI counter UI diagnostics screen that the fuser should be replaced. Note that the machine and fuser will continue to run if the fuser is not replaced at this time.

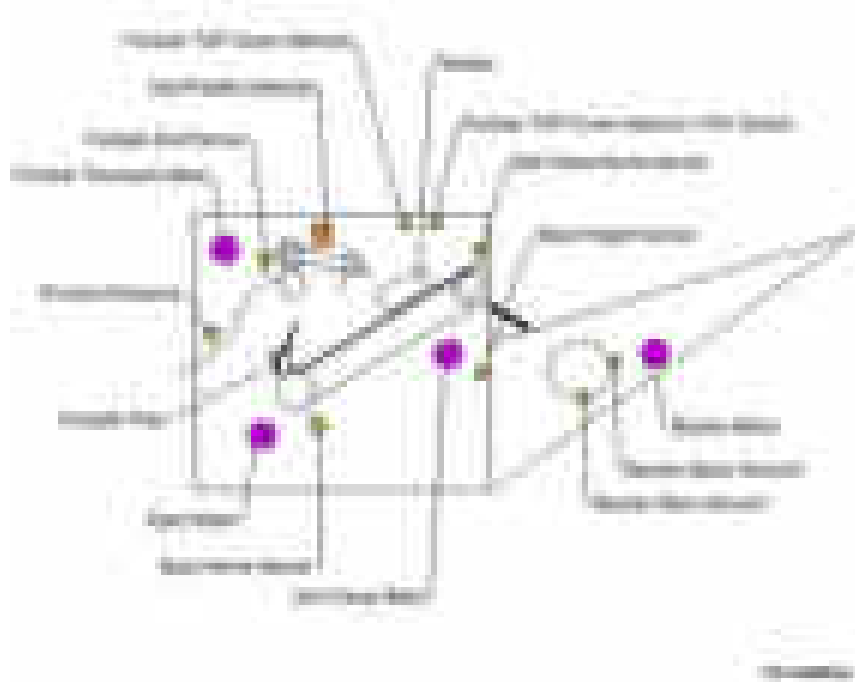
Figure 1 Components overview

The Integrated Office Finisher transports prints from the IOT to the compile tray where they are compiled and tamped into sets. The sets then are stapled and or offset (as specified) and delivered to the stack tray.

As the paper is transported past multiple sensors, signals are sent to the finisher PWB control logic that regulate various motors and solenoids used in the Integrated Office Finisher. Refer to [Figure 1](#).

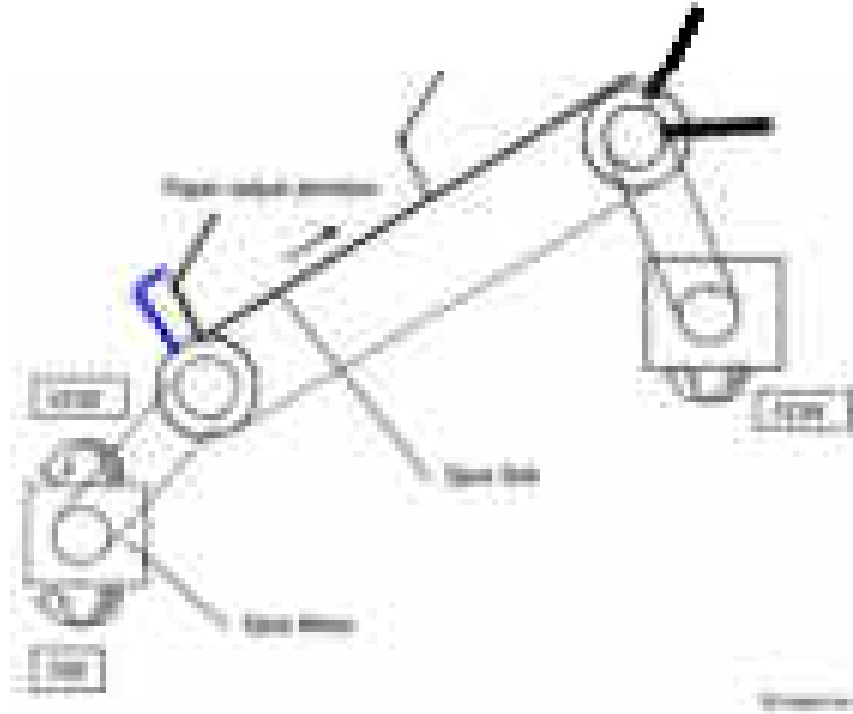
Figure 11 Set ejection operation

Once a specified number of sheets of paper have accumulated in the compile tray, the eject motor rotates forward (CW) for a specified time to drive the eject belts and output the set onto the stack tray.

Once the sets of paper have been output, the eject motor rotates in the reverse direction (CCW) to return the eject belts to the home position. Refer to [Figure 11](#).
