Xerox® VersaLink® C7000 Color Printer & C7030 Family Color Multifunction Printer Service Manual

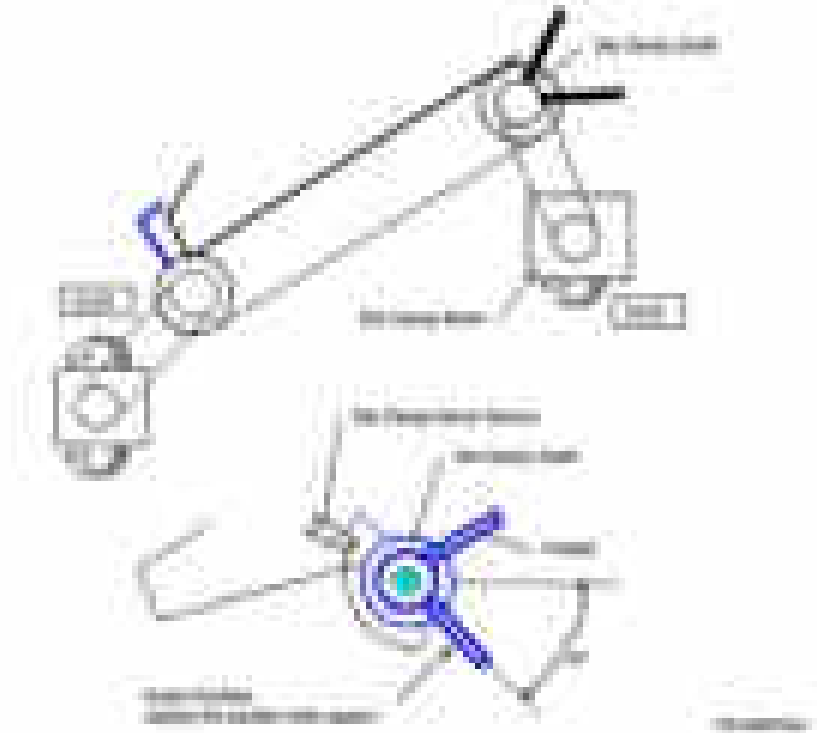
Figure 12 Set ejection operation detail

When the belt eject operation has output a set, the set clamp motor rotates in the reverse direction (CCW), which drives the set clamp shaft forward (CW). The paddles of the set clamp shaft rotate to register and hold the sheets of paper on the stack tray.

The home position of the set clamp shaft is such that the paddles hold paper. In this position the set clamp home sensor is not blocked. When the set clamp shaft is driven from its home position, the set clamp home sensor is blocked and the shaft will rotate until it returns to the home position. Refer to [Figure 12](#).

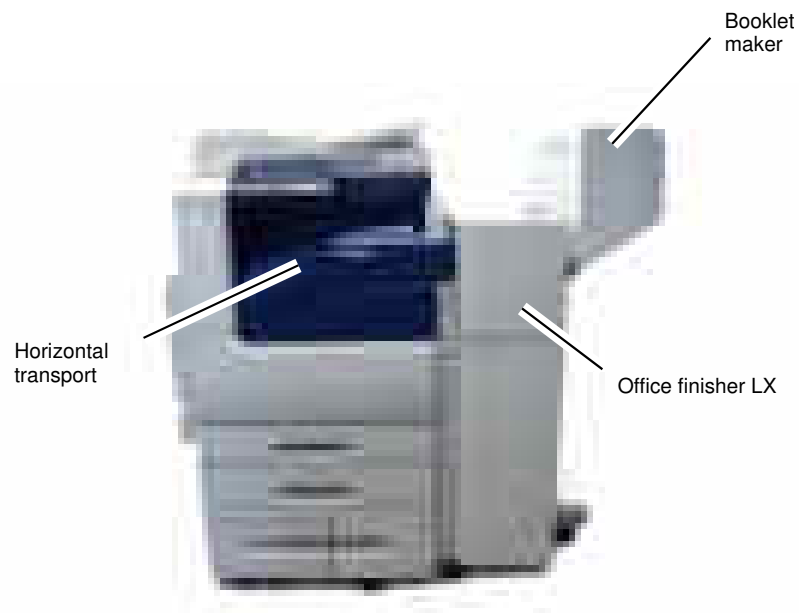
Figure 1 Overview

- **Horizontal Transport Assembly** - feeds the sheets exiting from the IOT to the finisher.
- **Finisher** - squares up the edges of sheets in the compiler tray to create sets and ejects/offsets the sets into the stacker tray.
- **Compiler Stapler** - Staples sets as specified.
- **Hole Punch Assembly** - Punches 2, 3 or 4 holes depending on the market. If ordered by the customer, the punch unit is in the horizontal transport.
- **Stacker Tray** - Collects the sets ejected from the finisher.
- **Booklet Maker** - (optional) saddle stitches and creases booklets

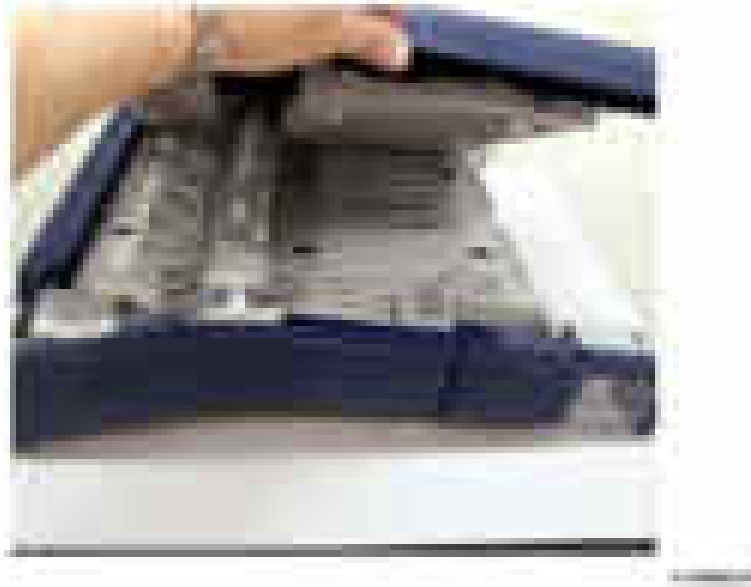
Figure 4 Horizontal transport assembly

The top cover can be opened for jam clearance. Refer to [Figure 4](#).

NOTE: If a booklet maker also is installed, the hole punch is installed in the horizontal transport.

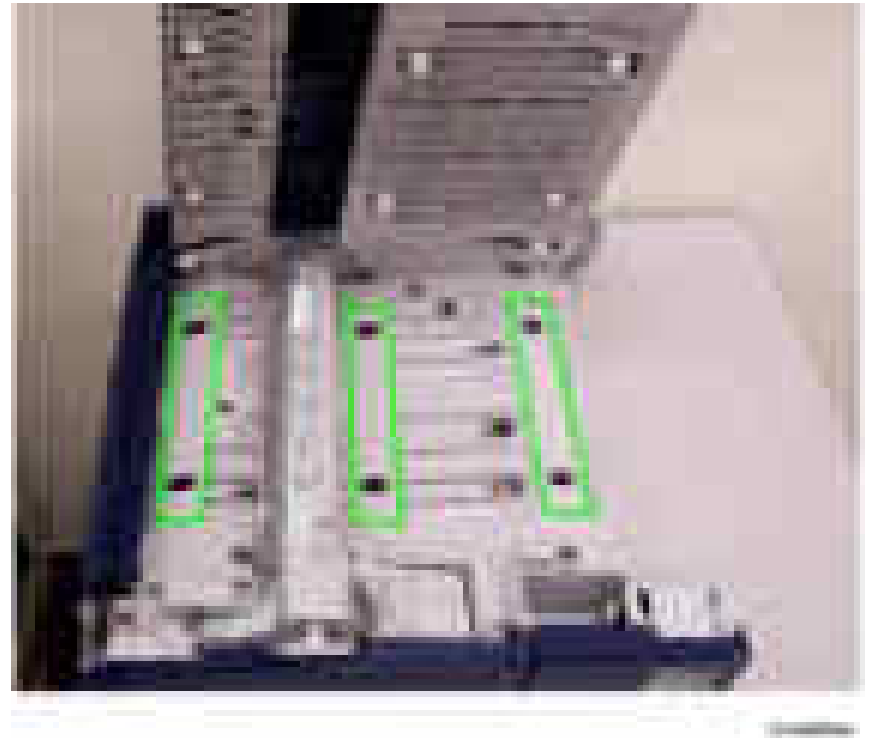
Figure 7 Transport rolls

The paper is moved through the horizontal transport assembly by three sets of transport rolls.

Drive is provided to the transport rolls by the transport motor through a system of gears and belts. Refer to [Figure 7](#).

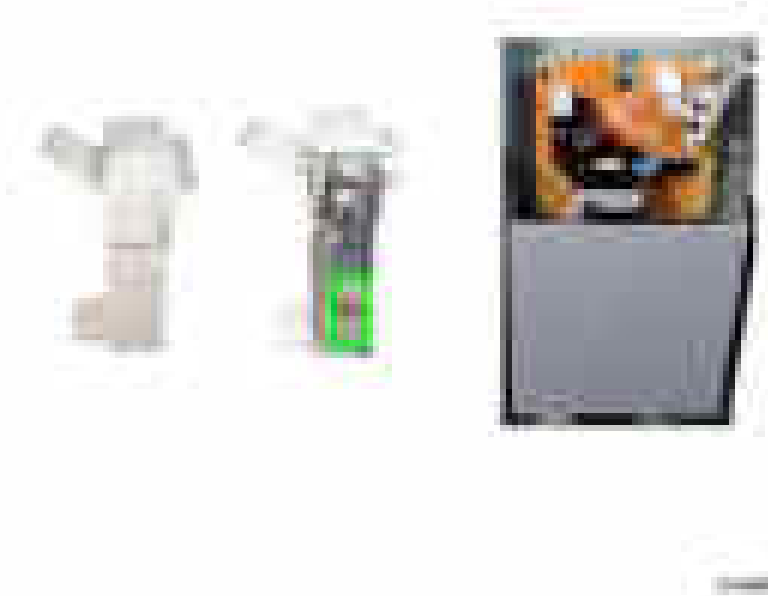
Figure 8 Low voltage power supply

Power is supplied to the finisher components by the low voltage power supply (LVPS).

The LVPS receives 110/240VAC supply from the GFI via the power cord and provides +24V to the finisher PWB. Refer to [Figure 8](#).

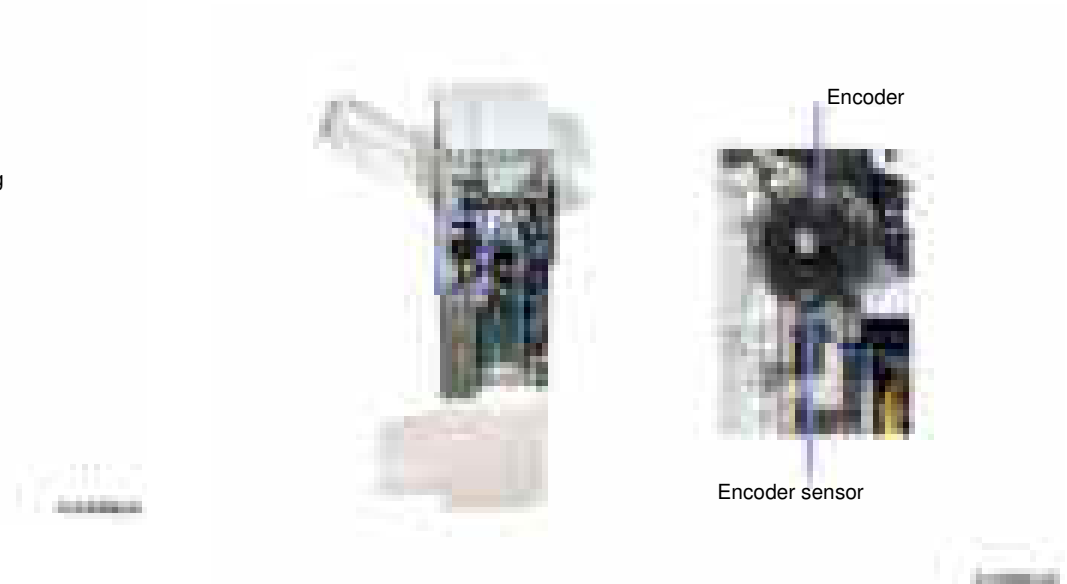
Figure 13 Encoder and sensor

The encoder has a number of apertures cut into it and is connected directly to the main stacker tray drive gear via a shaft.

As the stacker tray drive gear rotates to lower or raise the stacker tray, the encoder also rotates. The rotation of the encoder is monitored by the encoder wheel sensor which is an optical sensor that reflects light onto the encoder. Refer to [Figure 13](#).

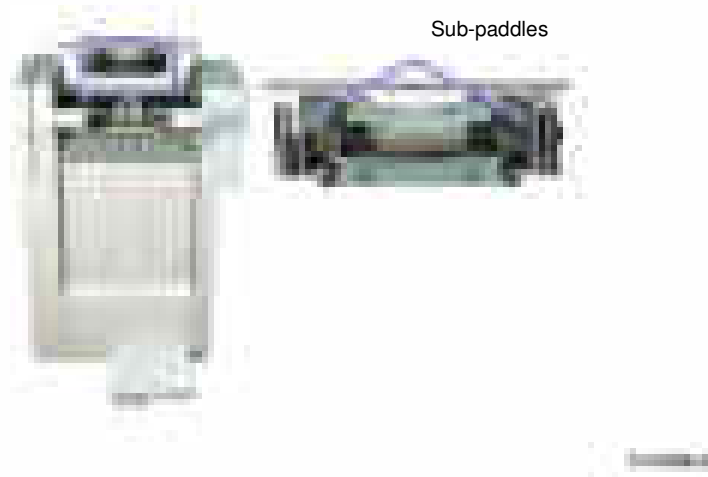
Figure 18 Sub paddle assembly

The sub-paddle assembly actively drives fed paper into the compiler tray when it exits the exit roll.

The sub-paddle assembly consists of a set of sub-paddles, an eject chute, and a solenoid. drive is provided by the transport motor. Refer to [Figure 18](#).

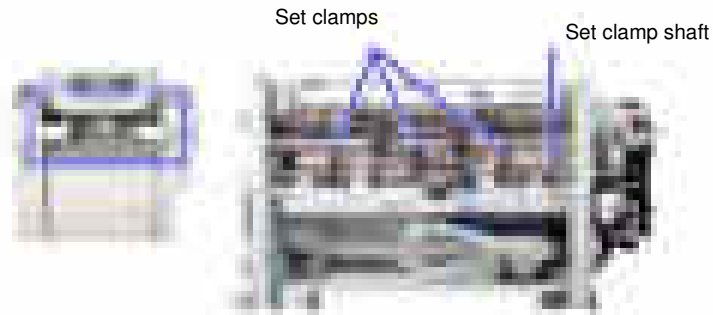
Figure 28 Set clamps

The set clamp assembly uses set clamps to hold sets of paper in position on the stacker tray. The set clamps are fixed to the set clamp shaft which is rotated by the set clamp quadrant gear. Drive is provided by the main exit drive gear. Refer to [Figure 28](#).

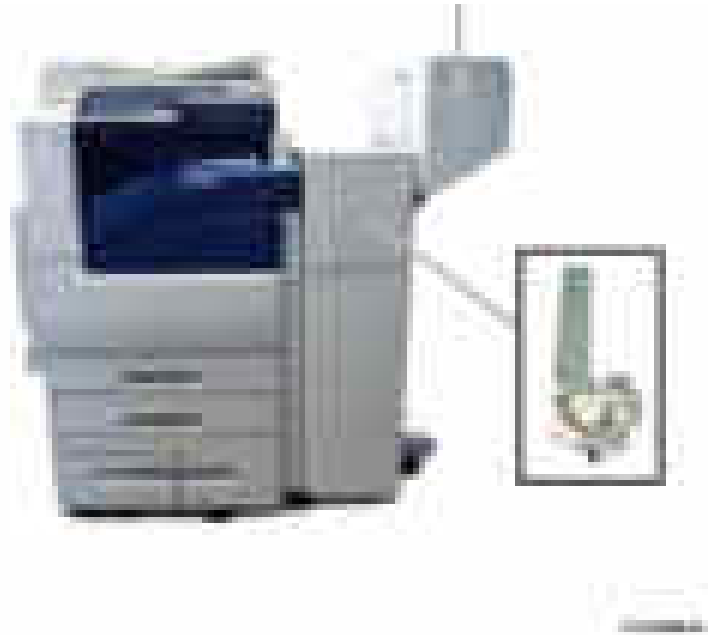
Figure 30 Booklet maker

The optional booklet maker produces pre-creased booklets with either 1 or 2 staples. The booklet maker is supplied with a crease assembly which is installed into the Finisher LX. Refer to [Figure 30](#).

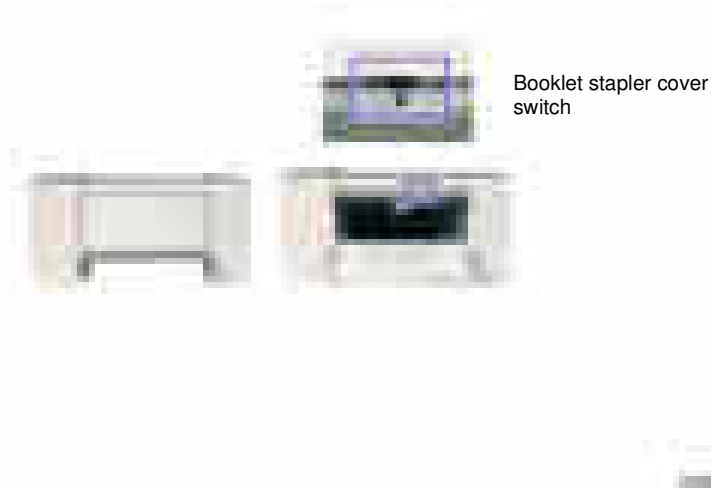
Figure 32 Booklet stapler cover switch

The booklet stapler cover switch is actuated when the side cover is opened. When actuated, all + 24V supplies are removed from the booklet maker. Refer to [Figure 32](#).

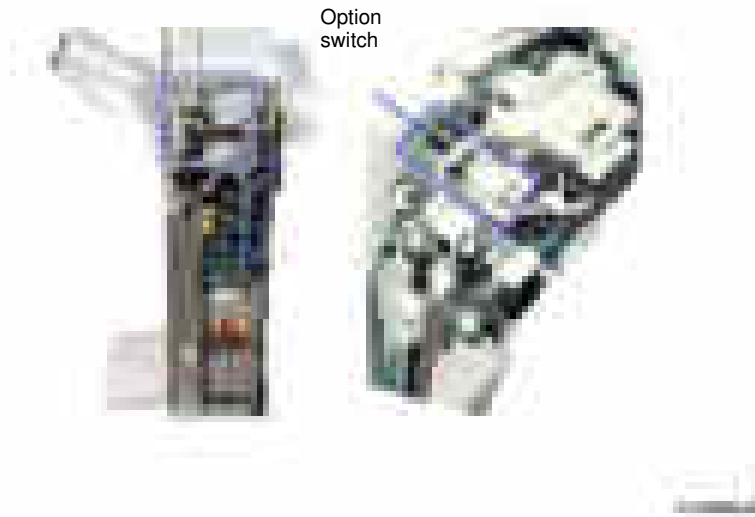
Figure 34 Finisher side interlock

An option switch is used to detect when the booklet maker is installed on the finisher. This Interlock is located on the Finisher LX, not the booklet maker.

When Interlocks are open, power is removed and an error message displays on the UI. Refer to [Figure 34](#).

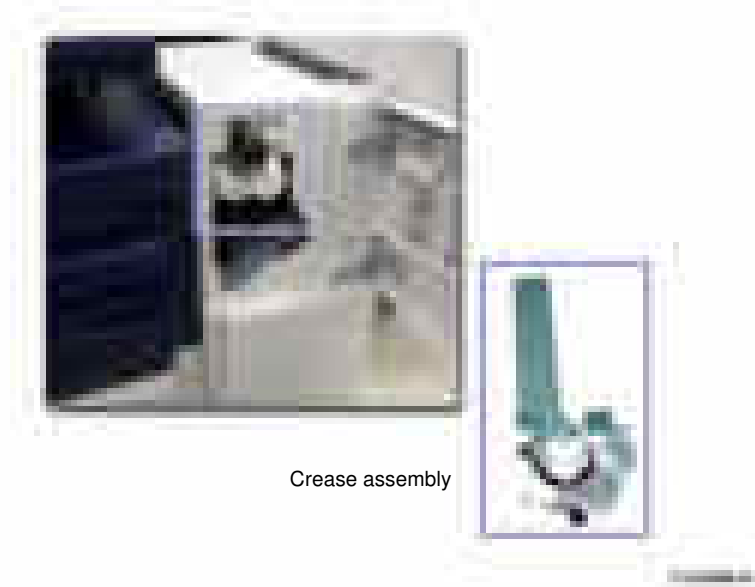
Figure 38 Crease assembly

It is installed behind the compiler within the Finisher LX and is controlled by the finisher PWB.

Refer to [Figure 38](#).

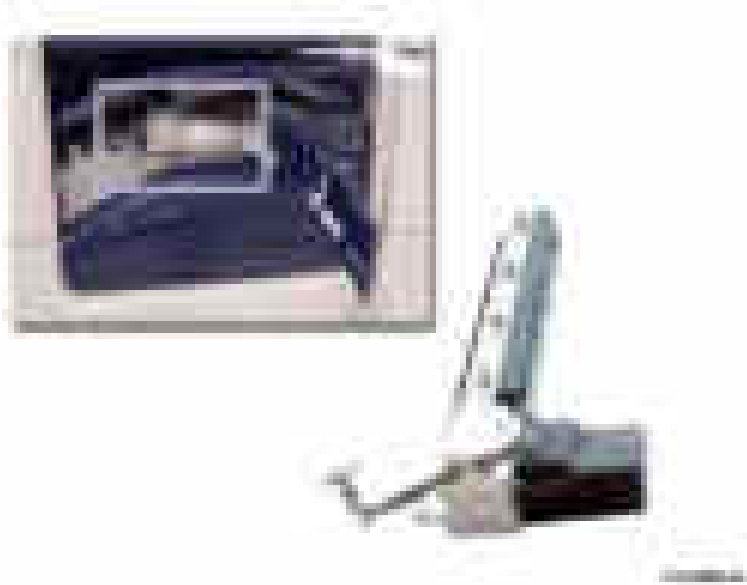
Figure 44 Hole punch assembly

The hole punch assembly punches either 2 or 4 holes in Europe or 2 or 3 holes in North America. The hole punch assembly is installed within the horizontal transport. It is controlled by the finisher PWB. Refer to [Figure 44](#).

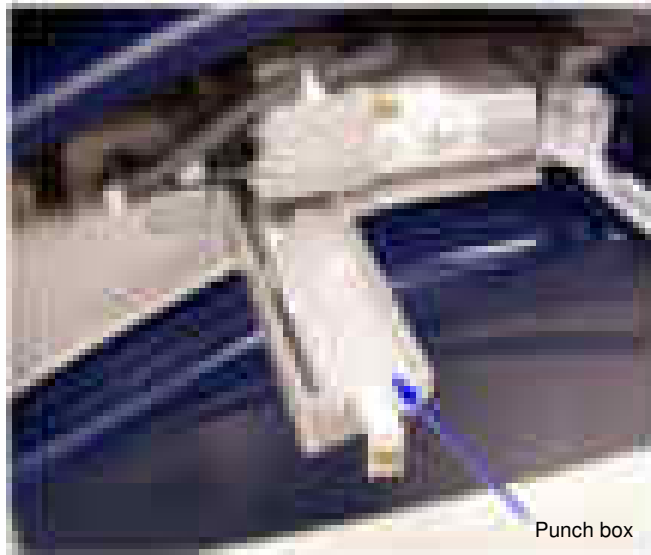
Figure 48 Hole punch box

The punch box is located beneath the hole punch assembly and collects the discarded chads. This will need to be emptied periodically. Refer to [Figure 48](#).
