1-5-2 Self-diagnosis

(1) Self-diagnostic function

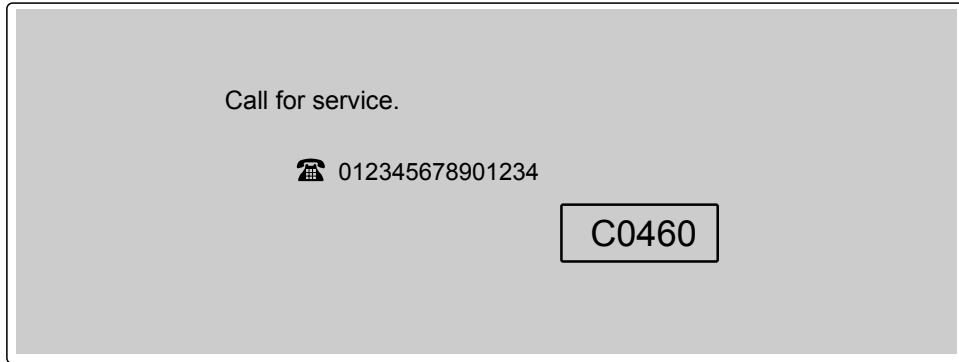
Figure 1-5-1

This unit is equipped with a self-diagnostic function. When a problem is detected, copying is disabled and the problem displayed as a code consisting of C followed by a number between 0060 and 9080, indicating the nature of the problem. A message is also displayed requesting the user to call for service.

After removing the problem, the self-diagnostic function can be reset by turning front cover/feed cover switch off and back on.
